Profile/Photo Observation Report

Date:	11/16/2021	Weather:		Coding:	PACP 7.0
Pipe Length (ft):	173.0	Owner:	City of Hobart	Pre Clean:	Heavy Cleaning
P.O.#:	YES502259	Surveyor:	S. Bucklin	PSR:	P-605-020-018
Customer:	City of Hobart	Clean Date:	11/16/2021	Shape:	C

Street:	Henry Street	Flow Control:	Not Controlled
City:	Hobart, IN	Year Renewed:	
Location:	Local rural streets with light traffic, t	Tape/Media #:	
Purpose:	Routine Assessment	Dia/Height:	12"
Use:	Sanitary Sewage Pipe	Material:	VCP
Drain Area:		Lining:	None
Category:	NA		
Comment:			
Location Details:		Direction of Survey:	Downstream
US MH:	M-605-018	DS MH:	M-605-020
		Total Length Surveyed (ft):	173.0

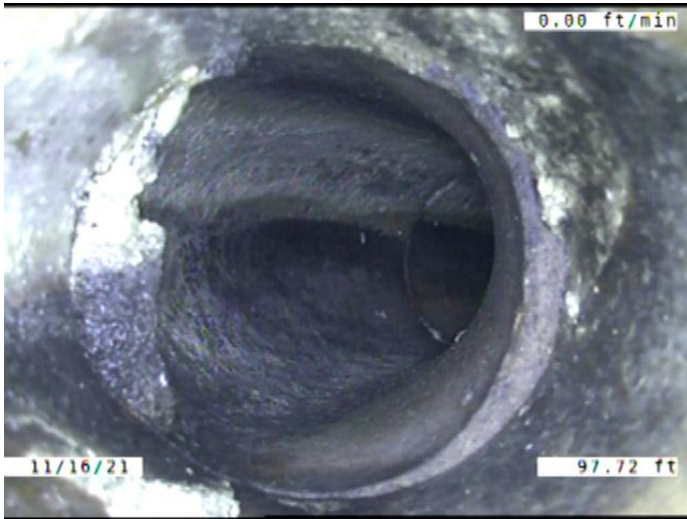
Code: **TFD**
Description: **Tap Factory Defective**

Distance (ft): **93.6**
Structural Grade: **0**
O&M Grade: **3**
Clock Start/From: **2**
Clock To:
1st Value: **4.000**
2nd Value:
Value Percent:
Continuous Index:
Within 8" of Joint: **YES**
Remarks: **OFFSET**

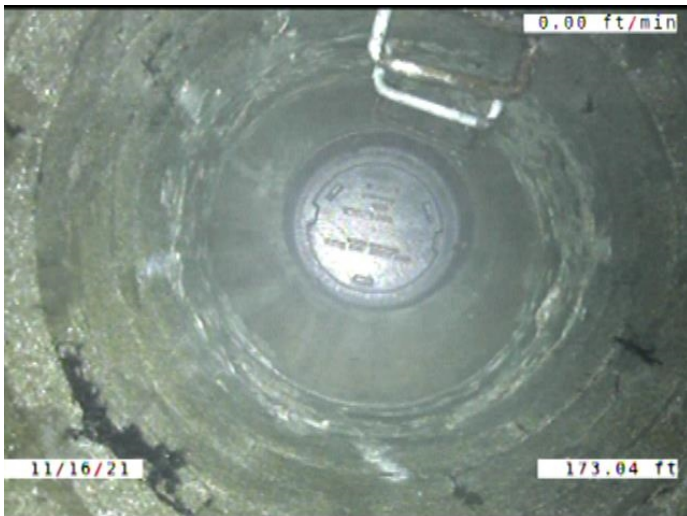
Code: **DAE**
 Description: **Deposits Attached Encrustation**

Distance (ft): **173.0**
 Structural Grade: **0**
 O&M Grade: **2**
 Clock Start/From: **7**
 Clock To: **5**
 1st Value:
 2nd Value:
 Value Percent: **5.000**
 Continuous Index: **F01**
 Within 8" of Joint: **YES**
 Remarks:
