Street:	Henry Street		Flow Control:	Not Controlled	
City:	City of Hobart		Year Renewed:		
Location:	Local rural streets with light traffic, t		Tape/Media #:		
Purpose:	Routine Assessment		Dia/Height:	12"	
Use:	Sanitary Sewage Pipe		Material:	VCP	
Drain Area:			Lining:	None	
Category:	NA				
Comment:					
Location Details:			Direction of Survey:	Downstream	
US MH:	M-605-021	DS MH:	M-605-023	Total Length Surveyed (ft):	175.7

Tuesday, April 25, 2023

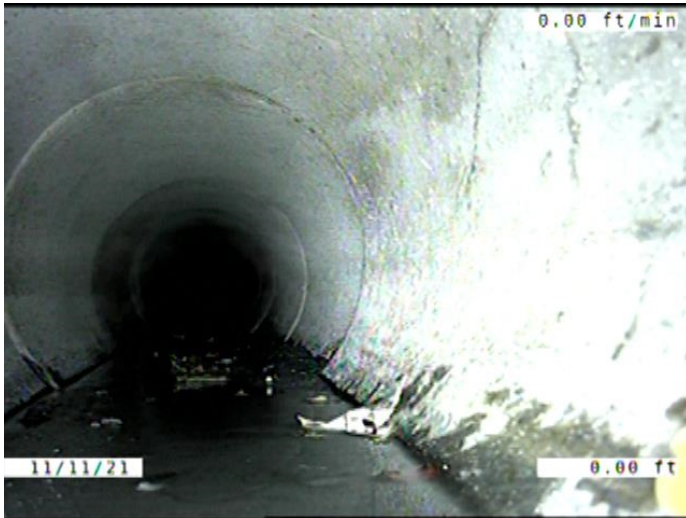
Code: **MWL**
Description: **Miscellaneous Water Level**

Distance (ft): **.0**
Structural Grade: **0**
O&M Grade: **0**
Clock Start/From:
Clock To:
1st Value:
2nd Value:
Value Percent: **5.000**
Continuous Index:
Within 8" of Joint: **NO**
Remarks:
