Profile/Photo Observation Report

Date:	11/11/2021	Weather:		Coding:	PACP 7.0
Pipe Length (ft):	175.7	Owner:	City of Hobart	Pre Clean:	Heavy Cleaning
P.O.#:	YES502259	Surveyor:	Steven Bucklin	PSR:	P-605-023-021
Customer:	City of Hobart, IN (Red	Clean Date:	11/10/2021	Shape:	C

Street:	Henry Street	Flow Control:	Not Controlled
City:	City of Hobart	Year Renewed:	
Location:	Local rural streets with light traffic, t	Tape/Media #:	
Purpose:	Routine Assessment	Dia/Height:	12"
Use:	Sanitary Sewage Pipe	Material:	VCP
Drain Area:		Lining:	None
Category:	NA		
Comment:			
Location Details:		Direction of Survey:	Downstream
US MH:	M-605-021	DS MH:	M-605-023
		Total Length Surveyed (ft):	175.7

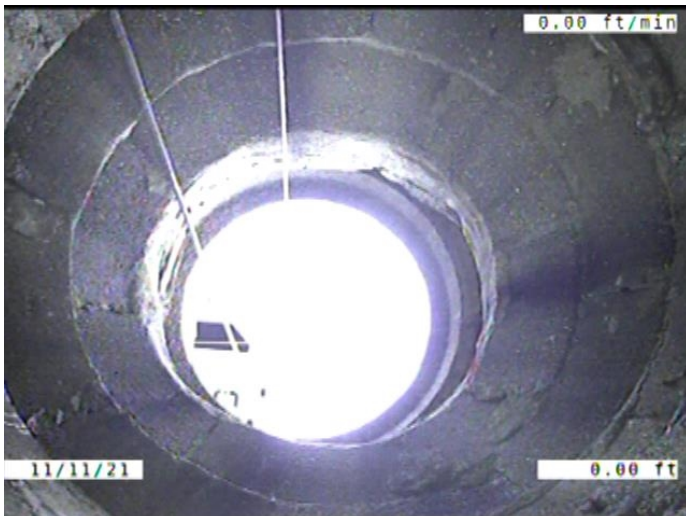
Code: **AMH**
Description: **Manhole**

Distance (ft): **.0**
Structural Grade: **0**
O&M Grade: **0**
Clock Start/From:
Clock To:
1st Value:
2nd Value:
Value Percent:
Continuous Index:
Within 8" of Joint: **NO**
Remarks: **M-605-021**

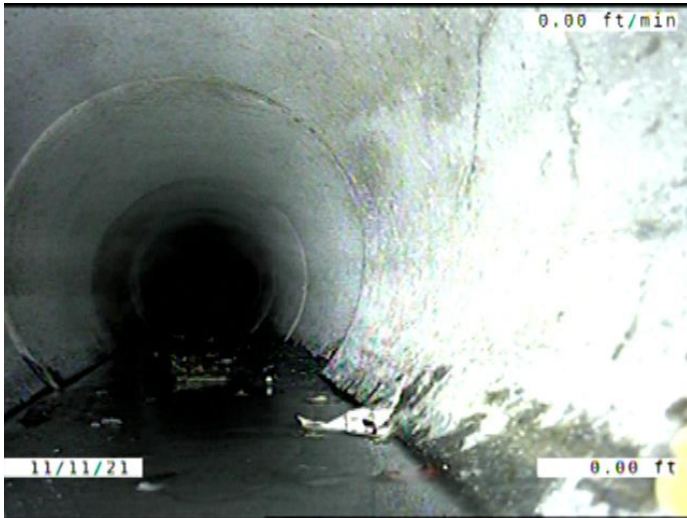
Code: **MWL**
Description: **Miscellaneous Water Level**

Distance (ft): **.0**
Structural Grade: **0**
O&M Grade: **0**
Clock Start/From:
Clock To:
1st Value:
2nd Value:
Value Percent: **5.000**
Continuous Index:
Within 8" of Joint: **NO**
Remarks:

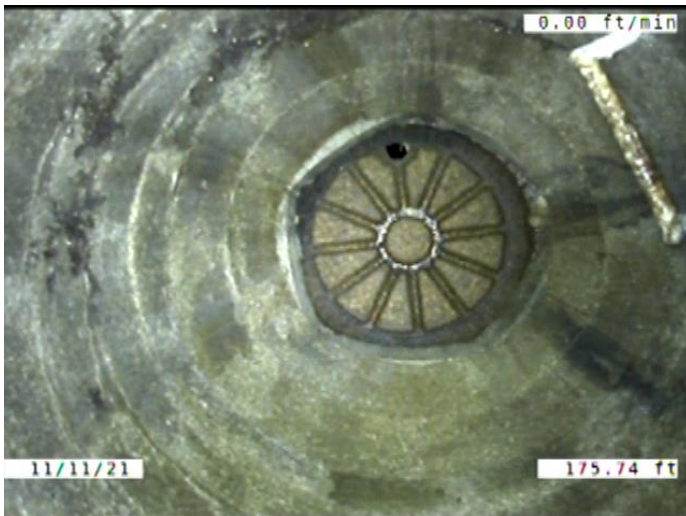
Code: **AMH**
 Description: **Manhole**

Distance (ft): **175.7**
 Structural Grade: **0**
 O&M Grade: **0**
 Clock Start/From:
 Clock To:
 1st Value:
 2nd Value:
 Value Percent:
 Continuous Index:
 Within 8" of Joint: **NO**
 Remarks: **M-605-023**
