## Profile/Photo Observation Report

Date:	11/11/2021	Weather:		Coding:	PACP 7.0
Pipe Length (ft):	141.6	Owner:	City of Hobart	Pre Clean:	Heavy Cleaning
P.O.#:	YES502259	Surveyor:	Steven Bucklin	PSR:	P-605-022-023
Customer:	City of Hobart, IN (Red	Clean Date:	11/10/2021	Shape:	C

Street:	West 2nd Street	Flow Control:	Not Controlled
City:	City of Hobart	Year Renewed:	
Location:	Local rural streets with light traffic, t	Tape/Media #:	
Purpose:	Routine Assessment	Dia/Height:	10"
Use:	Sanitary Sewage Pipe	Material:	VCP
Drain Area:		Lining:	None
Category:	NA		
Comment:			
Location Details:		Direction of Survey:	Upstream
US MH:	M-605-023	DS MH:	M-605-022
		Total Length Surveyed (ft):	141.5

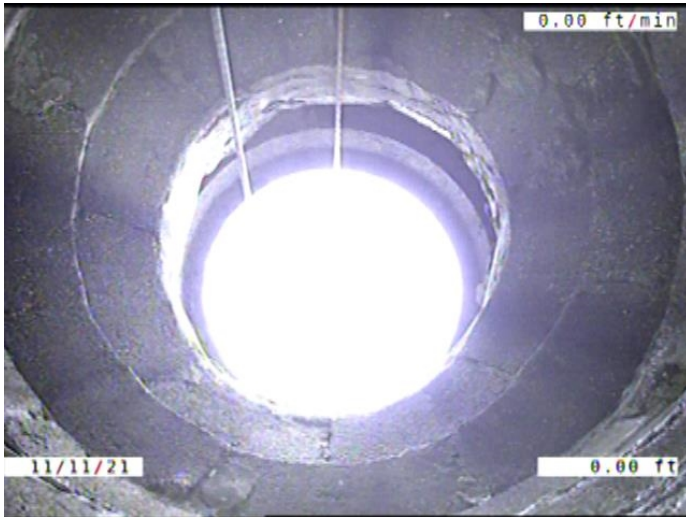
Code: **AMH**  
 Description: **Manhole**

Distance (ft): **.0**  
 Structural Grade: **0**  
 O&M Grade: **0**  
 Clock Start/From:  
 Clock To:  
 1st Value:  
 2nd Value:  
 Value Percent:  
 Continuous Index:  
 Within 8" of Joint: **NO**  
 Remarks: **M-605-022**

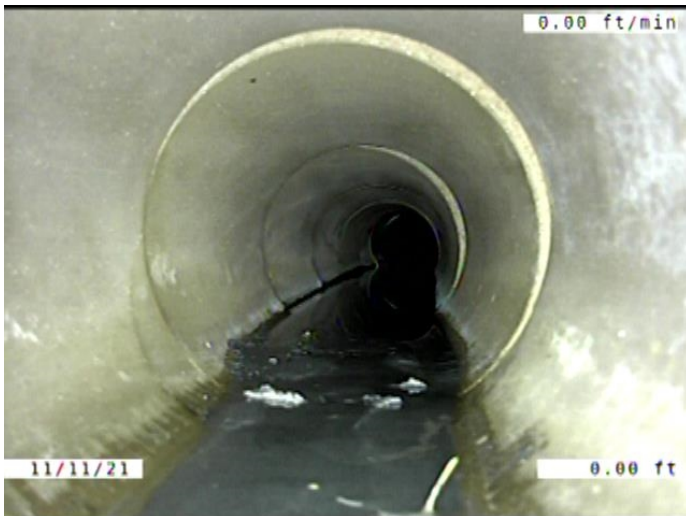
Code: **MWL**  
 Description: **Miscellaneous Water Level**

Distance (ft): **.0**  
 Structural Grade: **0**  
 O&M Grade: **0**  
 Clock Start/From:  
 Clock To:  
 1st Value:  
 2nd Value:  
 Value Percent: **5.000**  
 Continuous Index:  
 Within 8" of Joint: **NO**  
 Remarks:

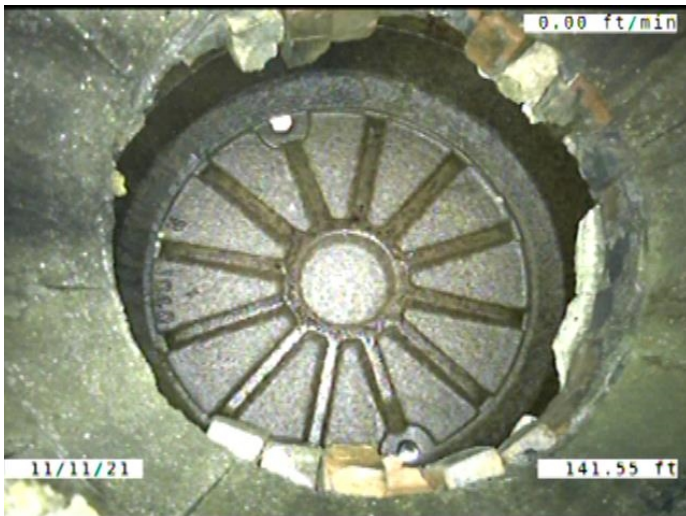
Code: **AMH**  
 Description: **Manhole**

Distance (ft): **141.5**  
 Structural Grade: **0**  
 O&M Grade: **0**  
 Clock Start/From:  
 Clock To:  
 1st Value:  
 2nd Value:  
 Value Percent:  
 Continuous Index:  
 Within 8" of Joint: **NO**  
 Remarks: **M-605-023**
