Street:	West 2nd Street		Flow Control:	Not Controlled	
City:	City of Hobart		Year Renewed:		
Location:	Local rural streets with light traffic, t		Tape/Media #:		
Purpose:	Routine Assessment		Dia/Height:	10"	
Use:	Sanitary Sewage Pipe		Material:	VCP	
Drain Area:			Lining:	None	
Category:	NA				
Comment:					
Location Details:			Direction of Survey:	Upstream	
US MH:	M-605-023	DS MH:	M-605-024	Total Length Surveyed (ft):	140.7

Tuesday, April 25, 2023

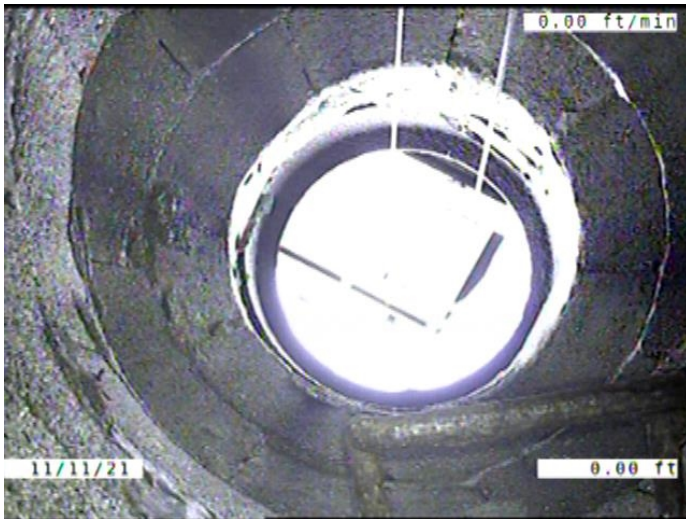
Code: **AMH**
Description: **Manhole**

Distance (ft): **.0**
Structural Grade: **0**
O&M Grade: **0**
Clock Start/From:
Clock To:
1st Value:
2nd Value:
Value Percent:
Continuous Index:
Within 8" of Joint: **NO**
Remarks: **M-605-024**
