Street:	West 2nd Street		Flow Control:	Not Controlled	
City:	City of Hobart		Year Renewed:		
Location:	Local rural streets with light traffic, t		Tape/Media #:		
Purpose:	Routine Assessment		Dia/Height:	10"	
Use:	Sanitary Sewage Pipe		Material:	VCP	
Drain Area:			Lining:	None	
Category:	NA				
Comment:					
Location Details:			Direction of Survey:	Upstream	
US MH:	M-605-023	DS MH:	M-605-024	Total Length Surveyed (ft):	140.7

**Wednesday, January 19, 2022**

**M-605-023**

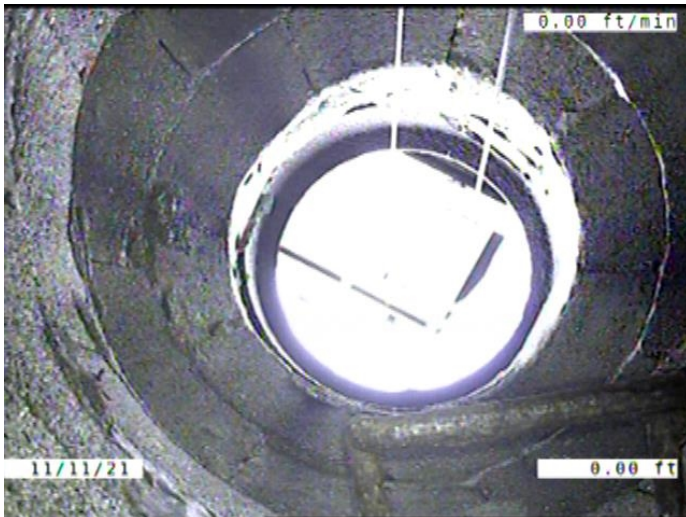
Code: **AMH**  
Description: **Manhole**

Distance (ft): **.0**  
Structural Grade: **0**  
O&M Grade: **0**  
Clock Start/From:  
Clock To:  
1st Value:  
2nd Value:  
Value Percent:  
Continuous Index:  
Within 8" of Joint: **NO**  
Remarks: **M-605-024**

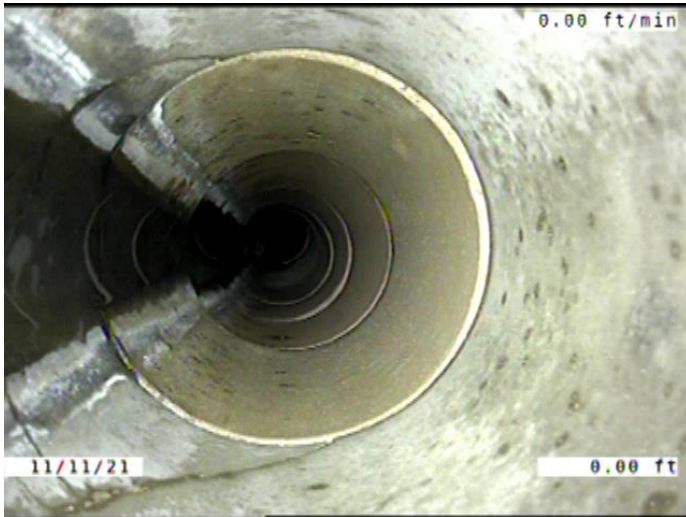
Code: **MWL**  
 Description: **Miscellaneous Water Level**

Distance (ft): **.0**  
 Structural Grade: **0**  
 O&M Grade: **0**  
 Clock Start/From:  
 Clock To:  
 1st Value:  
 2nd Value:  
 Value Percent: **5.000**  
 Continuous Index:  
 Within 8" of Joint: **NO**  
 Remarks:

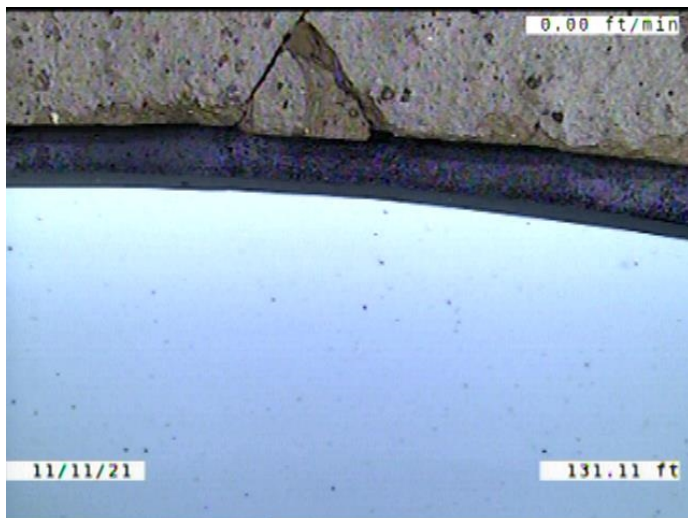
Code: **MMC**  
 Description: **Miscellaneous Material Change**

Distance (ft): **131.1**  
 Structural Grade: **0**  
 O&M Grade: **0**  
 Clock Start/From:  
 Clock To:  
 1st Value:  
 2nd Value:  
 Value Percent:  
 Continuous Index:  
 Within 8" of Joint: **NO**  
 Remarks: **VCP TO PVC**

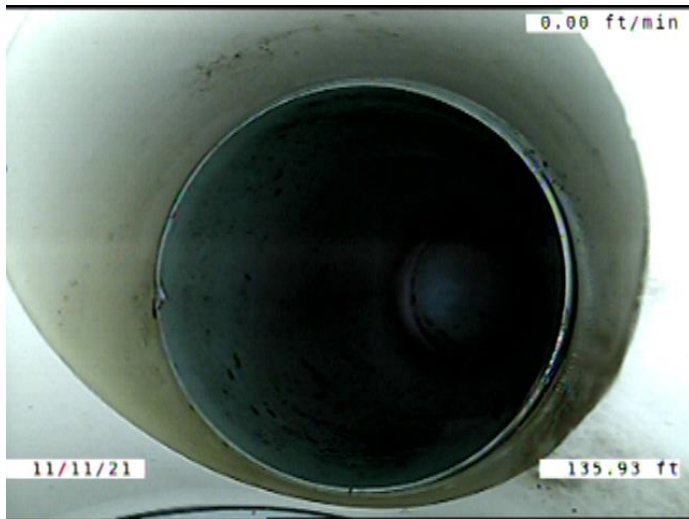
Code: **TF**  
 Description: **Tap Factory**

Distance (ft): **135.9**  
 Structural Grade: **0**  
 O&M Grade: **0**  
 Clock Start/From: **2**  
 Clock To:  
 1st Value: **4.000**  
 2nd Value:  
 Value Percent:  
 Continuous Index:  
 Within 8" of Joint: **YES**  
 Remarks:

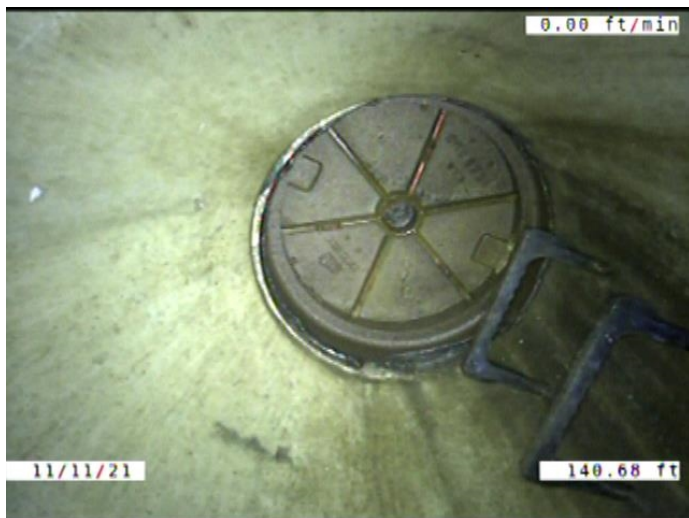
Code: **AMH**  
 Description: **Manhole**

Distance (ft): **140.7**  
 Structural Grade: **0**  
 O&M Grade: **0**  
 Clock Start/From:  
 Clock To:  
 1st Value:  
 2nd Value:  
 Value Percent:  
 Continuous Index:  
 Within 8" of Joint: **NO**  
 Remarks: **M-605-023**
