Profile/Photo Observation Report

Date:	04/25/2018	Weather:		Coding:	PACP 6.0
Pipe Length (ft):	247.1	Owner:	NA	Pre Clean:	Not Known
P.O.#:		Surveyor:	Jen Costello	PSR:	P-605-026-025
Customer:		Clean Date:	01/01/1900	Shape:	C

Street:	Ash	Flow Control:	Not Controlled
City:	Hobart, IN	Year Renewed:	
Location:	Other	Tape/Media #:	
Purpose:	Not Known	Dia/Height:	12"
Use:	Sanitary	Material:	VCP
Drain Area:	NA	Lining:	
Category:	NA		
Comment:	Flow direction wrong.

Location Details:		Direction of Survey:	Downstream
US MH:	M-605-025	DS MH:	M-605-026
		Total Length Surveyed (ft):	248.5

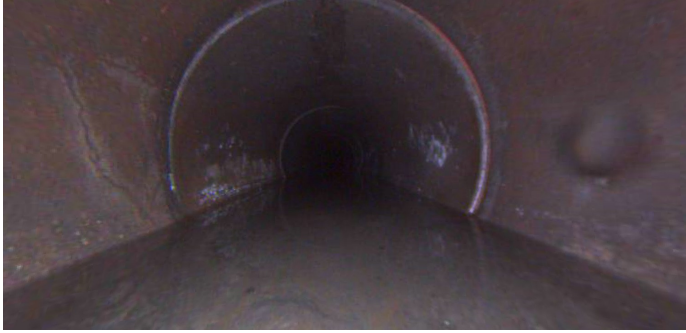
Code: **AMH**
Description: **Manhole**

Distance (ft): **.0**
Structural Grade: **0**
O&M Grade: **0**
Clock Start/From:
Clock To:
1st Value:
2nd Value:
Value Percent:
Continuous Index:
Within 8" of Joint: **NO**
Remarks: **M-605-025**

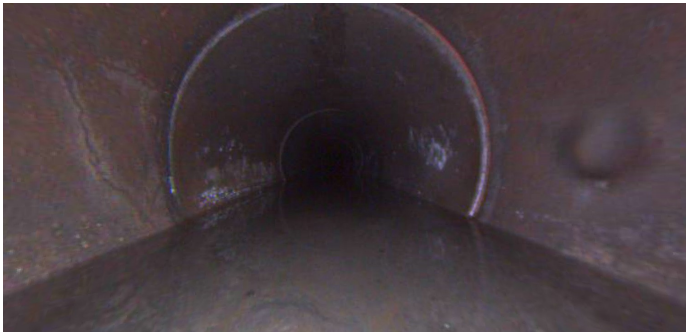
Code: **MWL**
Description: **Water Level**

Distance (ft): **.0**
Structural Grade: **0**
O&M Grade: **0**
Clock Start/From:
Clock To:
1st Value:
2nd Value:
Value Percent: **20.000**
Continuous Index:
Within 8" of Joint: **NO**
Remarks:

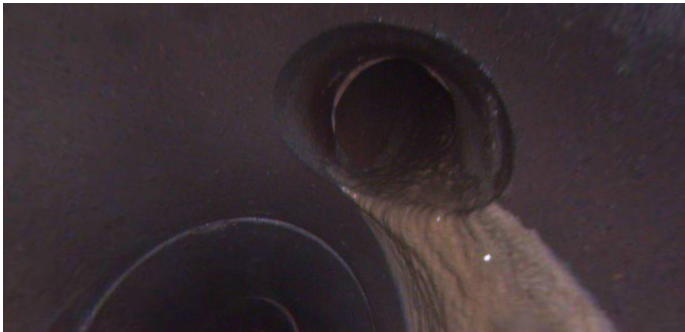
Code: **TFA**
Description: **Tap Factory Active**

Distance (ft): **12.5**
Structural Grade: **0**
O&M Grade: **0**
Clock Start/From: **1**
Clock To:
1st Value: **4.000**
2nd Value:
Value Percent:
Continuous Index:
Within 8" of Joint:
Remarks:

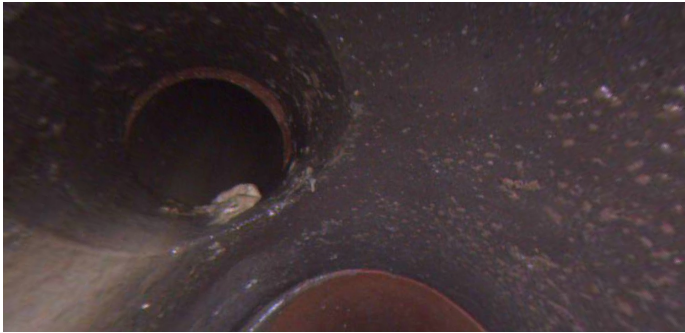
Code: **TF**
Description: **Tap Factory**

Distance (ft): **47.8**
Structural Grade: **0**
O&M Grade: **0**
Clock Start/From: **11**
Clock To:
1st Value: **4.000**
2nd Value:
Value Percent:
Continuous Index:
Within 8" of Joint:
Remarks:

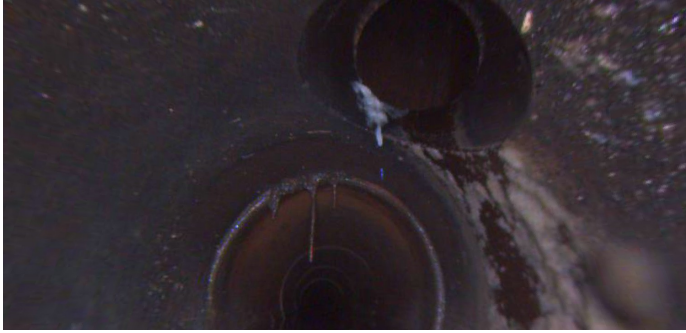
Code: **TF**
Description: **Tap Factory**

Distance (ft): **53.7**
Structural Grade: **0**
O&M Grade: **0**
Clock Start/From: **1**
Clock To:
1st Value: **4.000**
2nd Value:
Value Percent:
Continuous Index:
Within 8" of Joint:
Remarks:

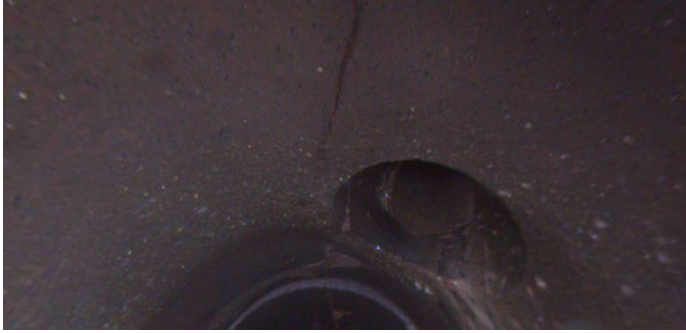
Code: **TF**
Description: **Tap Factory**

Distance (ft): **92.9**
Structural Grade: **0**
O&M Grade: **0**
Clock Start/From: **1**
Clock To:
1st Value: **4.000**
2nd Value:
Value Percent:
Continuous Index:
Within 8" of Joint:
Remarks:

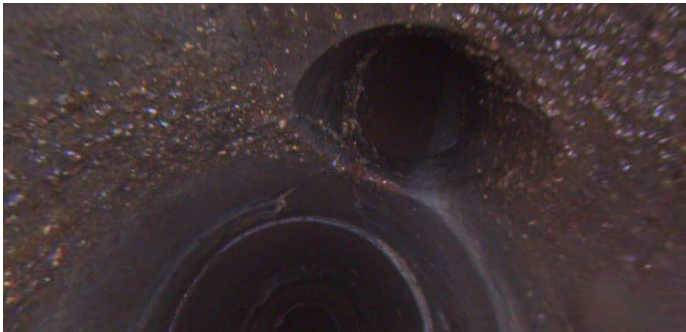
Code: **TF**
Description: **Tap Factory**

Distance (ft): **132.3**
Structural Grade: **0**
O&M Grade: **0**
Clock Start/From: **1**
Clock To:
1st Value: **4.000**
2nd Value:
Value Percent:
Continuous Index:
Within 8" of Joint:
Remarks:

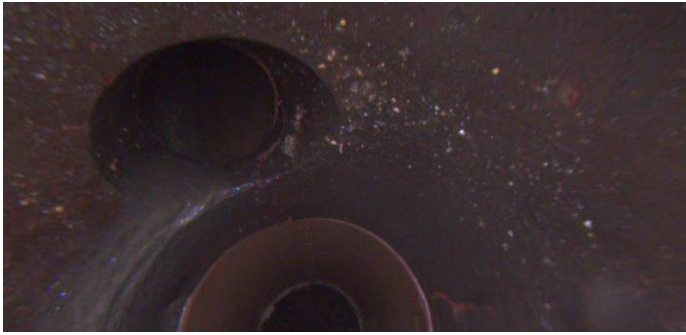
Code: **TF**
Description: **Tap Factory**

Distance (ft): **134.2**
Structural Grade: **0**
O&M Grade: **0**
Clock Start/From: **11**
Clock To:
1st Value: **4.000**
2nd Value:
Value Percent:
Continuous Index:
Within 8" of Joint:
Remarks:

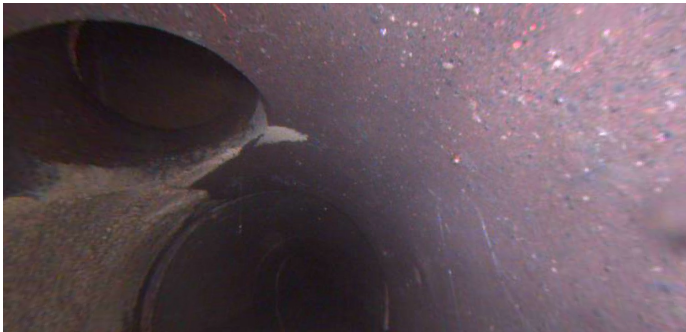
Code: **TF**
Description: **Tap Factory**

Distance (ft): **157.0**
Structural Grade: **0**
O&M Grade: **0**
Clock Start/From: **11**
Clock To:
1st Value: **4.000**
2nd Value:
Value Percent:
Continuous Index:
Within 8" of Joint:
Remarks:

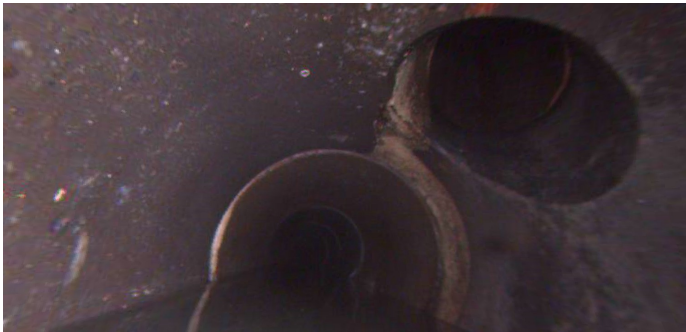
Code: **TF**
Description: **Tap Factory**

Distance (ft): **175.3**
Structural Grade: **0**
O&M Grade: **0**
Clock Start/From: **2**
Clock To:
1st Value: **4.000**
2nd Value:
Value Percent:
Continuous Index:
Within 8" of Joint:
Remarks:

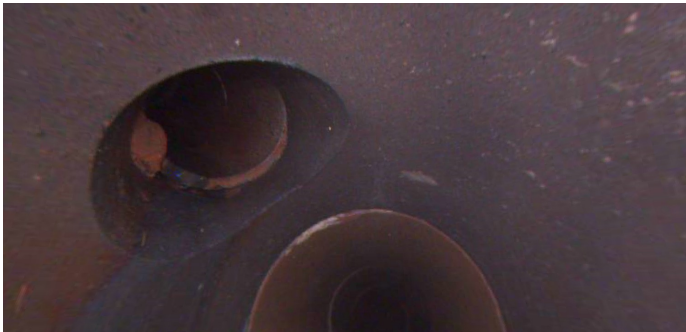
Code: **TF**
Description: **Tap Factory**

Distance (ft): **201.9**
Structural Grade: **0**
O&M Grade: **0**
Clock Start/From: **10**
Clock To:
1st Value: **4.000**
2nd Value:
Value Percent:
Continuous Index:
Within 8" of Joint:
Remarks:

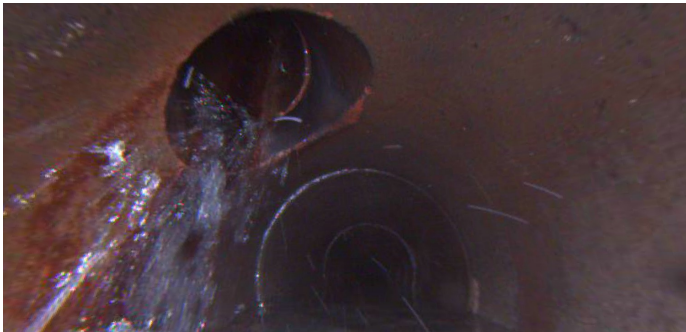
Code: **TFA**
Description: **Tap Factory Active**

Distance (ft): **238.3**
Structural Grade: **0**
O&M Grade: **0**
Clock Start/From: **10**
Clock To:
1st Value: **4.000**
2nd Value:
Value Percent:
Continuous Index:
Within 8" of Joint:
Remarks:

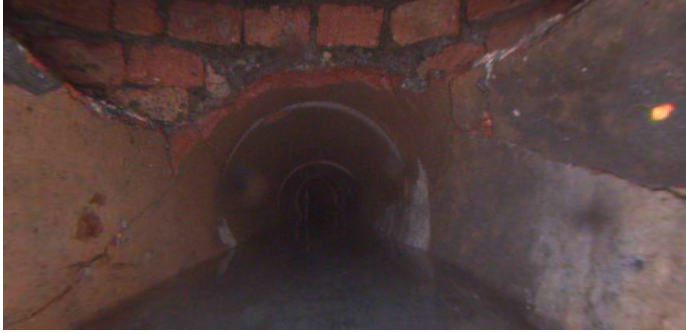
Code:	AMH
Description:	Manhole
Distance (ft):	248.5
Structural Grade:	0
O&M Grade:	0
Clock Start/From:	
Clock To:	
1st Value:	
2nd Value:	
Value Percent:	
Continuous Index:	
Within 8" of Joint:	NO
Remarks:	M-605-026
