## Profile/Photo Observation Report

Street:	<b>W 2ND ST &amp; S ASH ST</b>	Flow Control:	<b>Not Controlled</b>
City:	<b>Hobart, IN</b>	Year Renewed:	
Location:	<b>Other</b>	Tape/Media #:	
Purpose:	<b>Not Known</b>	Dia/Height:	<b>12"</b>
Use:	<b>Sanitary</b>	Material:	<b>VCP</b>
Drain Area:	<b>NA</b>	Lining:	
Category:	<b>NA</b>		
Comment:

Location Details:		Direction of Survey:	<b>Downstream</b>
US MH:	<b>M-605-026</b>	DS MH:	<b>M-605-027</b>
		Total Length Surveyed (ft):	<b>48.0</b>

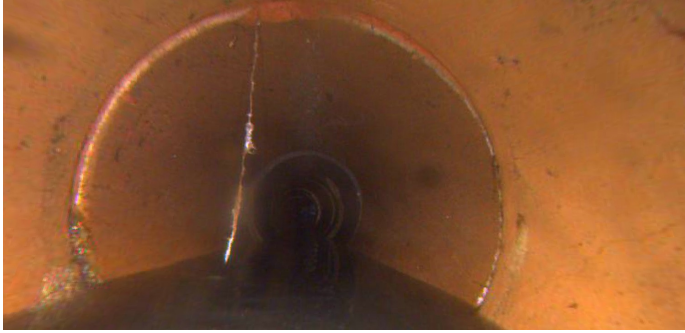
Code: **AMH**  
Description: **Manhole**

Distance (ft): **.0**  
Structural Grade: **0**  
O&M Grade: **0**  
Clock Start/From:  
Clock To:  
1st Value:  
2nd Value:  
Value Percent:  
Continuous Index:  
Within 8" of Joint: **NO**  
Remarks: **M-605-026**

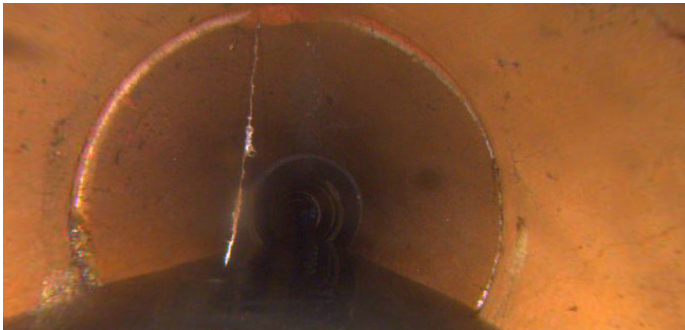
Code: **MWL**  
Description: **Water Level**

Distance (ft): **.0**  
Structural Grade: **0**  
O&M Grade: **0**  
Clock Start/From:  
Clock To:  
1st Value:  
2nd Value:  
Value Percent: **20.000**  
Continuous Index:  
Within 8" of Joint: **NO**  
Remarks:

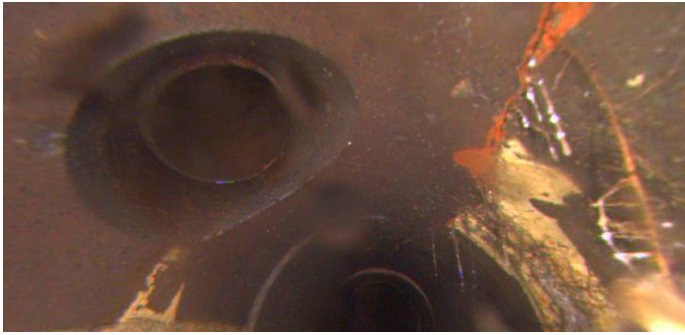
Code: **TF**  
Description: **Tap Factory**

Distance (ft): **26.7**  
Structural Grade: **0**  
O&M Grade: **0**  
Clock Start/From: **11**  
Clock To:  
1st Value: **4.000**  
2nd Value:  
Value Percent:  
Continuous Index:  
Within 8" of Joint:  
Remarks:
