RedZone  
ROBOTICS

Street:	South Ash Street		Flow Control:	Not Controlled	
City:	City of Hobart		Year Renewed:		
Location:	Local rural streets with light traffic, t		Tape/Media #:		
Purpose:	Routine Assessment		Dia/Height:	12"	
Use:	Sanitary Sewage Pipe		Material:	VCP	
Drain Area:			Lining:	None	
Category:	NA				
Comment:					
Location Details:			Direction of Survey:	Downstream	
US MH:	M-605-027	DS MH:	M-605-028	Total Length Surveyed (ft):	175.9

O&M Index:	<b>1.97</b>	O&M Quick:	<b>423A</b>	O&M Rating:	<b>179.00</b>
Structural Index:	<b>3.86</b>	Structural Quick:	<b>524I</b>	Structural Rating:	<b>224.00</b>
Overall Index:	<b>2.70</b>	Overall Quick:	<b>524I</b>	Overall Rating:	<b>403.00</b>

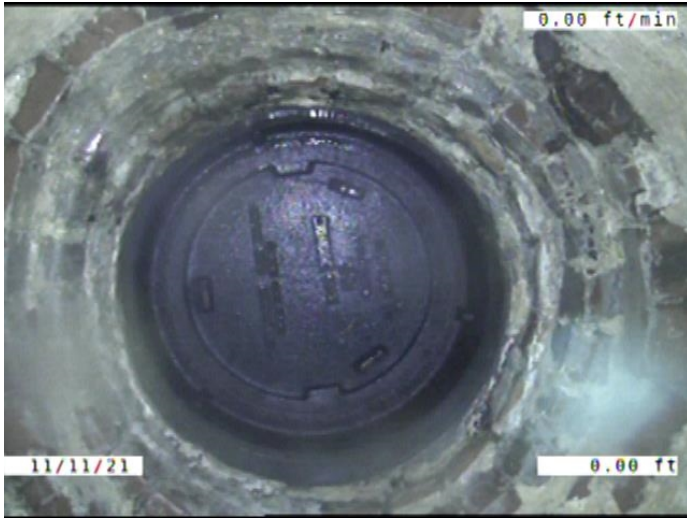
Code: **AMH**  
Description: **Manhole**

Distance (ft): **.0**  
Structural Grade: **0**  
O&M Grade: **0**  
Clock Start/From:  
Clock To:  
1st Value:  
2nd Value:  
Value Percent:  
Continuous Index:  
Within 8" of Joint: **NO**  
Remarks: **M-605-027**

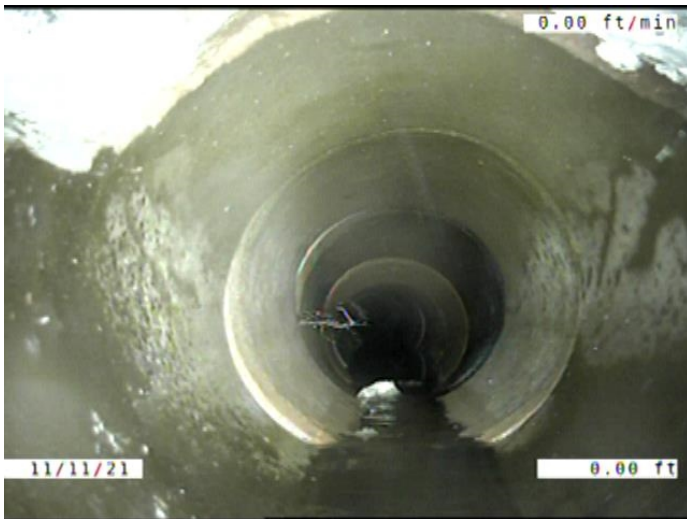
Code: **MWL**  
Description: **Miscellaneous Water Level**

Distance (ft): **.0**  
Structural Grade: **0**  
O&M Grade: **0**  
Clock Start/From:  
Clock To:  
1st Value:  
2nd Value:  
Value Percent: **5.000**  
Continuous Index:  
Within 8" of Joint: **NO**  
Remarks:

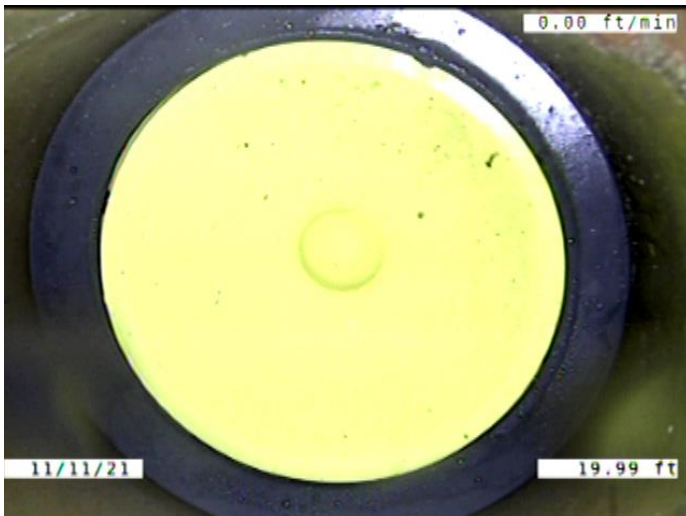
Code: **TFC**  
 Description: **Tap Factory Capped**

Distance (ft): **20.0**  
 Structural Grade: **0**  
 O&M Grade: **0**  
 Clock Start/From: **1**  
 Clock To:  
 1st Value: **4.000**  
 2nd Value:  
 Value Percent:  
 Continuous Index:  
 Within 8" of Joint: **YES**  
 Remarks:

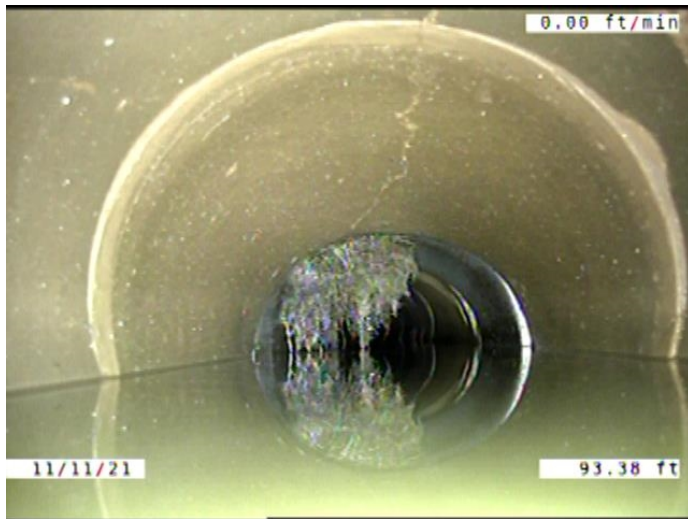
Code: **MWL**  
 Description: **Miscellaneous Water Level**

Distance (ft): **93.4**  
 Structural Grade: **0**  
 O&M Grade: **0**  
 Clock Start/From:  
 Clock To:  
 1st Value:  
 2nd Value:  
 Value Percent: **40.000**  
 Continuous Index:  
 Within 8" of Joint: **NO**  
 Remarks:

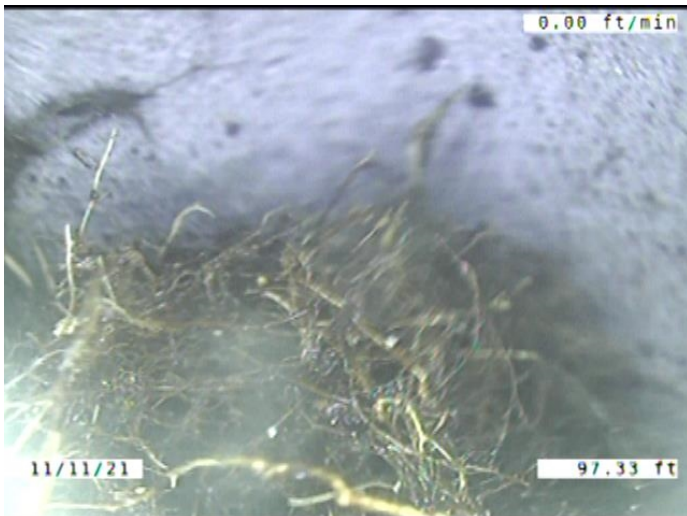
Code: **MCU**  
 Description: **Miscellaneous Camera Underwater**

Distance (ft): **97.3**  
 Structural Grade: **0**  
 O&M Grade: **4**  
 Clock Start/From:  
 Clock To:  
 1st Value:  
 2nd Value:  
 Value Percent:  
 Continuous Index:  
 Within 8" of Joint: **NO**  
 Remarks: **Out at 98.1**

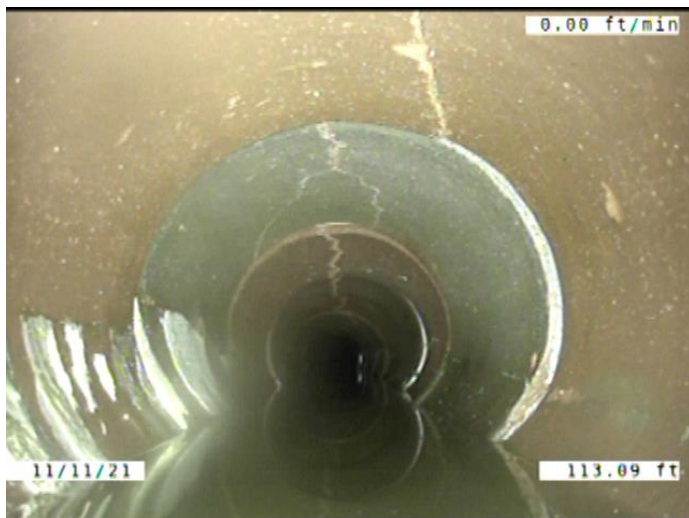
Code: **MWL**  
Description: **Miscellaneous Water Level**

Distance (ft): **113.1**  
Structural Grade: **0**  
O&M Grade: **0**  
Clock Start/From:  
Clock To:  
1st Value:  
2nd Value:  
Value Percent: **5.000**  
Continuous Index:  
Within 8" of Joint: **NO**  
Remarks:

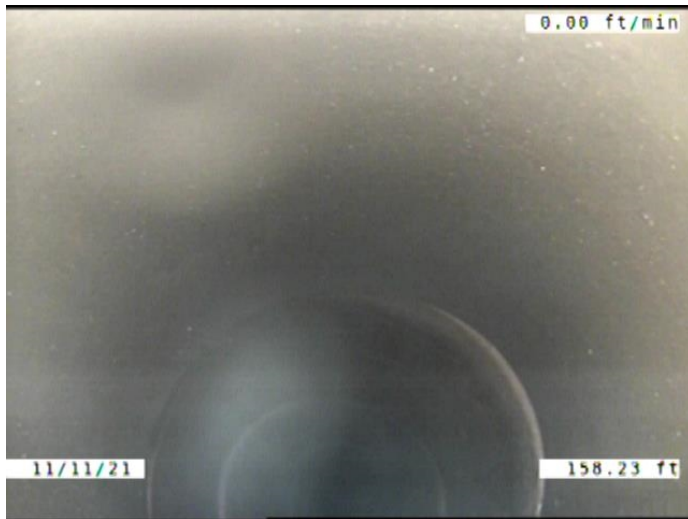
Code: **MWL**  
Description: **Miscellaneous Water Level**

Distance (ft): **158.2**  
Structural Grade: **0**  
O&M Grade: **0**  
Clock Start/From:  
Clock To:  
1st Value:  
2nd Value:  
Value Percent: **15.000**  
Continuous Index:  
Within 8" of Joint: **NO**  
Remarks:

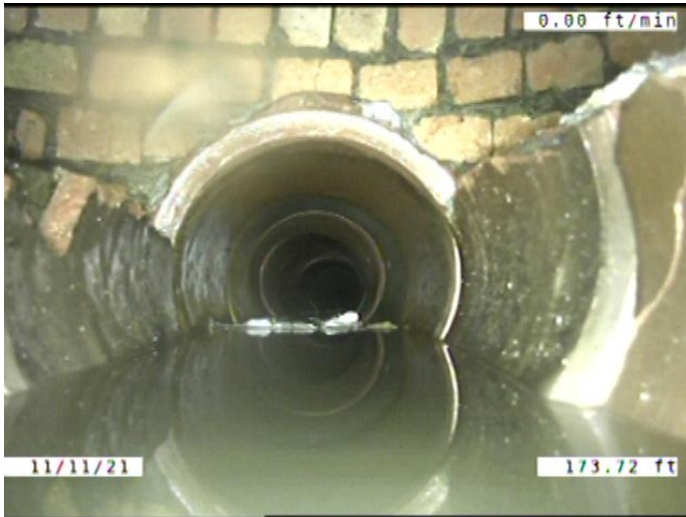
Code: **MWL**  
 Description: **Miscellaneous Water Level**

Distance (ft): **173.7**  
 Structural Grade: **0**  
 O&M Grade: **0**  
 Clock Start/From:  
 Clock To:  
 1st Value:  
 2nd Value:  
 Value Percent: **5.000**  
 Continuous Index:  
 Within 8" of Joint: **NO**  
 Remarks:

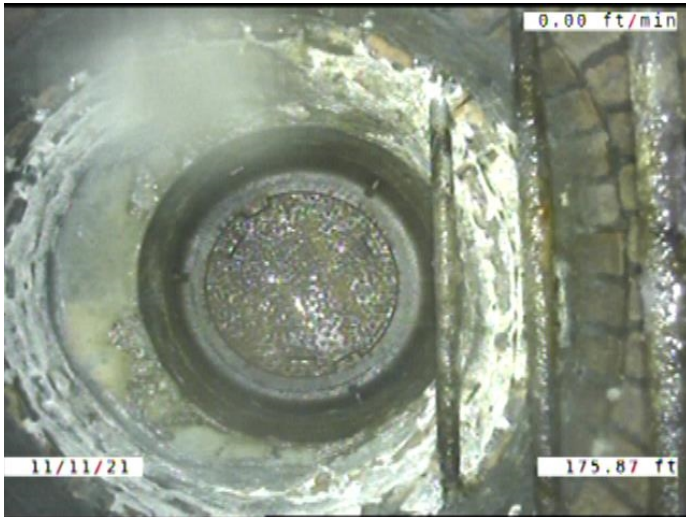
Code:	<b>AMH</b>
Description:	<b>Manhole</b>
Distance (ft):	<b>175.9</b>
Structural Grade:	<b>0</b>
O&M Grade:	<b>0</b>
Clock Start/From:	
Clock To:	
1st Value:	
2nd Value:	
Value Percent:	
Continuous Index:	
Within 8" of Joint:	<b>NO</b>
Remarks:	<b>M-605-028</b>
