## Profile/Photo Observation Report

Date:	11/11/2021	Weather:		Coding:	PACP 7.0
Pipe Length (ft):	172.2	Owner:	City of Hobart	Pre Clean:	Heavy Cleaning
P.O.#:	YES502259	Surveyor:	Steven Bucklin	PSR:	P-605-029-028
Customer:	City of Hobart, IN (Red	Clean Date:	11/10/2021	Shape:	C

Street:	South Ash Street	Flow Control:	Not Controlled
City:	City of Hobart	Year Renewed:	
Location:	Local rural streets with light traffic, t	Tape/Media #:	
Purpose:	Routine Assessment	Dia/Height:	12"
Use:	Sanitary Sewage Pipe	Material:	VCP
Drain Area:		Lining:	None
Category:	NA		
Comment:			
Location Details:		Direction of Survey:	Downstream
US MH:	M-605-028	DS MH:	M-605-029
		Total Length Surveyed (ft):	172.2

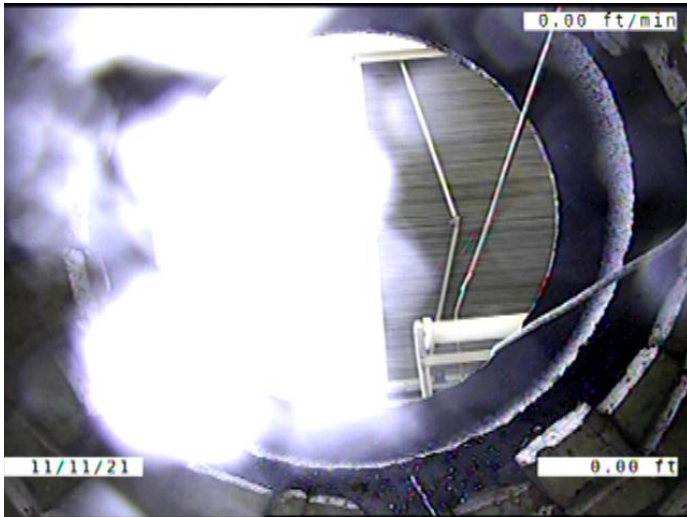
Code: **AMH**  
 Description: **Manhole**

Distance (ft): **.0**  
 Structural Grade: **0**  
 O&M Grade: **0**  
 Clock Start/From:  
 Clock To:  
 1st Value:  
 2nd Value:  
 Value Percent:  
 Continuous Index:  
 Within 8" of Joint: **NO**  
 Remarks: **M-605-028**

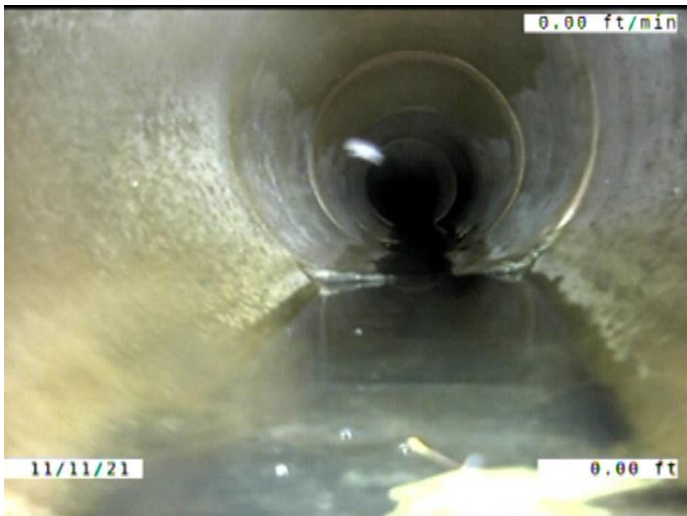
Code: **MWL**  
 Description: **Miscellaneous Water Level**

Distance (ft): **.0**  
 Structural Grade: **0**  
 O&M Grade: **0**  
 Clock Start/From:  
 Clock To:  
 1st Value:  
 2nd Value:  
 Value Percent: **5.000**  
 Continuous Index:  
 Within 8" of Joint: **NO**  
 Remarks:

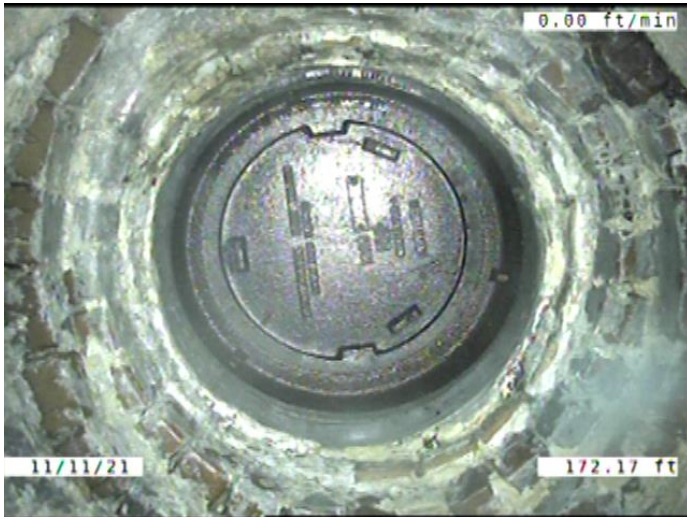
Code:	<b>AMH</b>
Description:	<b>Manhole</b>
Distance (ft):	<b>172.2</b>
Structural Grade:	<b>0</b>
O&M Grade:	<b>0</b>
Clock Start/From:	
Clock To:	
1st Value:	
2nd Value:	
Value Percent:	
Continuous Index:	
Within 8" of Joint:	<b>NO</b>
Remarks:	<b>M-605-029</b>
