Profile/Photo Observation Report

Date:	04/25/2018	Weather:		Coding:	PACP 6.0
Pipe Length (ft):	.0	Owner:	NA	Pre Clean:	Not Known
P.O.#:		Surveyor:	Jen Costello	PSR:	P-605-038-037
Customer:		Clean Date:	01/01/1900	Shape:	C

Street:	Summerlin	Flow Control:	Not Controlled
City:	Hobart, IN	Year Renewed:	
Location:	Light Highway	Tape/Media #:	
Purpose:	Not Known	Dia/Height:	12"
Use:	Sanitary	Material:	VCP
Drain Area:	NA	Lining:	
Category:	NA		
Comment:

Location Details:		Direction of Survey:	Downstream
US MH:	M-605-037	DS MH:	M-605-038
		Total Length Surveyed (ft):	288.0

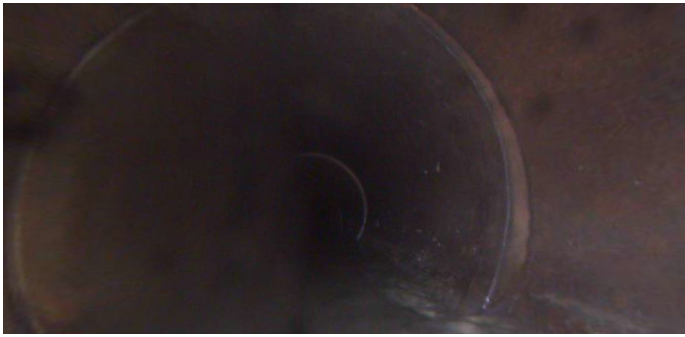
Code: **AMH**
Description: **Manhole**

Distance (ft): **.0**
Structural Grade: **0**
O&M Grade: **0**
Clock Start/From:
Clock To:
1st Value:
2nd Value:
Value Percent:
Continuous Index:
Within 8" of Joint: **NO**
Remarks: **M-605-037**

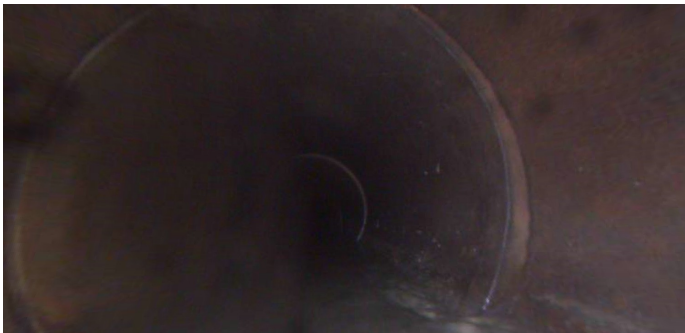
Code: **MWL**
Description: **Water Level**

Distance (ft): **.0**
Structural Grade: **0**
O&M Grade: **0**
Clock Start/From:
Clock To:
1st Value:
2nd Value:
Value Percent: **5.000**
Continuous Index:
Within 8" of Joint: **NO**
Remarks:

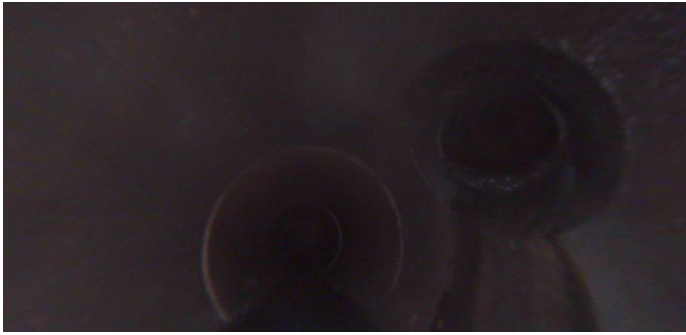
Code: **TFA**
Description: **Tap Factory Active**

Distance (ft): **51.0**
Structural Grade: **0**
O&M Grade: **0**
Clock Start/From: **9**
Clock To:
1st Value: **4.000**
2nd Value:
Value Percent:
Continuous Index:
Within 8" of Joint:
Remarks:

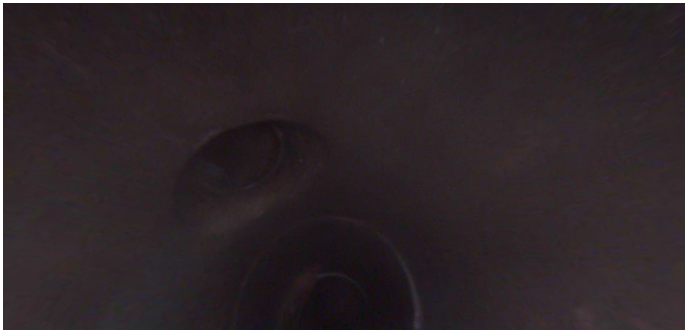
Code: **TF**
Description: **Tap Factory**

Distance (ft): **75.3**
Structural Grade: **0**
O&M Grade: **0**
Clock Start/From: **1**
Clock To:
1st Value: **4.000**
2nd Value:
Value Percent:
Continuous Index:
Within 8" of Joint:
Remarks:

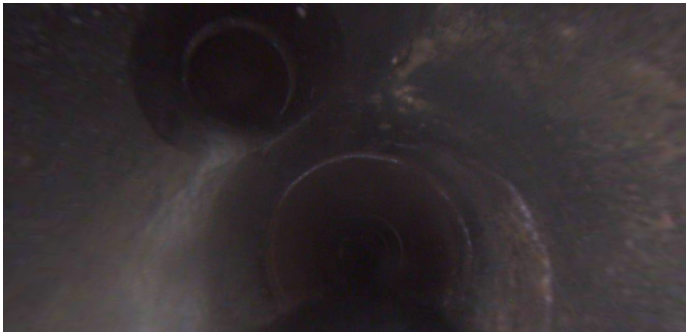
Code: **TFA**
Description: **Tap Factory Active**

Distance (ft): **115.3**
Structural Grade: **0**
O&M Grade: **0**
Clock Start/From: **1**
Clock To:
1st Value: **4.000**
2nd Value:
Value Percent:
Continuous Index:
Within 8" of Joint:
Remarks:

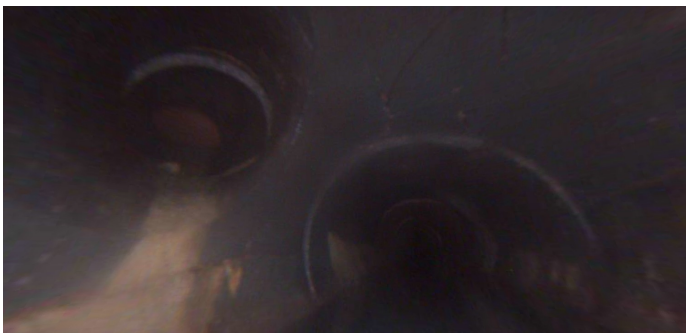
Code: **TF**
Description: **Tap Factory**

Distance (ft): **155.2**
Structural Grade: **0**
O&M Grade: **0**
Clock Start/From: **2**
Clock To:
1st Value: **4.000**
2nd Value:
Value Percent:
Continuous Index:
Within 8" of Joint:
Remarks:

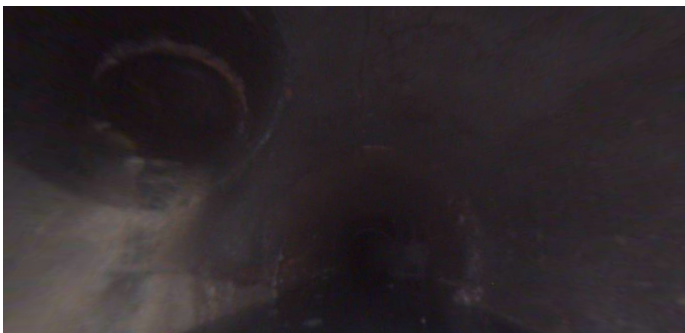
Code: **TF**
Description: **Tap Factory**

Distance (ft): **197.5**
Structural Grade: **0**
O&M Grade: **0**
Clock Start/From: **2**
Clock To:
1st Value: **4.000**
2nd Value:
Value Percent:
Continuous Index:
Within 8" of Joint:
Remarks:

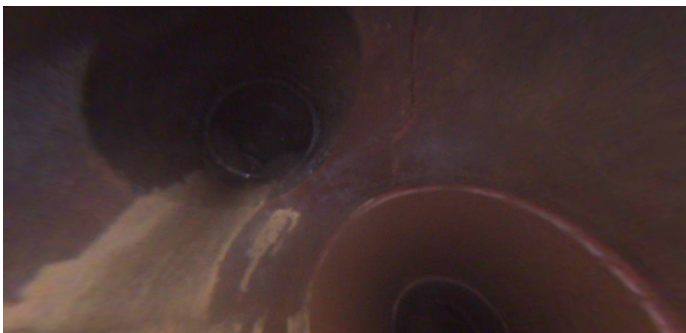
Code: **TF**
Description: **Tap Factory**

Distance (ft): **235.9**
Structural Grade: **0**
O&M Grade: **0**
Clock Start/From: **1**
Clock To:
1st Value: **4.000**
2nd Value:
Value Percent:
Continuous Index:
Within 8" of Joint:
Remarks:

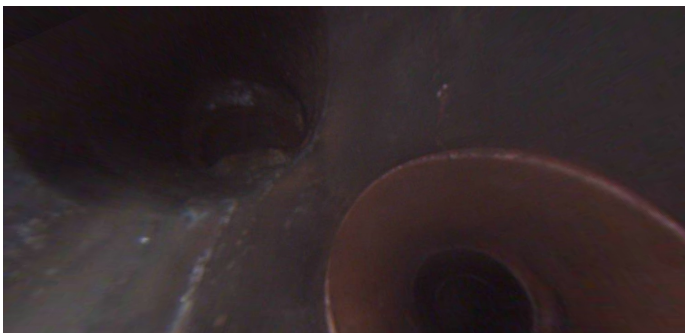
Code: **TF**
Description: **Tap Factory**

Distance (ft): **276.5**
Structural Grade: **0**
O&M Grade: **0**
Clock Start/From: **2**
Clock To:
1st Value: **4.000**
2nd Value:
Value Percent:
Continuous Index:
Within 8" of Joint:
Remarks:

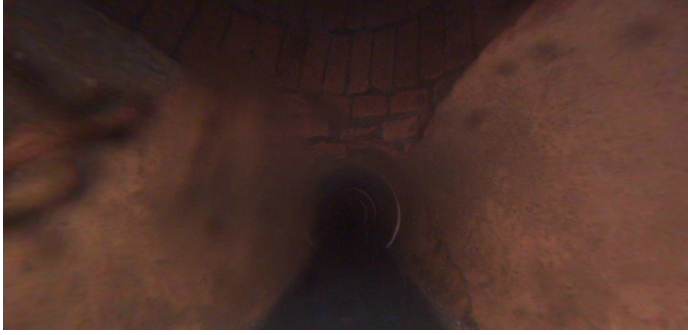
Code:	AMH
Description:	Manhole
Distance (ft):	288.0
Structural Grade:	0
O&M Grade:	0
Clock Start/From:	
Clock To:	
1st Value:	
2nd Value:	
Value Percent:	
Continuous Index:	
Within 8" of Joint:	NO
Remarks:	M-605-038
