Profile/Photo Observation Report

Date:	04/24/2018	Weather:		Coding:	PACP 6.0
Pipe Length (ft):	210.4	Owner:	NA	Pre Clean:	Not Known
P.O.#:		Surveyor:	Jen Costello	PSR:	P-605-039-038
Customer:		Clean Date:	01/01/1900	Shape:	C

Street:	S Pennsylvania St.	Flow Control:	Not Controlled
City:	Hobart, IN	Year Renewed:	
Location:	Other	Tape/Media #:	
Purpose:	Not Known	Dia/Height:	12"
Use:	Sanitary	Material:	VCP
Drain Area:	NA	Lining:	
Category:	NA		
Comment:

Location Details:		Direction of Survey:	Upstream
US MH:	M-605-038	DS MH:	M-605-039
		Total Length Surveyed (ft):	108.1

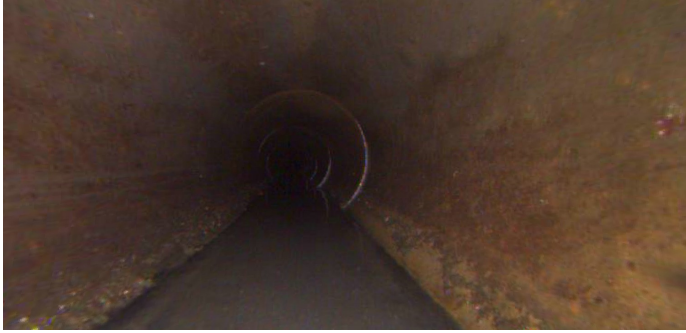
Code: **AMH**
Description: **Manhole**

Distance (ft): **.0**
Structural Grade: **0**
O&M Grade: **0**
Clock Start/From:
Clock To:
1st Value:
2nd Value:
Value Percent:
Continuous Index:
Within 8" of Joint: **NO**
Remarks: **M-605-039**

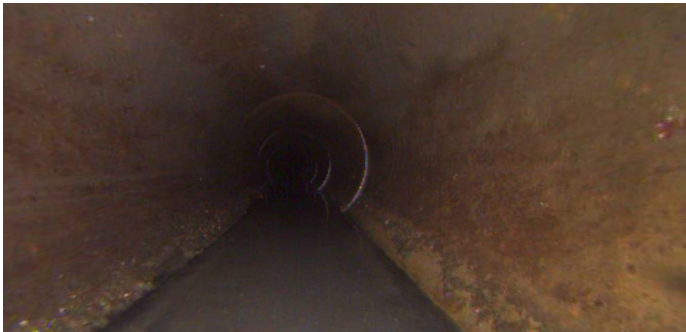
Code: **MWL**
Description: **Water Level**

Distance (ft): **.0**
Structural Grade: **0**
O&M Grade: **0**
Clock Start/From:
Clock To:
1st Value:
2nd Value:
Value Percent: **10.000**
Continuous Index:
Within 8" of Joint: **NO**
Remarks:
