Profile/Photo Observation Report

Date:	04/24/2018	Weather:		Coding:	PACP 6.0
Pipe Length (ft):	214.3	Owner:	NA	Pre Clean:	Not Known
P.O.#:		Surveyor:	Jen Costello	PSR:	P-605-040-039
Customer:		Clean Date:	01/01/1900	Shape:	C

Street:	S Pennsylvania St.	Flow Control:	Not Controlled
City:	Hobart, IN	Year Renewed:	
Location:	Other	Tape/Media #:	
Purpose:	Not Known	Dia/Height:	12"
Use:	Sanitary	Material:	VCP
Drain Area:	NA	Lining:	
Category:	NA		
Comment:

Location Details:		Direction of Survey:	Downstream
US MH:	M-605-039	DS MH:	M-605-040
		Total Length Surveyed (ft):	58.7

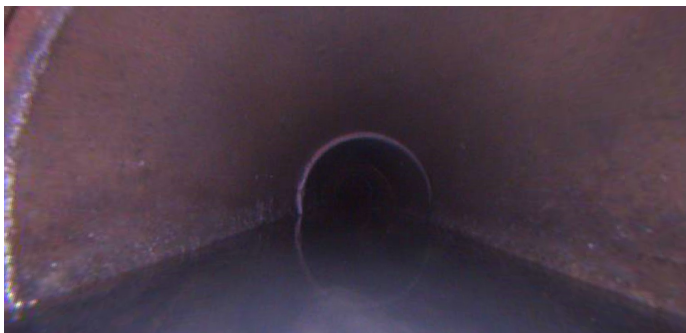
Code: **AMH**
Description: **Manhole**

Distance (ft): **.0**
Structural Grade: **0**
O&M Grade: **0**
Clock Start/From:
Clock To:
1st Value:
2nd Value:
Value Percent:
Continuous Index:
Within 8" of Joint: **NO**
Remarks: **M-605-039**

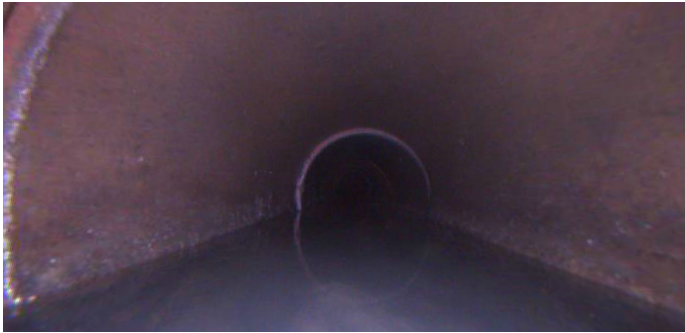
Code:	MWL
Description:	Water Level

Distance (ft):	.0
Structural Grade:	0
O&M Grade:	0
Clock Start/From:	
Clock To:	
1st Value:	
2nd Value:	
Value Percent:	30.000
Continuous Index:	
Within 8" of Joint:	NO
Remarks:

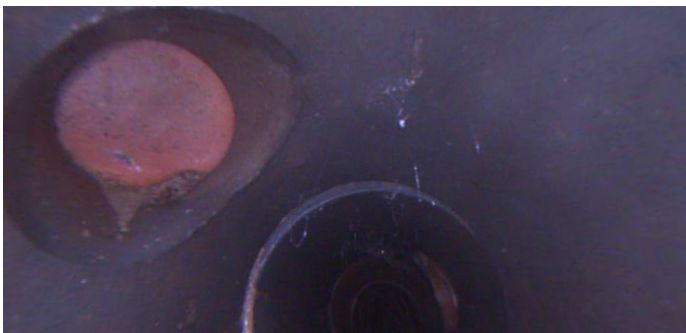
Code: **TF**
Description: **Tap Factory**

Distance (ft): **9.1**
Structural Grade: **0**
O&M Grade: **0**
Clock Start/From: **10**
Clock To:
1st Value: **4.000**
2nd Value:
Value Percent:
Continuous Index:
Within 8" of Joint:
Remarks:

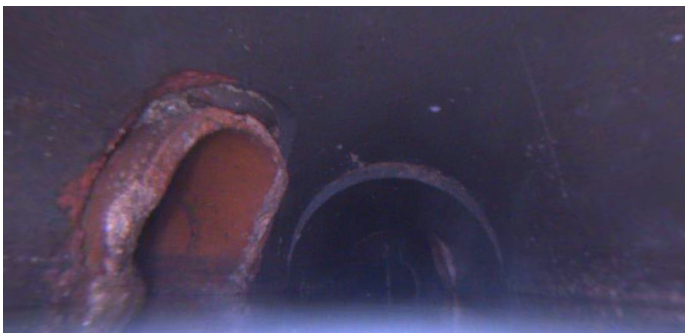
Code: **MWL**
Description: **Water Level**

Distance (ft): **53.1**
Structural Grade: **0**
O&M Grade: **0**
Clock Start/From:
Clock To:
1st Value:
2nd Value:
Value Percent: **40.000**
Continuous Index:
Within 8" of Joint: **NO**
Remarks:
