Profile/Photo Observation Report

Date:	11/14/2021	Weather:		Coding:	PACP 7.0
Pipe Length (ft):	331.8	Owner:	City of Hobart	Pre Clean:	Heavy Cleaning
P.O.#:	YES502259	Surveyor:	S. Bucklin	PSR:	P-604-001-061
Customer:	City of Hobart	Clean Date:	11/14/2021	Shape:	C

Street:	South Lake Park Avenue	Flow Control:	Not Controlled
City:	Hobart, IN	Year Renewed:	
Location:	Local rural streets with light traffic, t	Tape/Media #:	
Purpose:	Routine Assessment	Dia/Height:	10"
Use:	Sanitary Sewage Pipe	Material:	VCP
Drain Area:		Lining:	Cured-In-Place Pipe
Category:	NA		
Comment:

Location Details:		Direction of Survey:	Downstream
US MH:	M-605-061	DS MH:	M-604-001
		Total Length Surveyed (ft):	331.8

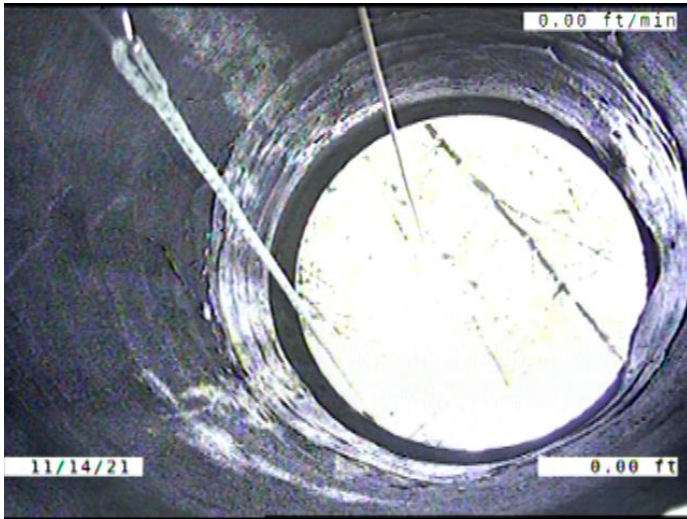
Code: **AMH**
 Description: **Manhole**

Distance (ft): **.0**
 Structural Grade: **0**
 O&M Grade: **0**
 Clock Start/From:
 Clock To:
 1st Value:
 2nd Value:
 Value Percent:
 Continuous Index:
 Within 8" of Joint: **NO**
 Remarks: **M-605-061**

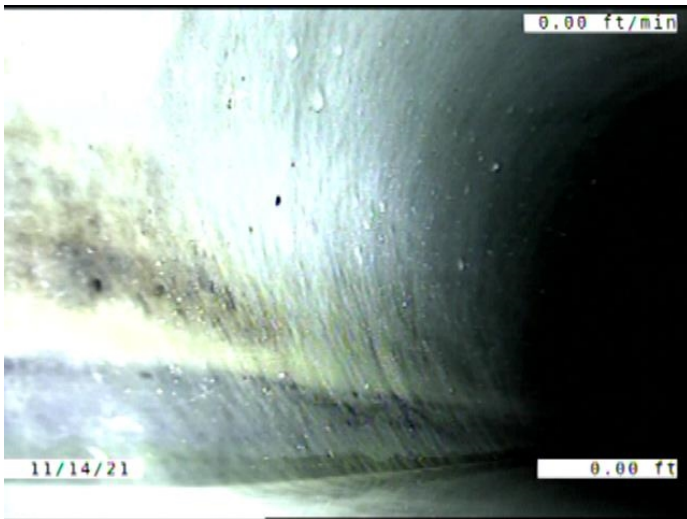
Code: **MWL**
 Description: **Miscellaneous Water Level**

Distance (ft): **.0**
 Structural Grade: **0**
 O&M Grade: **0**
 Clock Start/From:
 Clock To:
 1st Value:
 2nd Value:
 Value Percent: **10.000**
 Continuous Index:
 Within 8" of Joint: **NO**
 Remarks:

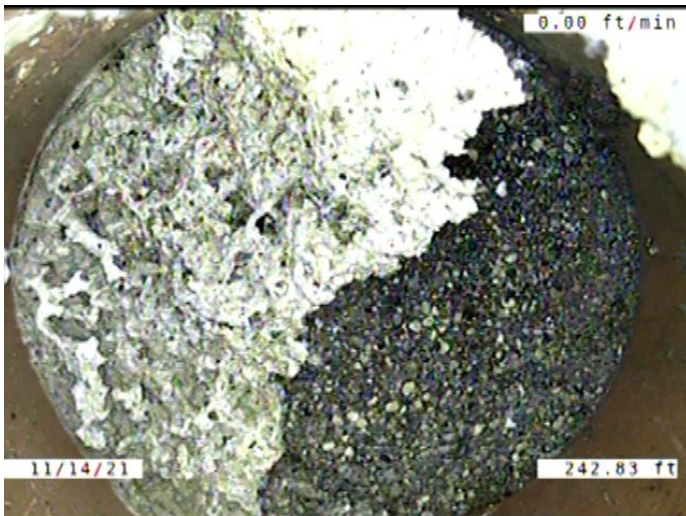
Code: **TBC**
 Description: **Tap Break-in Capped**

Distance (ft): **242.8**
 Structural Grade: **0**
 O&M Grade: **0**
 Clock Start/From: **3**
 Clock To:
 1st Value: **4.000**
 2nd Value:
 Value Percent:
 Continuous Index:
 Within 8" of Joint: **YES**
 Remarks:

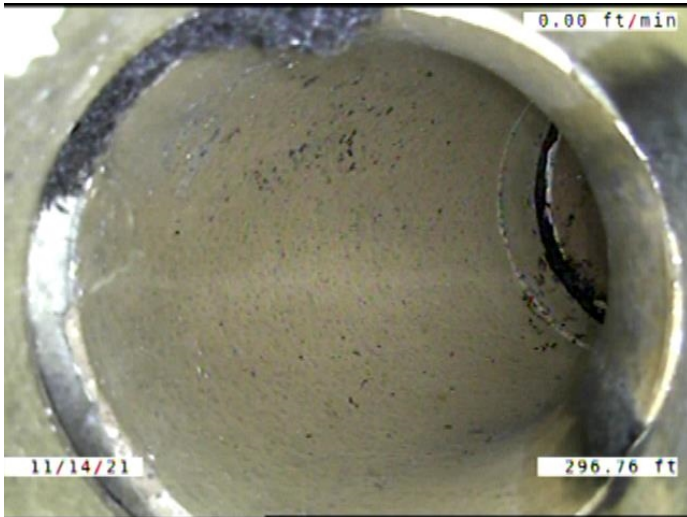
Code: **TB**
 Description: **Tap Break-in/Hammer**

Distance (ft): **296.8**
 Structural Grade: **0**
 O&M Grade: **0**
 Clock Start/From: **1**
 Clock To:
 1st Value: **4.000**
 2nd Value:
 Value Percent:
 Continuous Index:
 Within 8" of Joint: **NO**
 Remarks:

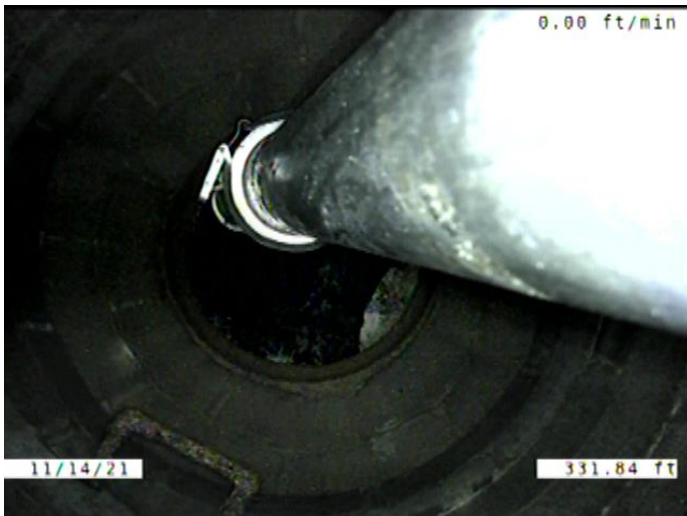
Code: **AMH**
 Description: **Manhole**

Distance (ft): **331.8**
 Structural Grade: **0**
 O&M Grade: **0**
 Clock Start/From:
 Clock To:
 1st Value:
 2nd Value:
 Value Percent:
 Continuous Index:
 Within 8" of Joint: **NO**
 Remarks: **M-604-001**
