Profile/Photo Observation Report

Date:	11/15/2021	Weather:		Coding:	PACP 7.0
Pipe Length (ft):	79.1	Owner:	City of Hobart	Pre Clean:	Heavy Cleaning
P.O.#:	YES502259	Surveyor:	S. Bucklin	PSR:	P-605-060-061
Customer:	City of Hobart	Clean Date:	11/14/2021	Shape:	C

Street:	South Lake Park Avenue	Flow Control:	Not Controlled
City:	Hobart, IN	Year Renewed:	
Location:	Local rural streets with light traffic, t	Tape/Media #:	
Purpose:	Routine Assessment	Dia/Height:	8"
Use:	Sanitary Sewage Pipe	Material:	VCP
Drain Area:		Lining:	None
Category:	NA		
Comment:			
Location Details:		Direction of Survey:	Upstream
US MH:	M-605-061	DS MH:	M-605-060
		Total Length Surveyed (ft):	79.1

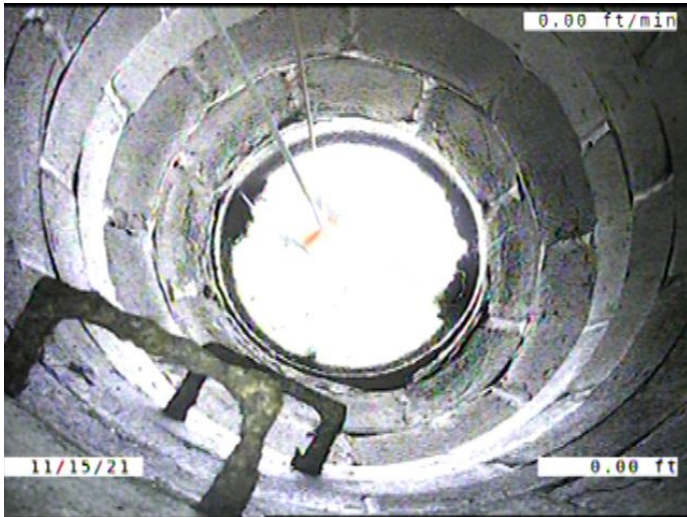
Code: **AMH**
 Description: **Manhole**

Distance (ft): **.0**
 Structural Grade: **0**
 O&M Grade: **0**
 Clock Start/From:
 Clock To:
 1st Value:
 2nd Value:
 Value Percent:
 Continuous Index:
 Within 8" of Joint: **NO**
 Remarks: **M-605-060**

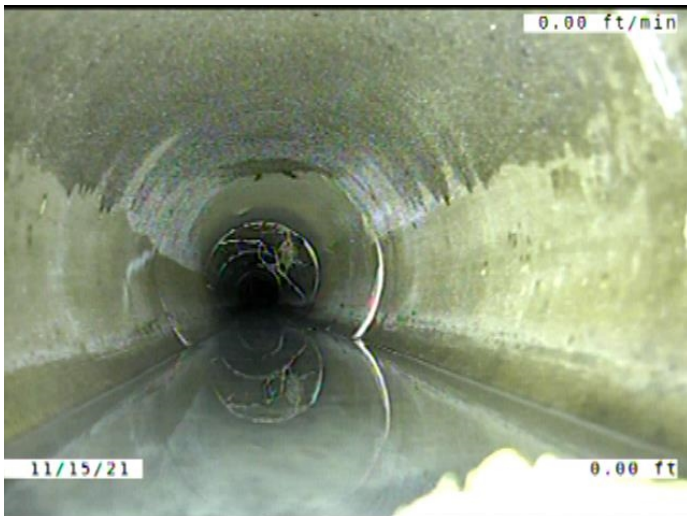
Code: **MWL**
 Description: **Miscellaneous Water Level**

Distance (ft): **.0**
 Structural Grade: **0**
 O&M Grade: **0**
 Clock Start/From:
 Clock To:
 1st Value:
 2nd Value:
 Value Percent: **5.000**
 Continuous Index:
 Within 8" of Joint: **NO**
 Remarks:
