Profile/Photo Observation Report

Date:	08/11/2022	Weather:		Coding:	PACP 7.0
Pipe Length (ft):	283.0	Owner:	City of Hobart	Pre Clean:	Heavy Cleaning
P.O.#:	YES502259	Surveyor:	S. Bucklin	PSR:	P-605-013-070
Customer:	City of Hobart	Clean Date:	08/01/2022	Shape:	C

Street:	Ellendale Street	Flow Control:	Not Controlled
City:	Hobart, IN	Year Renewed:	
Location:	Local rural streets with light traffic, t	Tape/Media #:	
Purpose:	Routine Assessment	Dia/Height:	12"
Use:	Sanitary Sewage Pipe	Material:	CP
Drain Area:		Lining:	None
Category:	NA		
Comment:

Location Details:		Direction of Survey:	Downstream
US MH:	M-605-070	DS MH:	M-605-013
		Total Length Surveyed (ft):	280.7

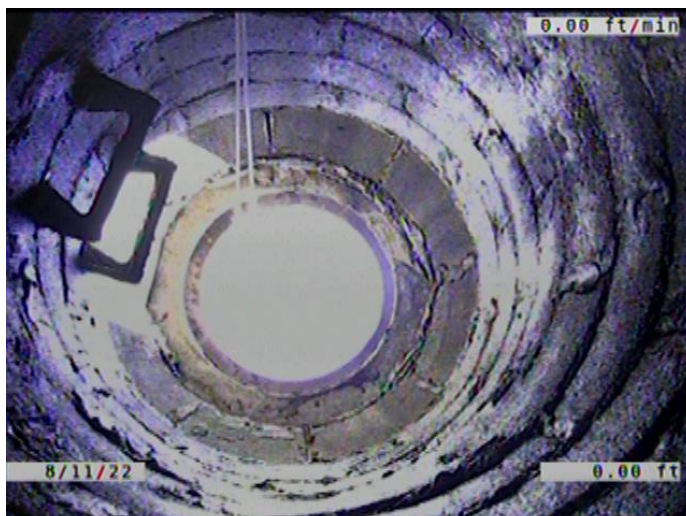
Code: **AMH**
Description: **Manhole**

Distance (ft): **.0**
Structural Grade: **0**
O&M Grade: **0**
Clock Start/From:
Clock To:
1st Value:
2nd Value:
Value Percent:
Continuous Index:
Within 8" of Joint: **NO**
Remarks: **M-605-070**

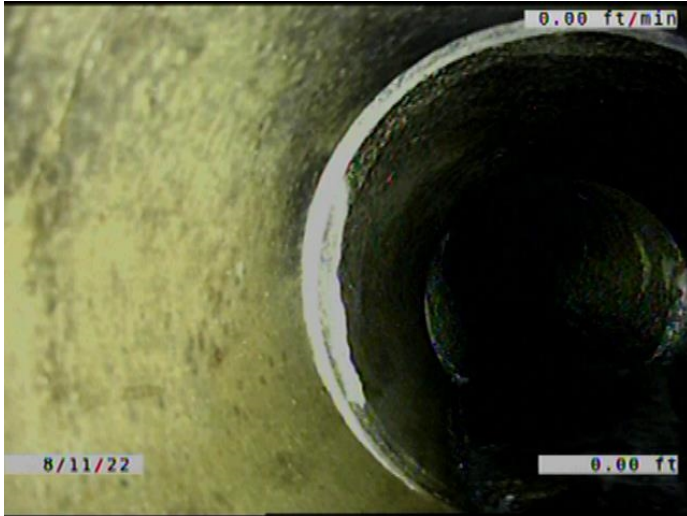
Code: **MWL**
Description: **Miscellaneous Water Level**

Distance (ft): **.0**
Structural Grade: **0**
O&M Grade: **0**
Clock Start/From:
Clock To:
1st Value:
2nd Value:
Value Percent: **5.000**
Continuous Index:
Within 8" of Joint: **NO**
Remarks:

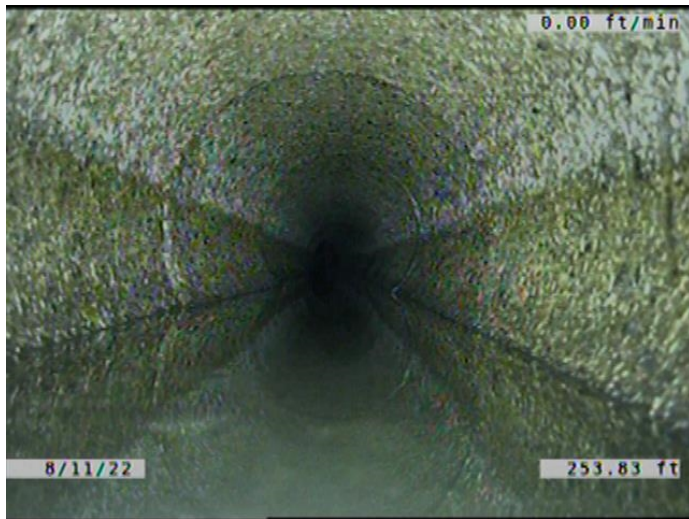
Code: **MWL**
 Description: **Miscellaneous Water Level**

Distance (ft): **253.8**
 Structural Grade: **0**
 O&M Grade: **0**
 Clock Start/From:
 Clock To:
 1st Value:
 2nd Value:
 Value Percent: **15.000**
 Continuous Index:
 Within 8" of Joint: **NO**
 Remarks:

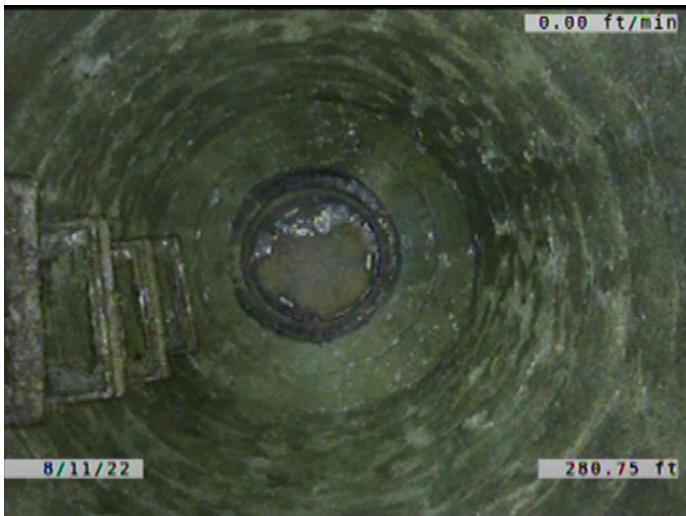
Code: **AMH**
 Description: **Manhole**

Distance (ft): **280.7**
 Structural Grade: **0**
 O&M Grade: **0**
 Clock Start/From:
 Clock To:
 1st Value:
 2nd Value:
 Value Percent:
 Continuous Index:
 Within 8" of Joint: **NO**
 Remarks: **M-605-013**
