Profile/Photo Observation Report

Street:	COURT ST & S ASH ST	Flow Control:	Not Controlled
City:	Hobart, IN	Year Renewed:	
Location:	Other	Tape/Media #:	
Purpose:	Not Known	Dia/Height:	12"
Use:	Sanitary	Material:	VCP
Drain Area:	NA	Lining:	
Category:	NA		
Comment:	Flow direction wrong. Debris at 65'.

Location Details:		Direction of Survey:	Downstream
US MH:	M-605-072	DS MH:	M-605-019
		Total Length Surveyed (ft):	67.0

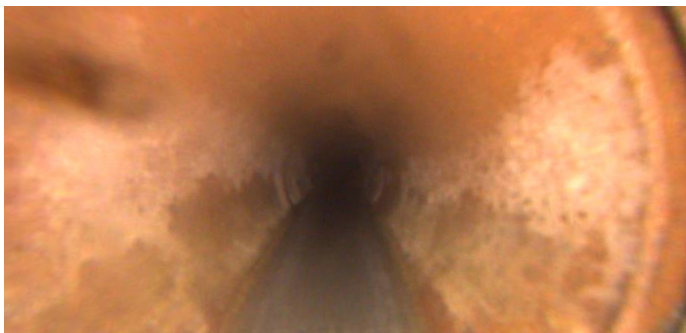
Code: **AMH**
Description: **Manhole**

Distance (ft): **.0**
Structural Grade: **0**
O&M Grade: **0**
Clock Start/From:
Clock To:
1st Value:
2nd Value:
Value Percent:
Continuous Index:
Within 8" of Joint: **NO**
Remarks: **M-605-072**
