Profile/Photo Observation Report

Date:	11/16/2021	Weather:		Coding:	PACP 7.0
Pipe Length (ft):	167.8	Owner:	City of Hobart	Pre Clean:	Light Cleaning
P.O.#:	YES502259	Surveyor:	S. Bucklin	PSR:	P-605-019-072
Customer:	City of Hobart	Clean Date:	11/16/2021	Shape:	C

Street:	Court Street	Flow Control:	Not Controlled
City:	Hobart, IN	Year Renewed:	
Location:	Local rural streets with light traffic, t	Tape/Media #:	
Purpose:	Routine Assessment	Dia/Height:	10"
Use:	Sanitary Sewage Pipe	Material:	VCP
Drain Area:		Lining:	None
Category:	NA		
Comment:			
Location Details:		Direction of Survey:	Upstream
US MH:	M-605-072	DS MH:	M-605-019
		Total Length Surveyed (ft):	167.8

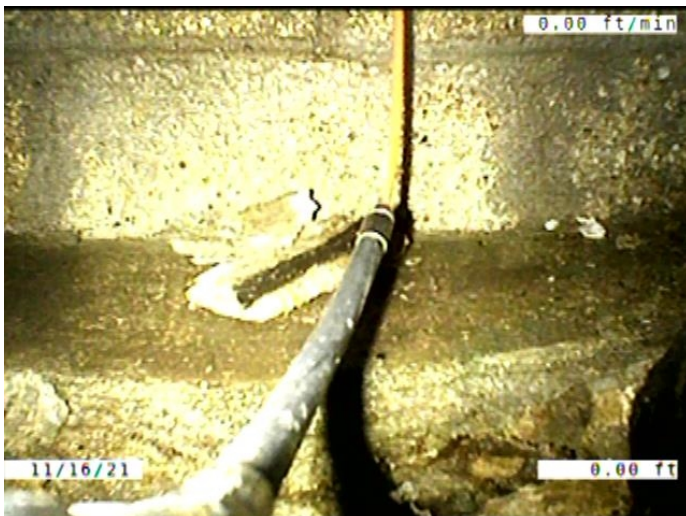
Code: **AMH**
Description: **Manhole**

Distance (ft): **.0**
Structural Grade: **0**
O&M Grade: **0**
Clock Start/From:
Clock To:
1st Value:
2nd Value:
Value Percent:
Continuous Index:
Within 8" of Joint: **NO**
Remarks: **M-605-019**

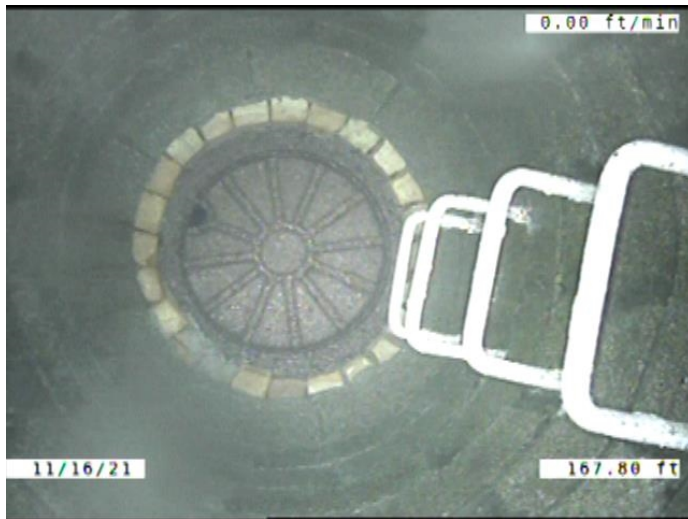
Code:	AMH
Description:	Manhole
Distance (ft):	167.8
Structural Grade:	0
O&M Grade:	0
Clock Start/From:	
Clock To:	
1st Value:	
2nd Value:	
Value Percent:	
Continuous Index:	
Within 8" of Joint:	NO
Remarks:	M-605-072
