# Profile/Photo Observation Report

Date:	11/16/2021	Weather:		Coding:	PACP 7.0
Pipe Length (ft):	167.8	Owner:	City of Hobart	Pre Clean:	Light Cleaning
P.O.#:	YES502259	Surveyor:	S. Bucklin	PSR:	P-605-019-072
Customer:	City of Hobart	Clean Date:	11/16/2021	Shape:	C

Street:	Court Street	Flow Control:	Not Controlled
City:	Hobart, IN	Year Renewed:	
Location:	Local rural streets with light traffic, t	Tape/Media #:	
Purpose:	Routine Assessment	Dia/Height:	10"
Use:	Sanitary Sewage Pipe	Material:	VCP
Drain Area:		Lining:	None
Category:	NA		
Comment:			
Location Details:		Direction of Survey:	Upstream
US MH:	M-605-072	DS MH:	M-605-019
		Total Length Surveyed (ft):	167.8

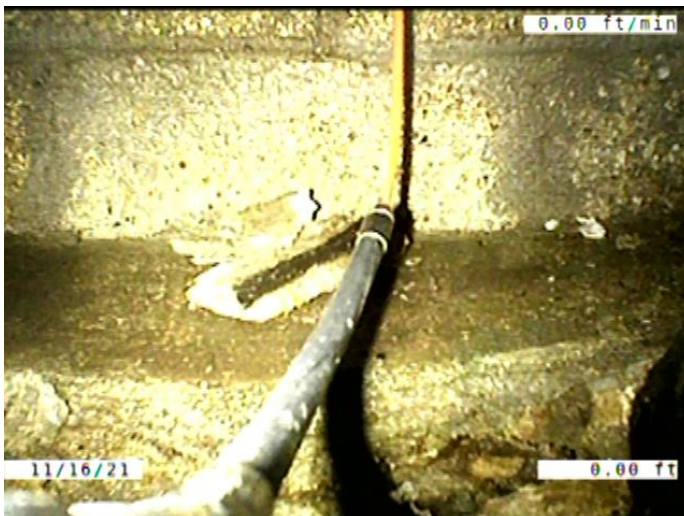
Code: **AMH**  
Description: **Manhole**

Distance (ft): **.0**  
Structural Grade: **0**  
O&M Grade: **0**  
Clock Start/From:  
Clock To:  
1st Value:  
2nd Value:  
Value Percent:  
Continuous Index:  
Within 8" of Joint: **NO**  
Remarks: **M-605-019**

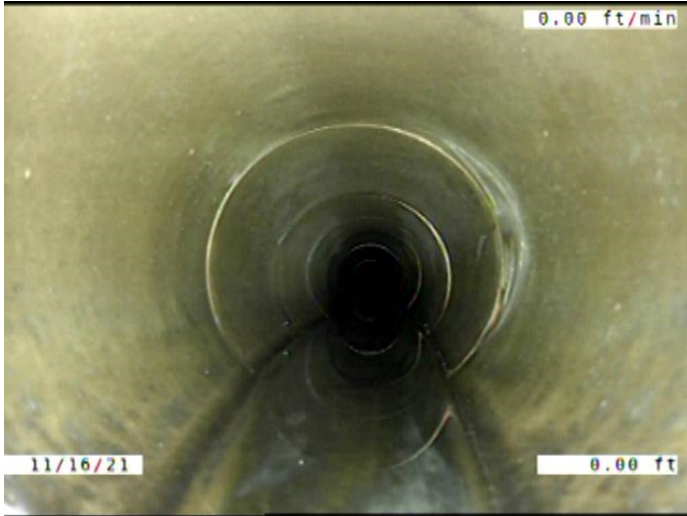
Code: **MWL**  
Description: **Miscellaneous Water Level**

Distance (ft): **.0**  
Structural Grade: **0**  
O&M Grade: **0**  
Clock Start/From:  
Clock To:  
1st Value:  
2nd Value:  
Value Percent: **5.000**  
Continuous Index:  
Within 8" of Joint: **NO**  
Remarks:

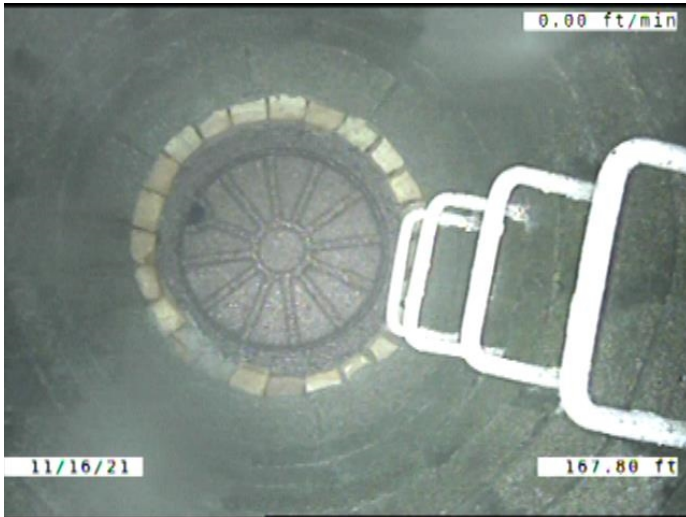
Code:	<b>AMH</b>
Description:	<b>Manhole</b>
Distance (ft):	<b>167.8</b>
Structural Grade:	<b>0</b>
O&M Grade:	<b>0</b>
Clock Start/From:	
Clock To:	
1st Value:	
2nd Value:	
Value Percent:	
Continuous Index:	
Within 8" of Joint:	<b>NO</b>
Remarks:	<b>M-605-072</b>
