Profile/Photo Observation Report

Date:	04/25/2018	Weather:		Coding:	PACP 6.0
Pipe Length (ft):	171.5	Owner:	NA	Pre Clean:	Not Known
P.O.#:		Surveyor:	Jen Costello	PSR:	P-605-073-074
Customer:		Clean Date:	01/01/1900	Shape:	C

Street:	MUNICIPAL DR & S ASH ST	Flow Control:	Not Controlled
City:	Hobart, IN	Year Renewed:	
Location:	Light Highway	Tape/Media #:	
Purpose:	Maintenance Related	Dia/Height:	12"
Use:	Sanitary	Material:	VCP
Drain Area:	NA	Lining:	Cured in Place
Category:	NA		
Comment:	Flow direction wrong. Debris at 5'.		
Location Details:		Direction of Survey:	Downstream
US MH:	M-605-074	DS MH:	M-605-073
		Total Length Surveyed (ft):	6.7

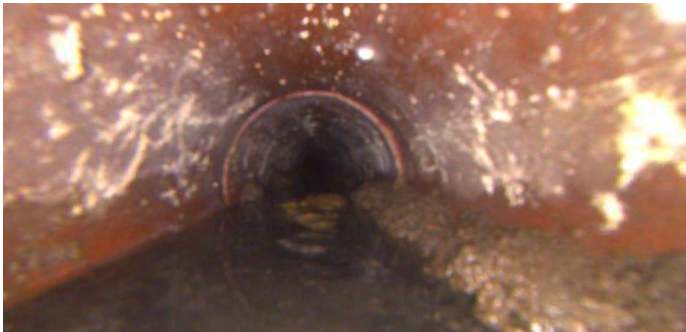
Code: **CL**
Description: **Crack Longitudinal**

Distance (ft): **6.7**
Structural Grade: **2**
O&M Grade: **0**
Clock Start/From: **2**
Clock To:
1st Value:
2nd Value:
Value Percent:
Continuous Index:
Within 8" of Joint:
Remarks:
