Profile/Photo Observation Report

Date:	11/18/2021	Weather:		Coding:	PACP 7.0
Pipe Length (ft):	160.4	Owner:	City of Hobart	Pre Clean:	Heavy Cleaning
P.O.#:	YES502259	Surveyor:	S. Bucklin	PSR:	P-605-074-075
Customer:	City of Hobart	Clean Date:	11/18/2021	Shape:	C

Street:	South Ash Street	Flow Control:	Not Controlled
City:	Hobart, IN	Year Renewed:	
Location:	Local rural streets with light traffic, t	Tape/Media #:	
Purpose:	Routine Assessment	Dia/Height:	10"
Use:	Sanitary Sewage Pipe	Material:	VCP
Drain Area:		Lining:	None
Category:	NA		
Comment:			
Location Details:		Direction of Survey:	Downstream
US MH:	M-605-075	DS MH:	M-605-074
		Total Length Surveyed (ft):	160.4

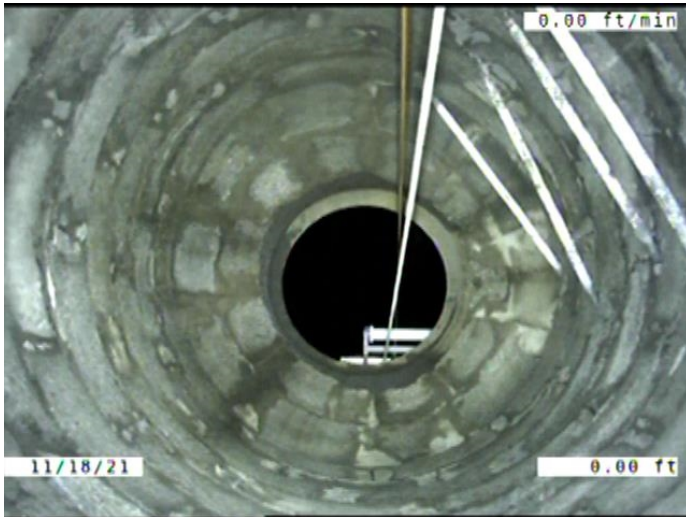
Code: **AMH**
 Description: **Manhole**

Distance (ft): **.0**
 Structural Grade: **0**
 O&M Grade: **0**
 Clock Start/From:
 Clock To:
 1st Value:
 2nd Value:
 Value Percent:
 Continuous Index:
 Within 8" of Joint: **NO**
 Remarks: **M-605-075**

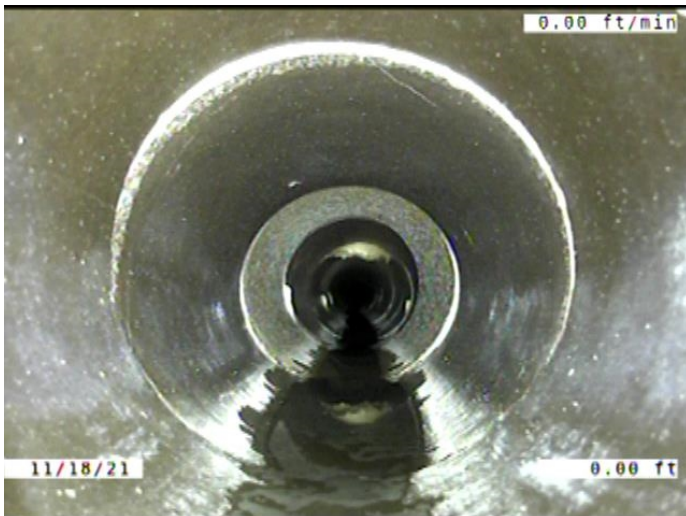
Code: **MWL**
 Description: **Miscellaneous Water Level**

Distance (ft): **.0**
 Structural Grade: **0**
 O&M Grade: **0**
 Clock Start/From:
 Clock To:
 1st Value:
 2nd Value:
 Value Percent: **5.000**
 Continuous Index:
 Within 8" of Joint: **NO**
 Remarks:

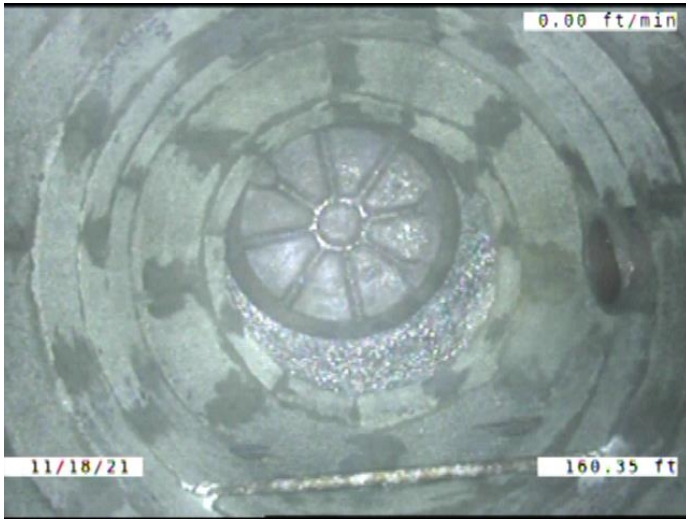
Code:	AMH
Description:	Manhole
Distance (ft):	160.4
Structural Grade:	0
O&M Grade:	0
Clock Start/From:	
Clock To:	
1st Value:	
2nd Value:	
Value Percent:	
Continuous Index:	
Within 8" of Joint:	NO
Remarks:	M-605-074
