Profile/Photo Observation Report

Date:	04/11/2018	Weather:		Coding:	PACP 6.0
Pipe Length (ft):	231.6	Owner:	NA	Pre Clean:	No Pre-Cleaning
P.O.#:		Surveyor:	Jen Costello	PSR:	P-606-012-011
Customer:		Clean Date:	01/01/1900	Shape:	C

Street:	W 8TH PL	Flow Control:	Not Controlled
City:	Hobart, IN	Year Renewed:	
Location:	Yard	Tape/Media #:	
Purpose:	Routine Assessment	Dia/Height:	10"
Use:	Sanitary	Material:	VCP
Drain Area:	NA	Lining:	
Category:	NA		
Comment:	Flow direction is marked wrong.		
Location Details:		Direction of Survey:	Upstream
US MH:	M-606-011	DS MH:	M-606-012
		Total Length Surveyed (ft):	221.0

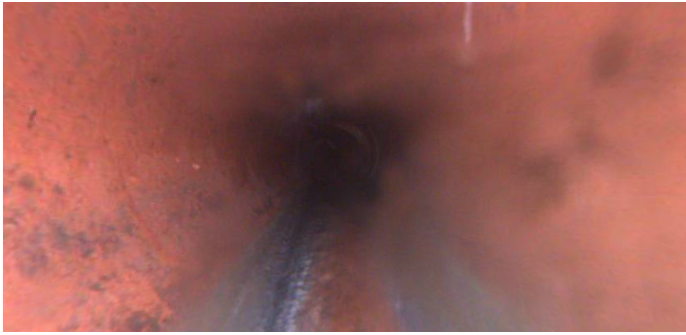
Code: **AMH**
Description: **Manhole**

Distance (ft): **.0**
Structural Grade: **0**
O&M Grade: **0**
Clock Start/From:
Clock To:
1st Value:
2nd Value:
Value Percent:
Continuous Index:
Within 8" of Joint: **NO**
Remarks: **M-606-012**

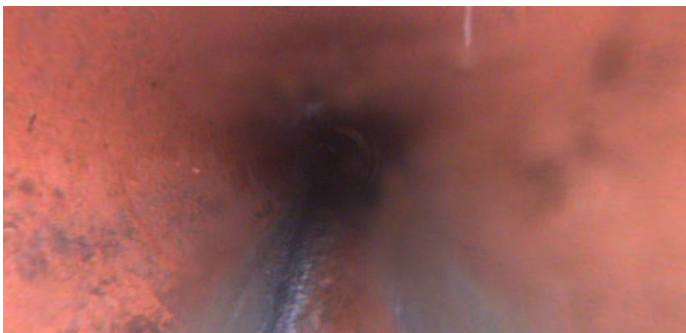
Code: **MWL**
Description: **Water Level**

Distance (ft): **.0**
Structural Grade: **0**
O&M Grade: **0**
Clock Start/From:
Clock To:
1st Value:
2nd Value:
Value Percent: **5.000**
Continuous Index:
Within 8" of Joint: **NO**
Remarks:

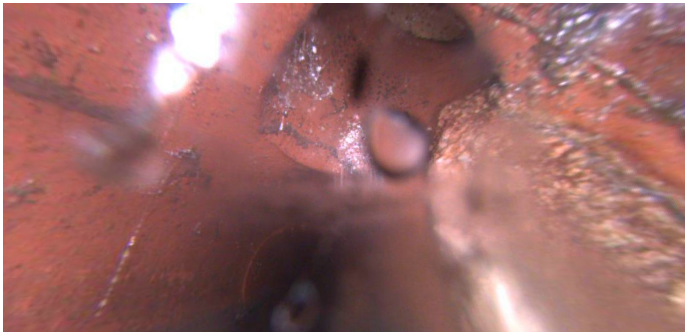
Code: **TFC**
Description: **Tap Factory Capped**

Distance (ft): **54.3**
Structural Grade: **0**
O&M Grade: **0**
Clock Start/From: **1**
Clock To:
1st Value: **4.000**
2nd Value:
Value Percent:
Continuous Index:
Within 8" of Joint:
Remarks:

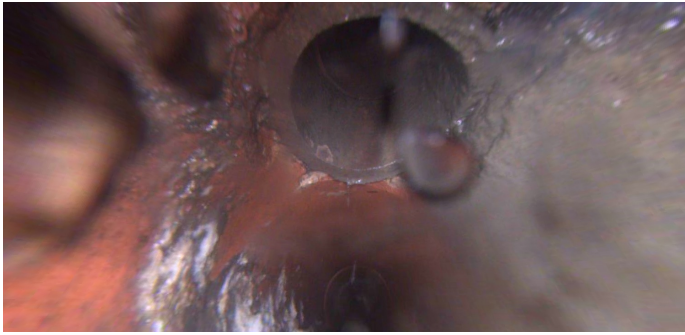
Code: **TB**
Description: **Tap Break-in**

Distance (ft): **77.4**
Structural Grade: **0**
O&M Grade: **0**
Clock Start/From: **12**
Clock To:
1st Value: **4.000**
2nd Value:
Value Percent:
Continuous Index:
Within 8" of Joint:
Remarks:

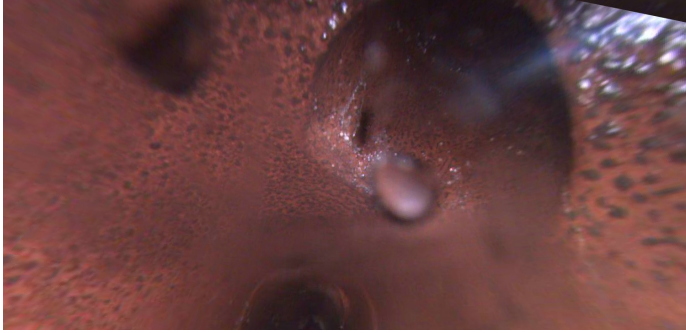
Code: **TF**
Description: **Tap Factory**

Distance (ft): **125.0**
Structural Grade: **0**
O&M Grade: **0**
Clock Start/From: **1**
Clock To:
1st Value: **4.000**
2nd Value:
Value Percent:
Continuous Index:
Within 8" of Joint:
Remarks:

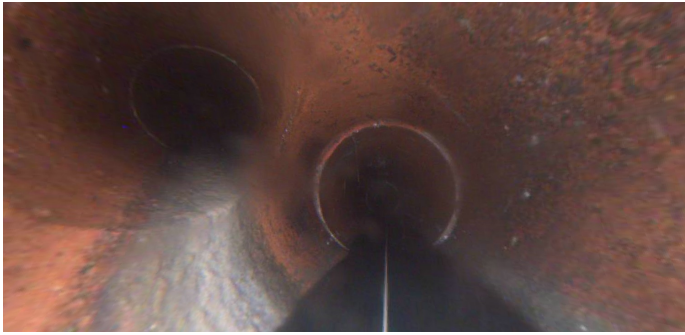
Code: **TFA**
Description: **Tap Factory Active**

Distance (ft): **198.5**
Structural Grade: **0**
O&M Grade: **0**
Clock Start/From: **2**
Clock To:
1st Value: **4.000**
2nd Value:
Value Percent:
Continuous Index:
Within 8" of Joint:
Remarks:

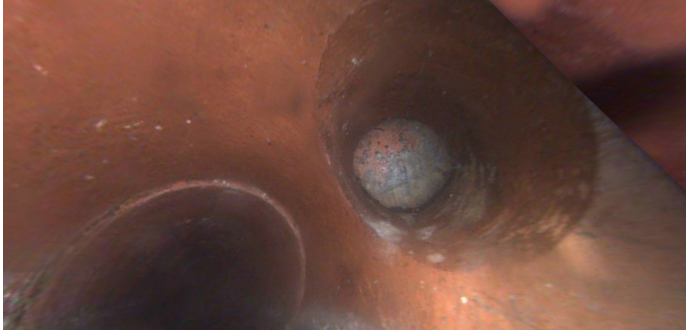
Code: **TFC**
Description: **Tap Factory Capped**

Distance (ft): **215.9**
Structural Grade: **0**
O&M Grade: **0**
Clock Start/From: **10**
Clock To:
1st Value: **4.000**
2nd Value:
Value Percent:
Continuous Index:
Within 8" of Joint:
Remarks:

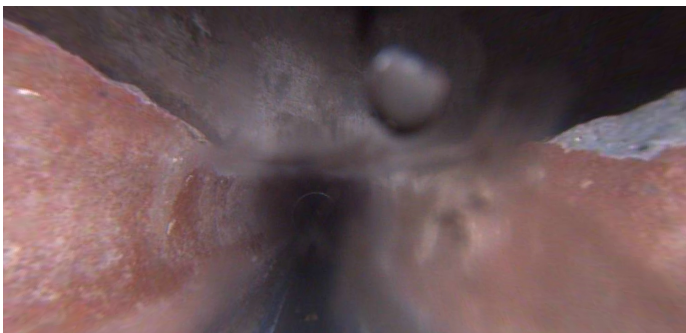
Code: **AMH**
Description: **Manhole**

Distance (ft): **221.0**
Structural Grade: **0**
O&M Grade: **0**
Clock Start/From:
Clock To:
1st Value:
2nd Value:
Value Percent:
Continuous Index:
Within 8" of Joint: **NO**
Remarks: **M-606-011**
