Profile/Photo Observation Report

Date:	02/18/2022	Weather:		Coding:	PACP 7.0
Pipe Length (ft):	51.0	Owner:	City of Hobart	Pre Clean:	Heavy Cleaning
P.O.#:	YES502259	Surveyor:	S. Bucklin	PSR:	P-606-014-013
Customer:	City of Hobart	Clean Date:	01/27/2022	Shape:	C

Street:	West 8th Place	Flow Control:	Not Controlled
City:	Hobart, IN	Year Renewed:	
Location:	Other	Tape/Media #:	
Purpose:	Routine Assessment	Dia/Height:	10"
Use:	Sanitary Sewage Pipe	Material:	VCP
Drain Area:		Lining:	None
Category:	NA		
Comment:			
Location Details:	DRIVEWAY	Direction of Survey:	Upstream
US MH:	M-606-013	DS MH:	M-606-014
		Total Length Surveyed (ft):	51.0

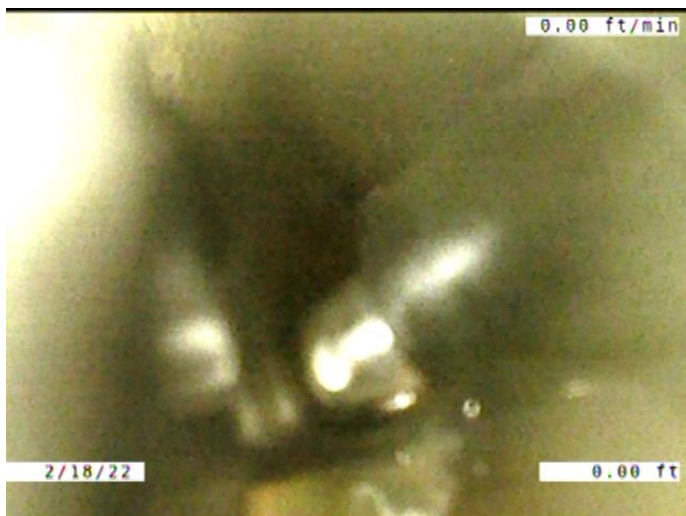
Code: **AMH**
Description: **Manhole**

Distance (ft): **.0**
Structural Grade: **0**
O&M Grade: **0**
Clock Start/From:
Clock To:
1st Value:
2nd Value:
Value Percent:
Continuous Index:
Within 8" of Joint: **NO**
Remarks: **M-606-014**

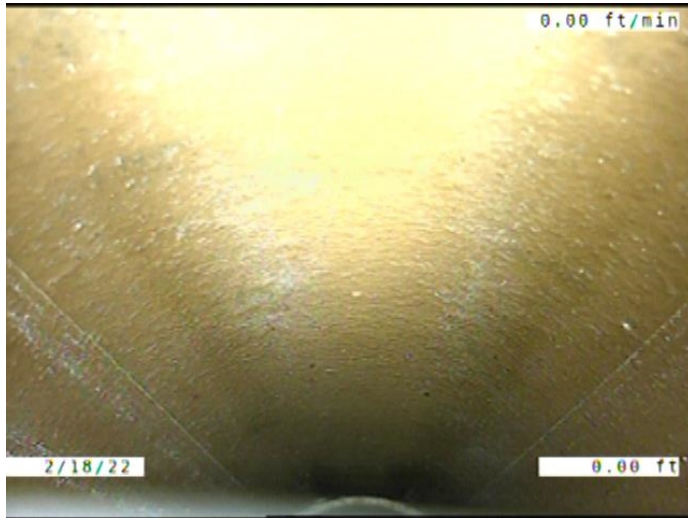
Code: **MWL**
Description: **Miscellaneous Water Level**

Distance (ft): **.0**
Structural Grade: **0**
O&M Grade: **0**
Clock Start/From:
Clock To:
1st Value:
2nd Value:
Value Percent: **35.000**
Continuous Index:
Within 8" of Joint: **NO**
Remarks:

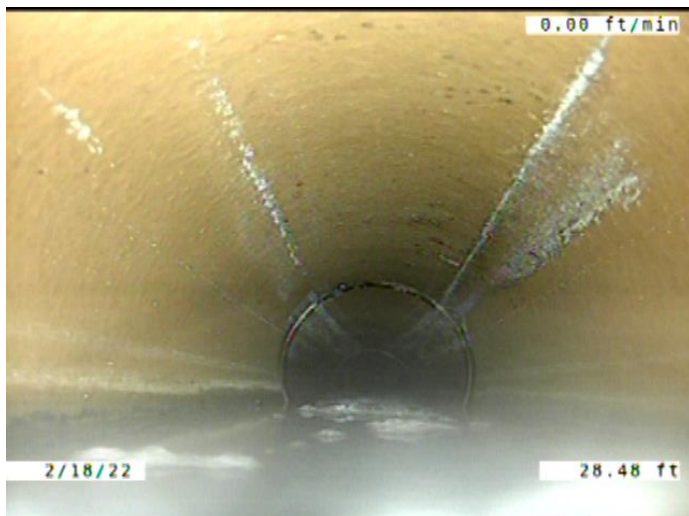
Code:	MWL
Description:	Miscellaneous Water Level
Distance (ft):	28.5
Structural Grade:	0
O&M Grade:	0
Clock Start/From:	
Clock To:	
1st Value:	
2nd Value:	
Value Percent:	20.000
Continuous Index:	
Within 8" of Joint:	NO
Remarks:

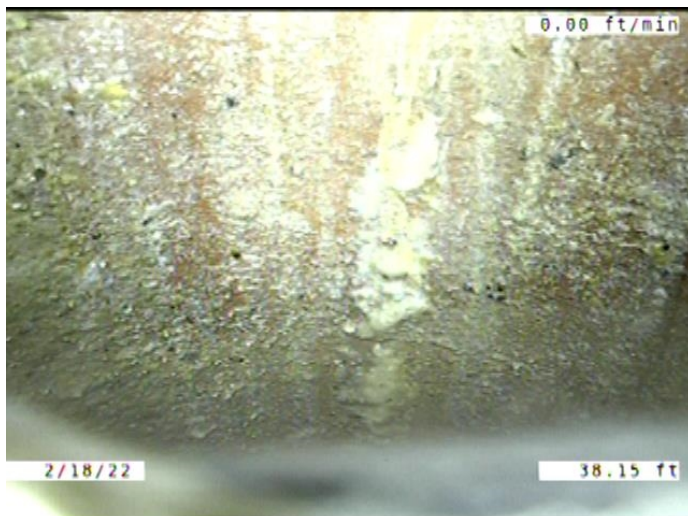
Code: **MWL**
Description: **Miscellaneous Water Level**

Distance (ft): **38.1**
Structural Grade: **0**
O&M Grade: **0**
Clock Start/From:
Clock To:
1st Value:
2nd Value:
Value Percent: **30.000**
Continuous Index:
Within 8" of Joint: **NO**
Remarks:

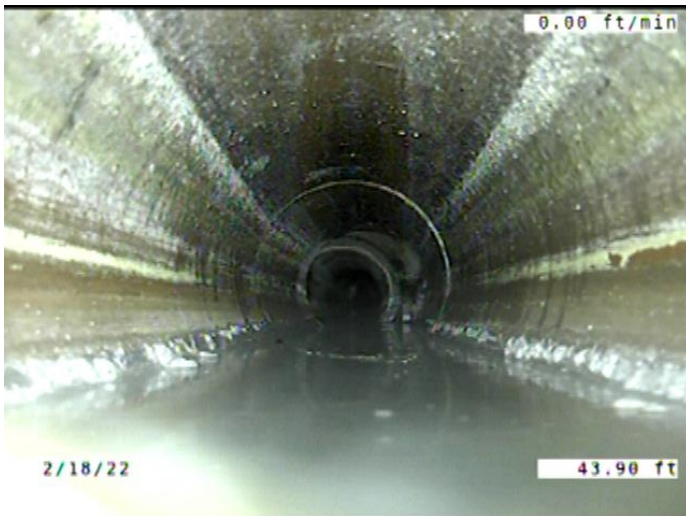
Code: **MWL**
 Description: **Miscellaneous Water Level**

Distance (ft): **43.9**
 Structural Grade: **0**
 O&M Grade: **0**
 Clock Start/From:
 Clock To:
 1st Value:
 2nd Value:
 Value Percent: **15.000**
 Continuous Index:
 Within 8" of Joint: **NO**
 Remarks:

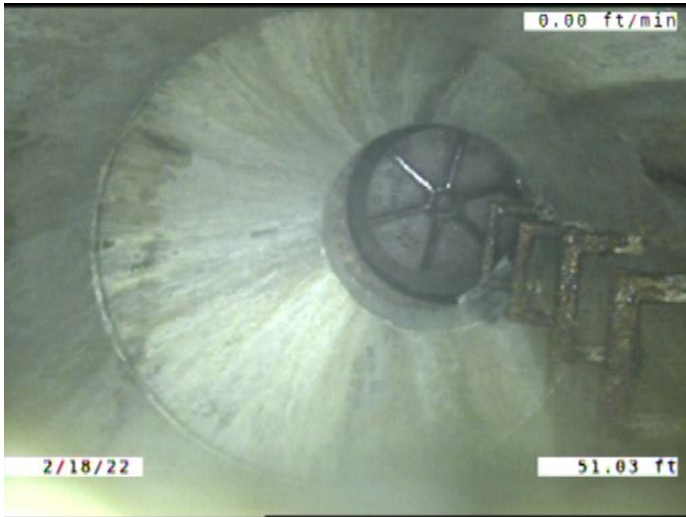
Code:	AMH
Description:	Manhole
Distance (ft):	51.0
Structural Grade:	0
O&M Grade:	0
Clock Start/From:	
Clock To:	
1st Value:	
2nd Value:	
Value Percent:	
Continuous Index:	
Within 8" of Joint:	NO
Remarks:	M-606-013
