Profile/Photo Observation Report

Street:	W 8TH PL	Flow Control:	Not Controlled
City:	Hobart, IN	Year Renewed:	
Location:	Yard	Tape/Media #:	
Purpose:	Routine Assessment	Dia/Height:	10"
Use:	Sanitary	Material:	VCP
Drain Area:	NA	Lining:	
Category:	NA		
Comment:

Location Details:		Direction of Survey:	Downstream
US MH:	M-606-015	DS MH:	M-606-019
		Total Length Surveyed (ft):	35.7

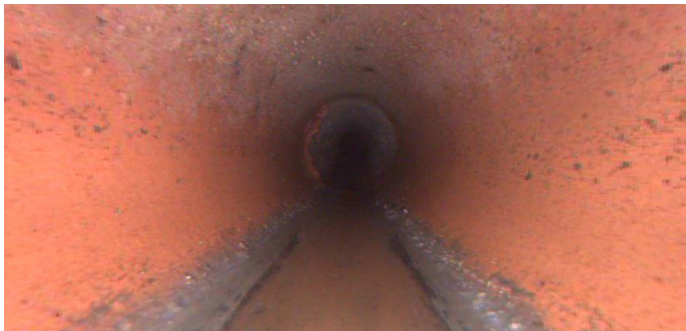
Code: **MWL**
Description: **Water Level**

Distance (ft): **.0**
Structural Grade: **0**
O&M Grade: **0**
Clock Start/From:
Clock To:
1st Value:
2nd Value:
Value Percent: **5.000**
Continuous Index:
Within 8" of Joint: **NO**
Remarks:

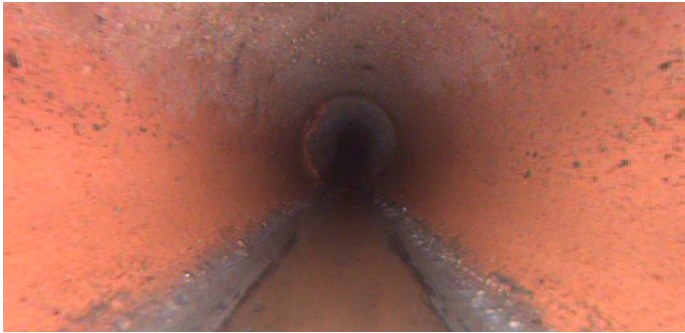
Code:	AMH
Description:	Manhole

Distance (ft):	.0
Structural Grade:	0
O&M Grade:	0
Clock Start/From:	
Clock To:	
1st Value:	
2nd Value:	
Value Percent:	
Continuous Index:	
Within 8" of Joint:	NO
Remarks:	M-606-015

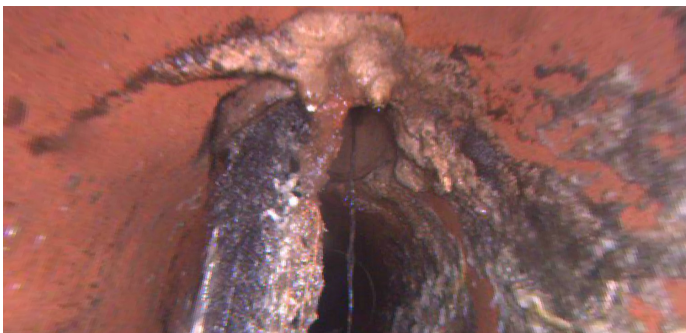
Code: **TF**
Description: **Tap Factory**

Distance (ft): **22.8**
Structural Grade: **0**
O&M Grade: **0**
Clock Start/From: **12**
Clock To:
1st Value: **4.000**
2nd Value:
Value Percent:
Continuous Index:
Within 8" of Joint:
Remarks:
