Profile/Photo Observation Report

Date:	05/08/2018	Weather:		Coding:	PACP 6.0
Pipe Length (ft):		Owner:	City of Hobart	Pre Clean:	Not Known
P.O.#:	301	Surveyor:	B. Helbling	PSR:	P-606-022-021
Customer:	City of Hobart	Clean Date:		Shape:	C

Street:	West 8th Street	Flow Control:	Not Controlled
City:	Hobart, IN	Year Renewed:	
Location:	Light Highway	Tape/Media #:	DEP301
Purpose:	Routine Assessment	Dia/Height:	18"
Use:	Sanitary	Material:	VCP
Drain Area:		Lining:	
Category:	NA		
Comment:	5-21-2018		
Location Details:		Direction of Survey:	Upstream
US MH:	M-606-021	DS MH:	M-606-022
		Total Length Surveyed (ft):	190.9

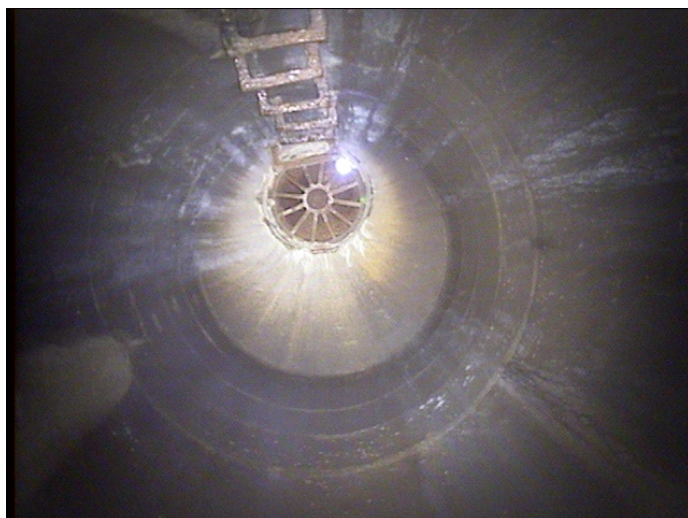
Code: **AMH**
 Description: **Manhole**

Distance (ft): **.0**
 Structural Grade: **0**
 O&M Grade: **0**
 Clock Start/From:
 Clock To:
 1st Value:
 2nd Value:
 Value Percent:
 Continuous Index:
 Within 8" of Joint: **NO**
 Remarks: **M-606-021**

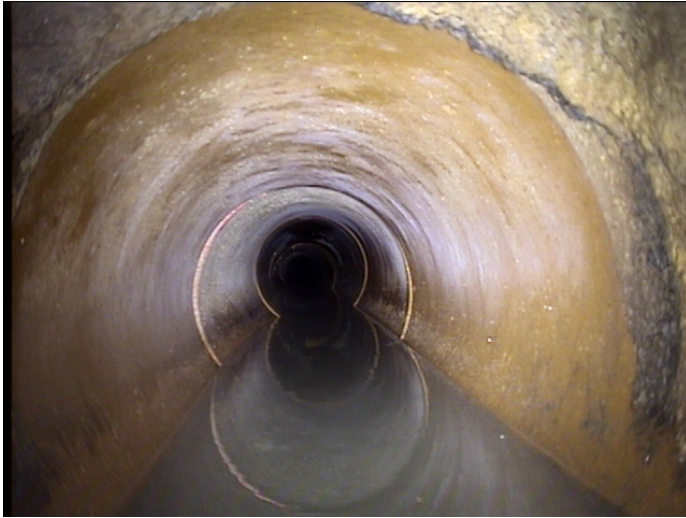
Code: **MWL**
Description: **Water Level**

Distance (ft): **.0**
Structural Grade: **0**
O&M Grade: **0**
Clock Start/From:
Clock To:
1st Value:
2nd Value:
Value Percent: **15.000**
Continuous Index:
Within 8" of Joint: **NO**
Remarks:
