Profile/Photo Observation Report

Date:	03/12/2024	Weather:		Coding:	PACP 7.0
Pipe Length (ft):	174.0	Owner:	City of Hobart	Pre Clean:	Heavy Cleaning
P.O.#:		Surveyor:	S. Bucklin	PSR:	P-606-053-052
Customer:	City of Hobart	Clean Date:	03/04/2024	Shape:	C

Street:	S ASH ST	Flow Control:	Not Controlled
City:	Hobart, IN	Year Renewed:	
Location:	Local rural streets with light traffic, t	Tape/Media #:	
Purpose:	Sewer System Evaluation Survey (SS	Dia/Height:	12"
Use:	Sanitary Sewage Pipe	Material:	VCP
Drain Area:		Lining:	None
Category:	NA		
Comment:			
Location Details:		Direction of Survey:	Downstream
US MH:	M-606-052	DS MH:	M-606-053
		Total Length Surveyed (ft):	171.8

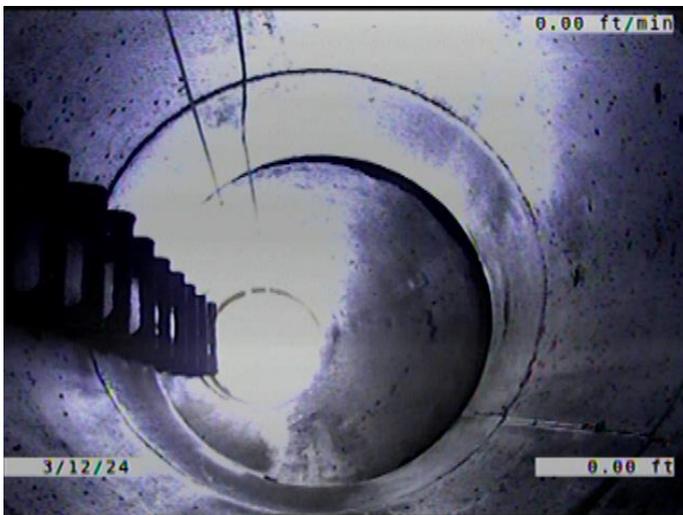
Code: **AMH**
Description: **Manhole**

Distance (ft): **.0**
Structural Grade: **0**
O&M Grade: **0**
Clock Start/From:
Clock To:
1st Value:
2nd Value:
Value Percent:
Continuous Index:
Within 8" of Joint: **NO**
Remarks: **M-606-052**

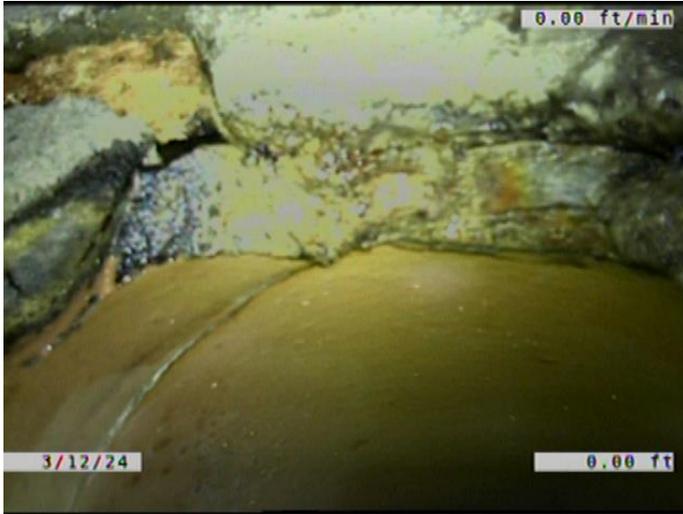
Code: **MWL**
Description: **Miscellaneous Water Level**

Distance (ft): **.0**
Structural Grade: **0**
O&M Grade: **0**
Clock Start/From:
Clock To:
1st Value:
2nd Value:
Value Percent: **35.000**
Continuous Index:
Within 8" of Joint: **NO**
Remarks:

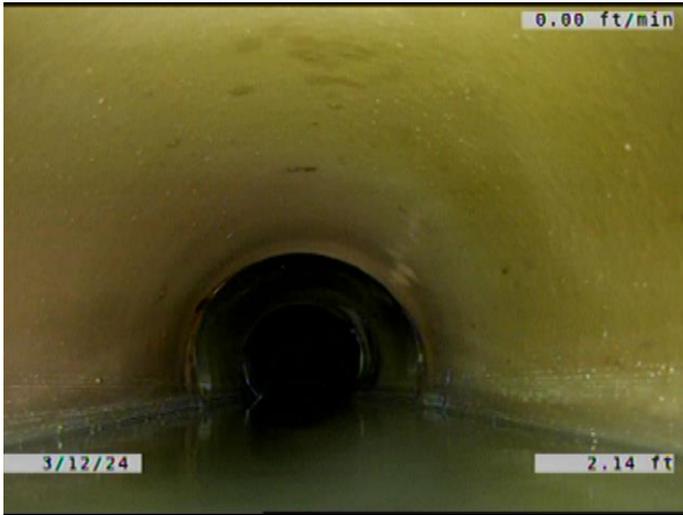
Code: **MWL**
Description: **Miscellaneous Water Level**

Distance (ft): **2.1**
Structural Grade: **0**
O&M Grade: **0**
Clock Start/From:
Clock To:
1st Value:
2nd Value:
Value Percent: **20.000**
Continuous Index:
Within 8" of Joint: **NO**
Remarks:

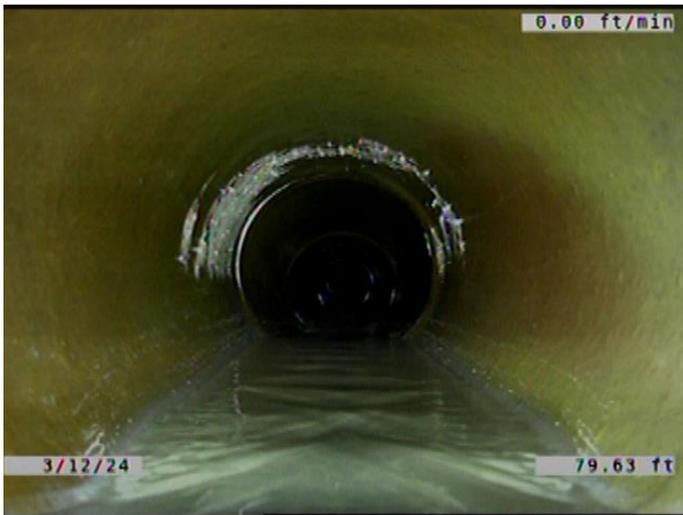
Code: **MWL**
 Description: **Miscellaneous Water Level**

Distance (ft): **79.6**
 Structural Grade: **0**
 O&M Grade: **0**
 Clock Start/From:
 Clock To:
 1st Value:
 2nd Value:
 Value Percent: **10.000**
 Continuous Index:
 Within 8" of Joint: **NO**
 Remarks:

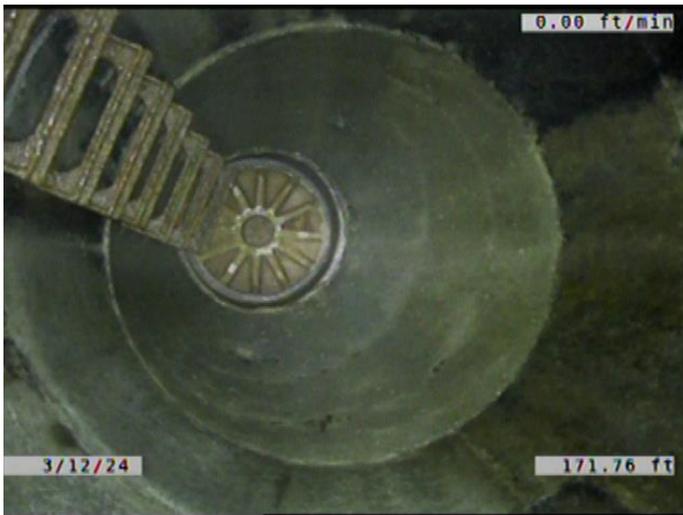
Code: **AMH**
 Description: **Manhole**

Distance (ft): **171.8**
 Structural Grade: **0**
 O&M Grade: **0**
 Clock Start/From:
 Clock To:
 1st Value:
 2nd Value:
 Value Percent:
 Continuous Index:
 Within 8" of Joint: **NO**
 Remarks: **M-606-053**
