Profile/Photo Observation Report

| Customer: | City of Hobart | Clean Date: | 02/29/2024 | Shape: | C |

| Street: | S ASH ST | Flow Control: | Not Controlled |
| US MH: | M-606-053 | DS MH: | M-606-054 |

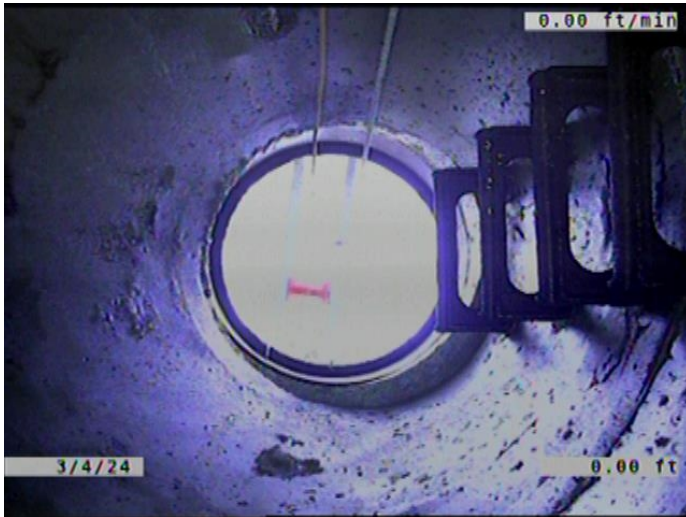
Code: **AMH**
Description: **Manhole**

Distance (ft): **.0**
Structural Grade: **0**
O&M Grade: **0**
Clock Start/From:
Clock To:
1st Value:
2nd Value:
Value Percent:
Continuous Index:
Within 8" of Joint: **NO**
Remarks: **M-606-053**

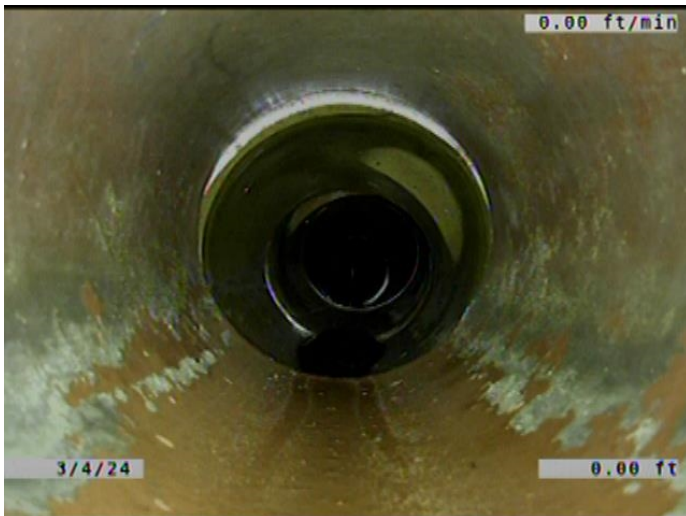
Code: **MWL**
Description: **Miscellaneous Water Level**

Distance (ft): **.0**
Structural Grade: **0**
O&M Grade: **0**
Clock Start/From:
Clock To:
1st Value:
2nd Value:
Value Percent: **5.000**
Continuous Index:
Within 8" of Joint: **NO**
Remarks:

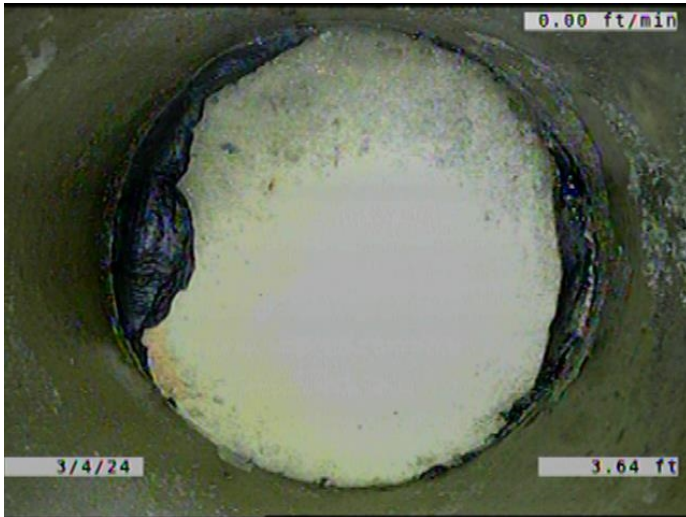
Code: **TFC**
Description: **Tap Factory Capped**

Distance (ft): **3.6**
Structural Grade: **0**
O&M Grade: **0**
Clock Start/From: **1**
Clock To:
1st Value: **6.000**
2nd Value:
Value Percent:
Continuous Index:
Within 8" of Joint: **YES**
Remarks:

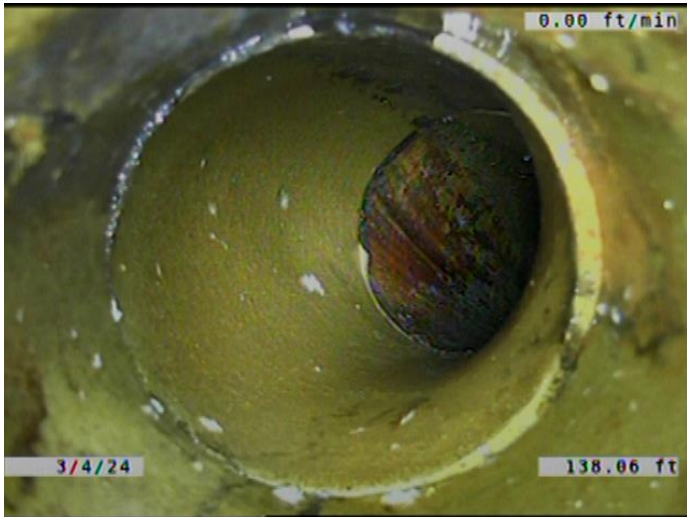
Code: **TF**
Description: **Tap Factory**

Distance (ft): **138.1**
Structural Grade: **0**
O&M Grade: **0**
Clock Start/From: **11**
Clock To:
1st Value: **6.000**
2nd Value:
Value Percent:
Continuous Index:
Within 8" of Joint: **YES**
Remarks:

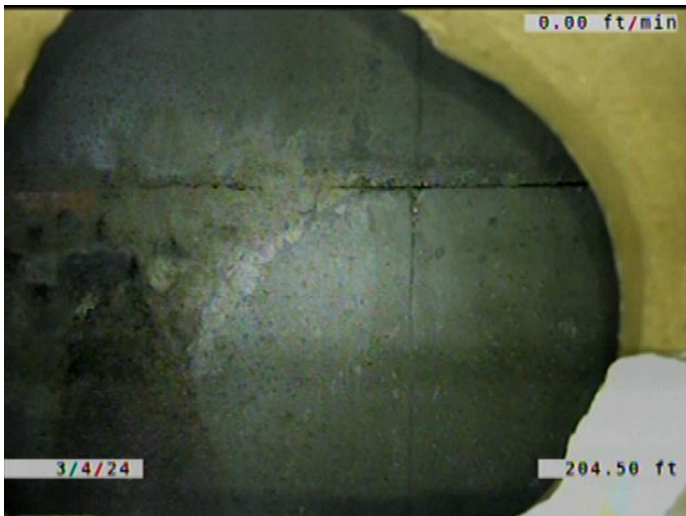
Code: **AMH**
 Description: **Manhole**

Distance (ft): **204.5**
 Structural Grade: **0**
 O&M Grade: **0**
 Clock Start/From:
 Clock To:
 1st Value:
 2nd Value:
 Value Percent:
 Continuous Index:
 Within 8" of Joint: **NO**
 Remarks: **M-606-054**
