# Profile/Photo Observation Report

Date:	02/09/2022	Weather:		Coding:	PACP 7.0
Pipe Length (ft):	201.5	Owner:	City of Hobart	Pre Clean:	Heavy Cleaning
P.O.#:	YES502259	Surveyor:	S. Bucklin	PSR:	P-606-071-058
Customer:	City of Hobart	Clean Date:	02/06/2022	Shape:	C

Street:	South Washington Street	Flow Control:	Not Controlled
City:	Hobart, IN	Year Renewed:	
Location:	Alley	Tape/Media #:	
Purpose:	Routine Assessment	Dia/Height:	10"
Use:	Sanitary Sewage Pipe	Material:	VCP
Drain Area:		Lining:	None
Category:	NA		
Comment:			
Location Details:		Direction of Survey:	Downstream
US MH:	M-606-058	DS MH:	M-606-071
		Total Length Surveyed (ft):	201.5

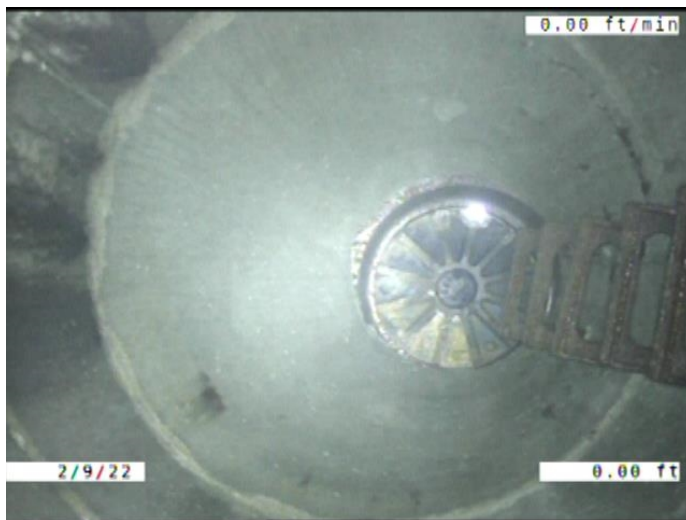
Code: **AMH**  
Description: **Manhole**

Distance (ft): **.0**  
Structural Grade: **0**  
O&M Grade: **0**  
Clock Start/From:  
Clock To:  
1st Value:  
2nd Value:  
Value Percent:  
Continuous Index:  
Within 8" of Joint: **NO**  
Remarks: **M-606-058**

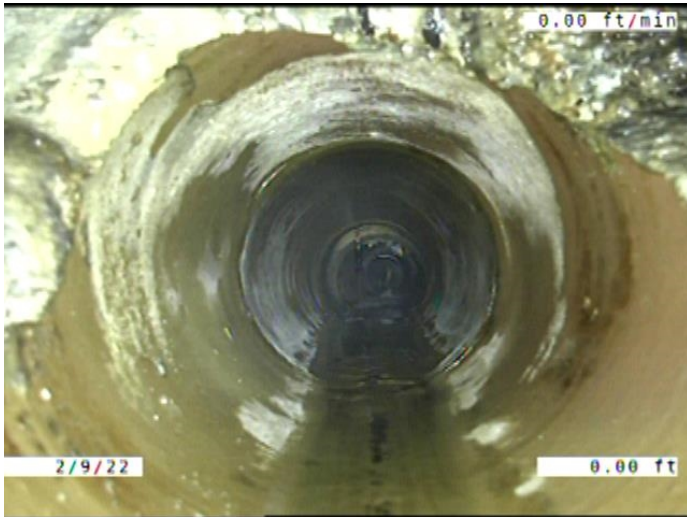
Code: **MWL**  
 Description: **Miscellaneous Water Level**

Distance (ft): **.0**  
 Structural Grade: **0**  
 O&M Grade: **0**  
 Clock Start/From:  
 Clock To:  
 1st Value:  
 2nd Value:  
 Value Percent: **5.000**  
 Continuous Index:  
 Within 8" of Joint: **NO**  
 Remarks:

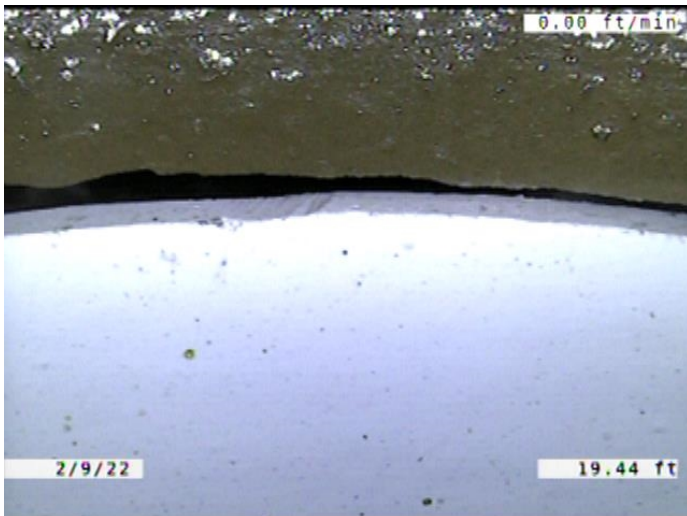
Code: **MMC**  
 Description: **Miscellaneous Material Change**

Distance (ft): **19.4**  
 Structural Grade: **0**  
 O&M Grade: **0**  
 Clock Start/From:  
 Clock To:  
 1st Value:  
 2nd Value:  
 Value Percent:  
 Continuous Index:  
 Within 8" of Joint: **NO**  
 Remarks: **VCP TO PVC**

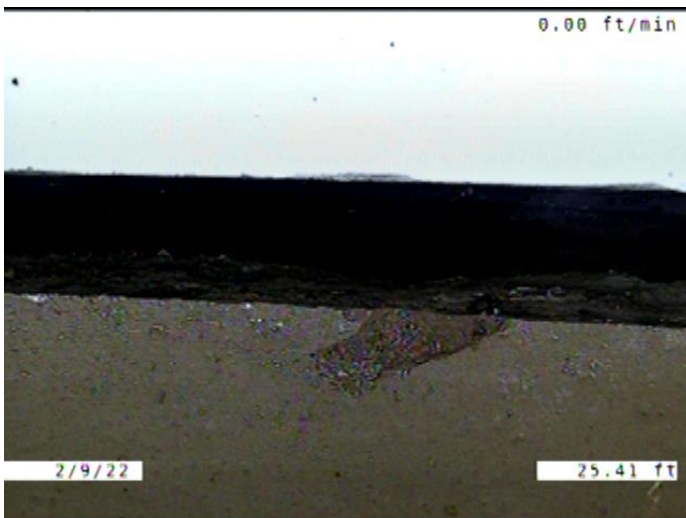
Code:	<b>MMC</b>
Description:	<b>Miscellaneous Material Change</b>
Distance (ft):	<b>25.4</b>
Structural Grade:	<b>0</b>
O&M Grade:	<b>0</b>
Clock Start/From:	
Clock To:	
1st Value:	
2nd Value:	
Value Percent:	
Continuous Index:	
Within 8" of Joint:	<b>NO</b>
Remarks:	<b>PVC TO VCP</b>

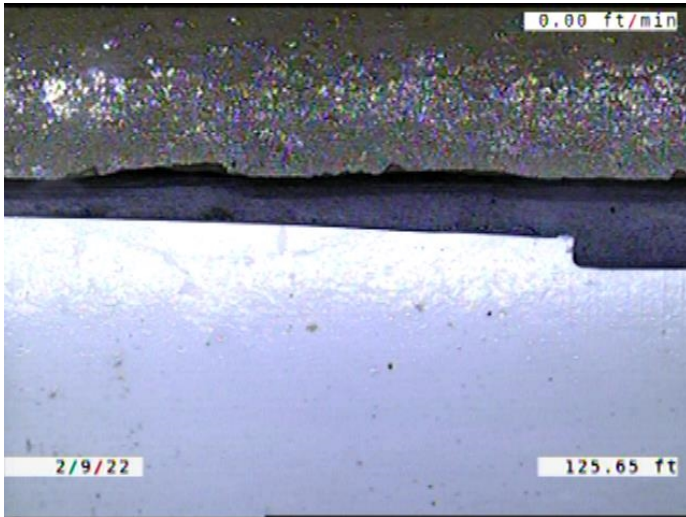
Code: **MMC**  
Description: **Miscellaneous Material Change**

Distance (ft): **125.6**  
Structural Grade: **0**  
O&M Grade: **0**  
Clock Start/From:  
Clock To:  
1st Value:  
2nd Value:  
Value Percent:  
Continuous Index:  
Within 8" of Joint: **NO**  
Remarks: **VCP TO PVC**

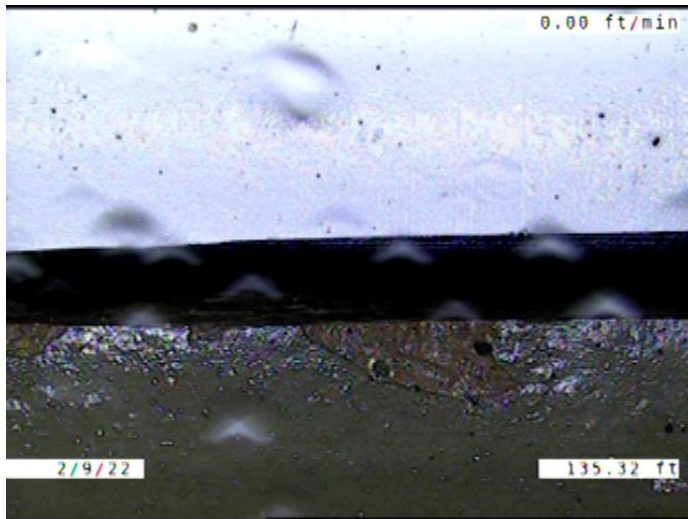
Code:	<b>MMC</b>
Description:	<b>Miscellaneous Material Change</b>
Distance (ft):	<b>135.3</b>
Structural Grade:	<b>0</b>
O&M Grade:	<b>0</b>
Clock Start/From:	
Clock To:	
1st Value:	
2nd Value:	
Value Percent:	
Continuous Index:	
Within 8" of Joint:	<b>NO</b>
Remarks:	<b>PVC TO VCP</b>

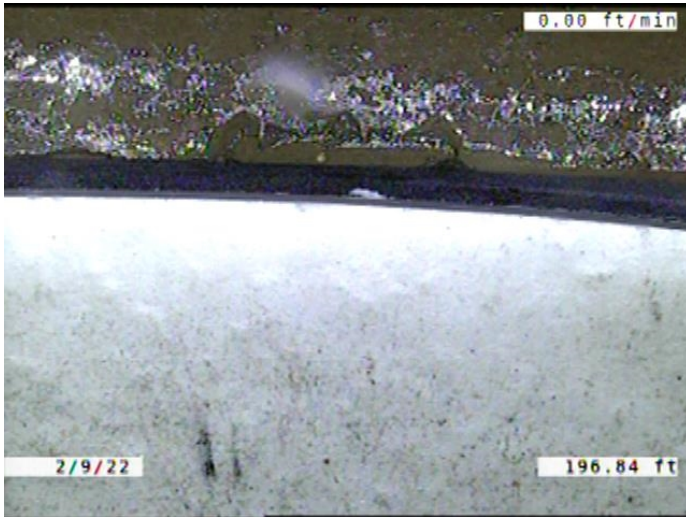
Code: **MMC**  
Description: **Miscellaneous Material Change**

Distance (ft): **196.8**  
Structural Grade: **0**  
O&M Grade: **0**  
Clock Start/From:  
Clock To:  
1st Value:  
2nd Value:  
Value Percent:  
Continuous Index:  
Within 8" of Joint: **NO**  
Remarks: **VCP TP PVC**

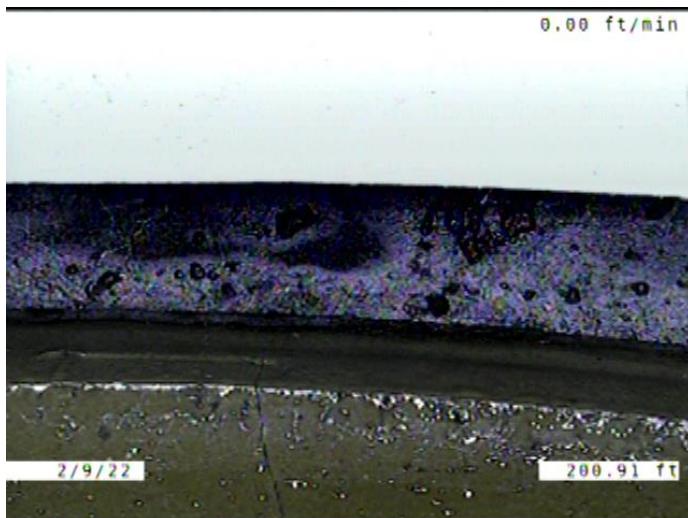
Code: **MMC**  
 Description: **Miscellaneous Material Change**

Distance (ft): **200.9**  
 Structural Grade: **0**  
 O&M Grade: **0**  
 Clock Start/From:  
 Clock To:  
 1st Value:  
 2nd Value:  
 Value Percent:  
 Continuous Index:  
 Within 8" of Joint: **NO**  
 Remarks: **PVC TO VCP**

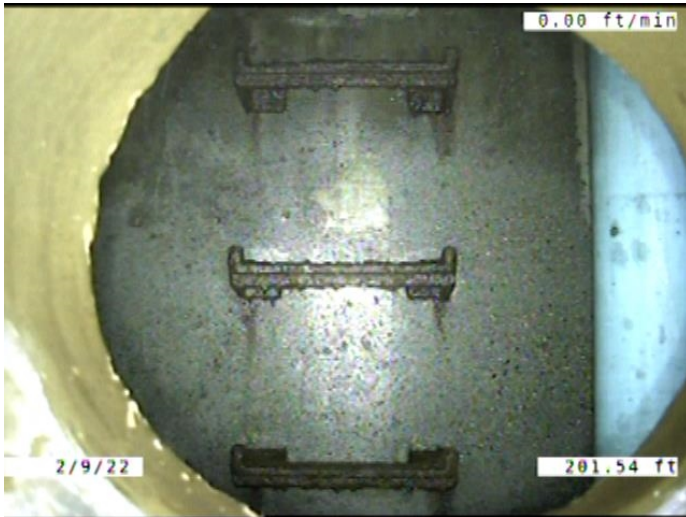
Code:	<b>AMH</b>
Description:	<b>Manhole</b>
Distance (ft):	<b>201.5</b>
Structural Grade:	<b>0</b>
O&M Grade:	<b>0</b>
Clock Start/From:	
Clock To:	
1st Value:	
2nd Value:	
Value Percent:	
Continuous Index:	
Within 8" of Joint:	<b>NO</b>
Remarks:	<b>M-606-071</b>
