Profile/Photo Observation Report

Date:	02/23/2024	Weather:		Coding:	PACP 7.0
Pipe Length (ft):	230.0	Owner:	City of Hobart	Pre Clean:	Heavy Cleaning
P.O.#:	YES502259	Surveyor:	S. Bucklin	PSR:	P-606-060-061
Customer:	City of Hobart	Clean Date:	12/12/2023	Shape:	C

Street:	S PENNSYLVANIA ST	Flow Control:	Not Controlled
City:	Hobart, IN	Year Renewed:	
Location:	Easement/Right of Way	Tape/Media #:	
Purpose:	Sewer System Evaluation Survey (SS)	Dia/Height:	10"
Use:	Sanitary Sewage Pipe	Material:	VCP
Drain Area:		Lining:	None
Category:	NA		
Comment:			
Location Details:		Direction of Survey:	Downstream
US MH:	M-606-061	DS MH:	M-606-060
		Total Length Surveyed (ft):	231.2

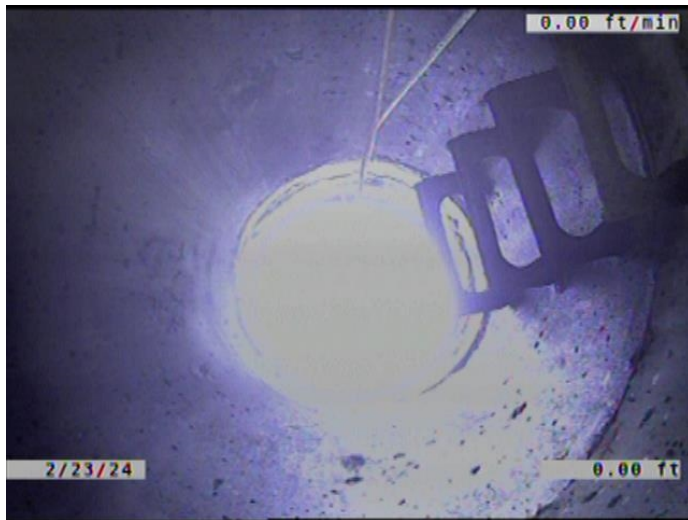
Code: **AMH**
 Description: **Manhole**

Distance (ft): **.0**
 Structural Grade: **0**
 O&M Grade: **0**
 Clock Start/From:
 Clock To:
 1st Value:
 2nd Value:
 Value Percent:
 Continuous Index:
 Within 8" of Joint: **NO**
 Remarks: **M-606-061**

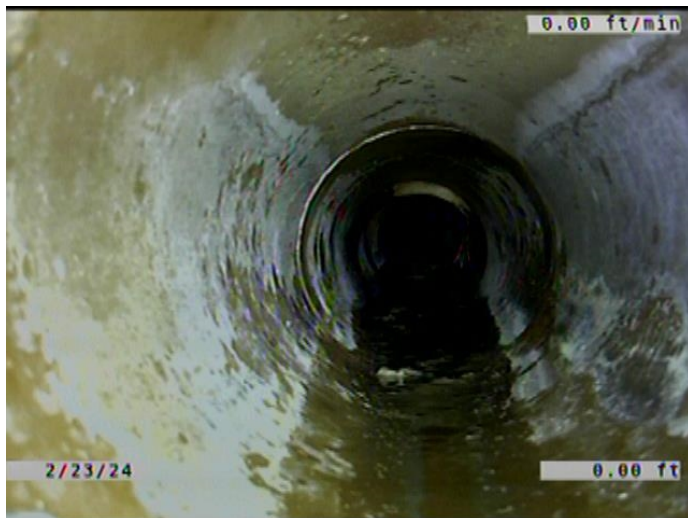
Code: **MWL**
 Description: **Miscellaneous Water Level**

Distance (ft): **.0**
 Structural Grade: **0**
 O&M Grade: **0**
 Clock Start/From:
 Clock To:
 1st Value:
 2nd Value:
 Value Percent: **5.000**
 Continuous Index:
 Within 8" of Joint: **NO**
 Remarks:

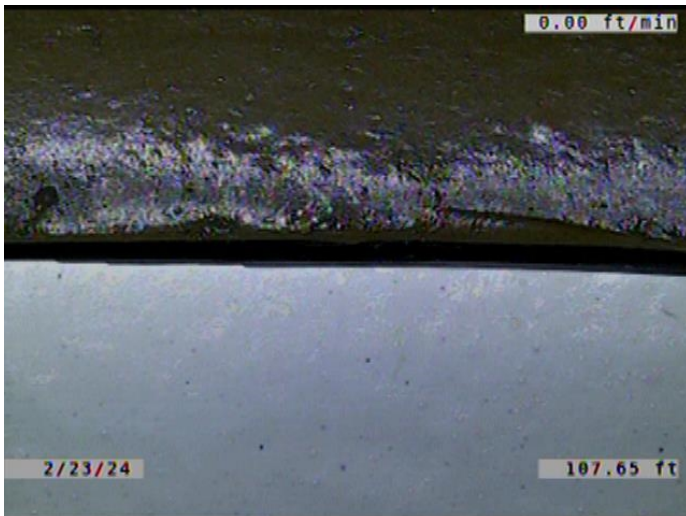
Code: **RPR**
Description: **Point Repair Replacement**

Distance (ft): **107.7**
Structural Grade: **0**
O&M Grade: **0**
Clock Start/From:
Clock To:
1st Value:
2nd Value:
Value Percent:
Continuous Index: **S07**
Within 8" of Joint: **YES**
Remarks: **REPLACED WITH PVC.**

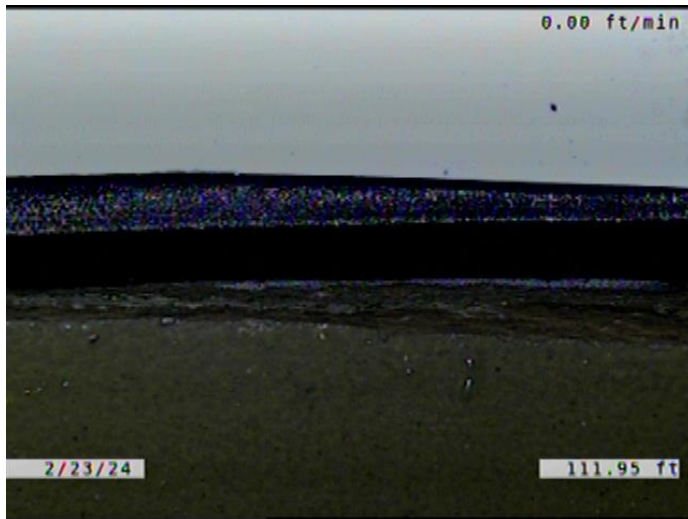
Code: **RPR**
 Description: **Point Repair Replacement**

Distance (ft): **111.9**
 Structural Grade: **0**
 O&M Grade: **0**
 Clock Start/From:
 Clock To:
 1st Value:
 2nd Value:
 Value Percent:
 Continuous Index: **F07**
 Within 8" of Joint: **YES**
 Remarks: **REPLACED WITH PVC.**

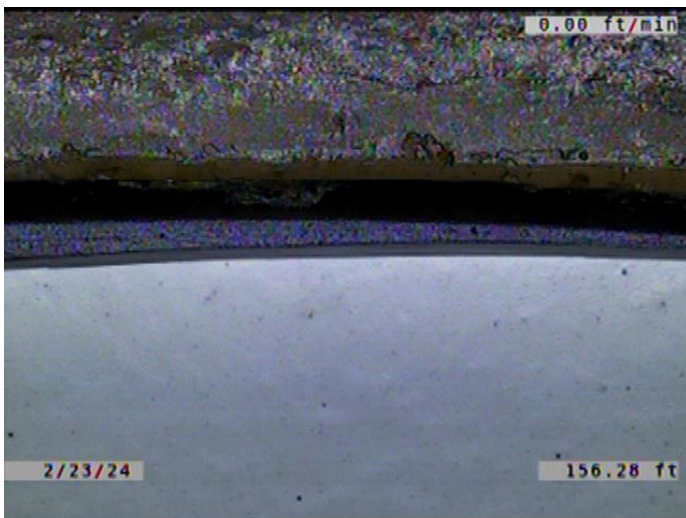
Code: **RPR**
Description: **Point Repair Replacement**

Distance (ft): **156.3**
Structural Grade: **0**
O&M Grade: **0**
Clock Start/From:
Clock To:
1st Value:
2nd Value:
Value Percent:
Continuous Index: **S09**
Within 8" of Joint: **YES**
Remarks: **REPLACED WITH PVC.**

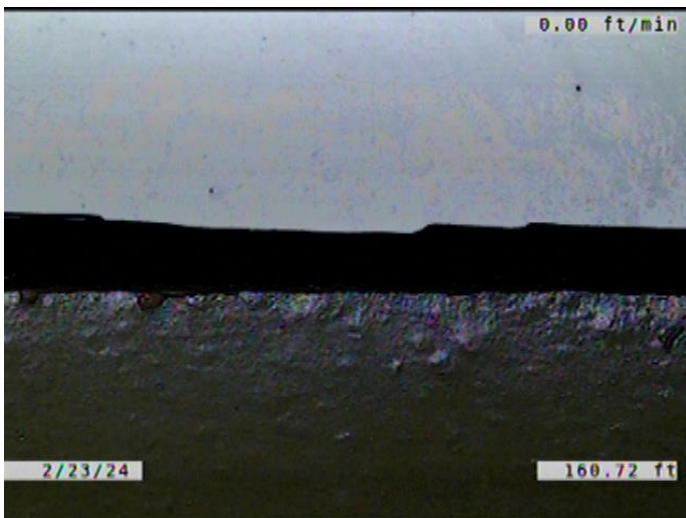
Code: **RPR**
Description: **Point Repair Replacement**

Distance (ft): **160.7**
Structural Grade: **0**
O&M Grade: **0**
Clock Start/From:
Clock To:
1st Value:
2nd Value:
Value Percent:
Continuous Index: **F09**
Within 8" of Joint: **YES**
Remarks: **REPLACED WITH PVC.**

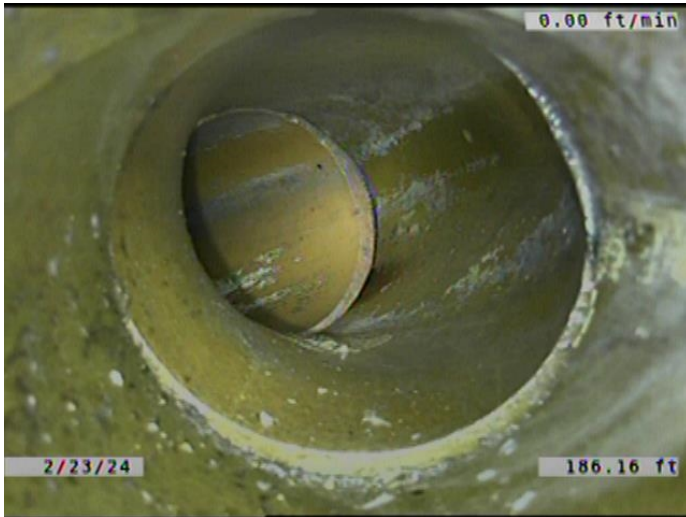
Code: **TF**
Description: **Tap Factory**

Distance (ft): **186.2**
Structural Grade: **0**
O&M Grade: **0**
Clock Start/From: **2**
Clock To:
1st Value: **6.000**
2nd Value:
Value Percent:
Continuous Index:
Within 8" of Joint: **YES**
Remarks:

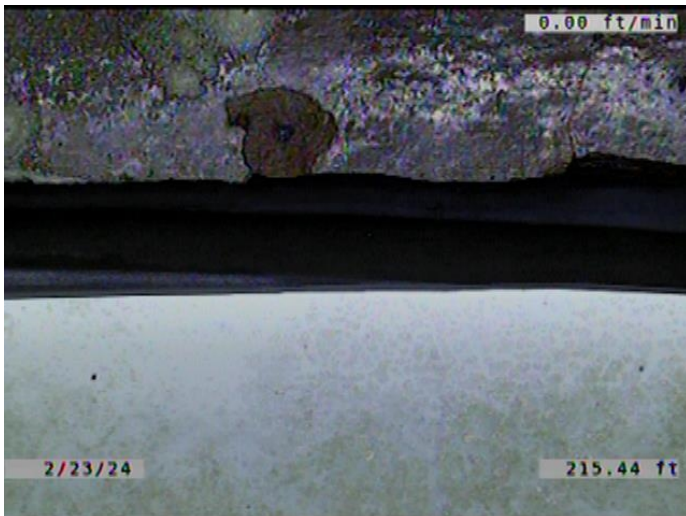
Code: **RPR**
 Description: **Point Repair Replacement**

Distance (ft): **215.4**
 Structural Grade: **0**
 O&M Grade: **0**
 Clock Start/From:
 Clock To:
 1st Value:
 2nd Value:
 Value Percent:
 Continuous Index: **S12**
 Within 8" of Joint: **YES**
 Remarks: **REPLACED WITH PVC.**

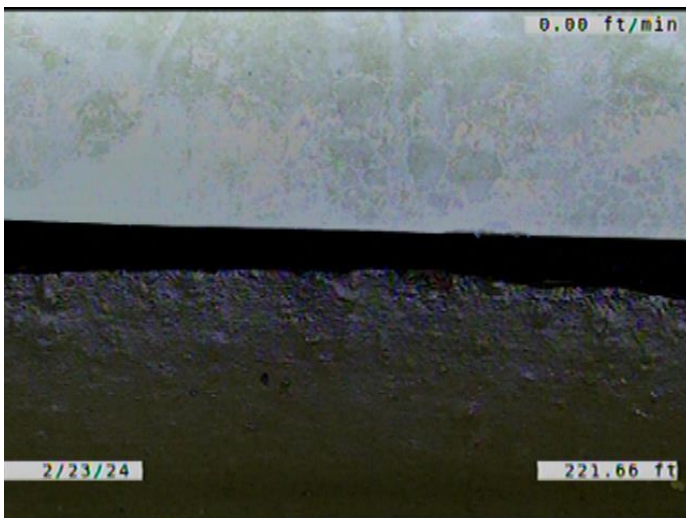
Code: **RPR**
Description: **Point Repair Replacement**

Distance (ft): **221.7**
Structural Grade: **0**
O&M Grade: **0**
Clock Start/From:
Clock To:
1st Value:
2nd Value:
Value Percent:
Continuous Index: **F12**
Within 8" of Joint: **YES**
Remarks: **REPLACED WITH PVC.**

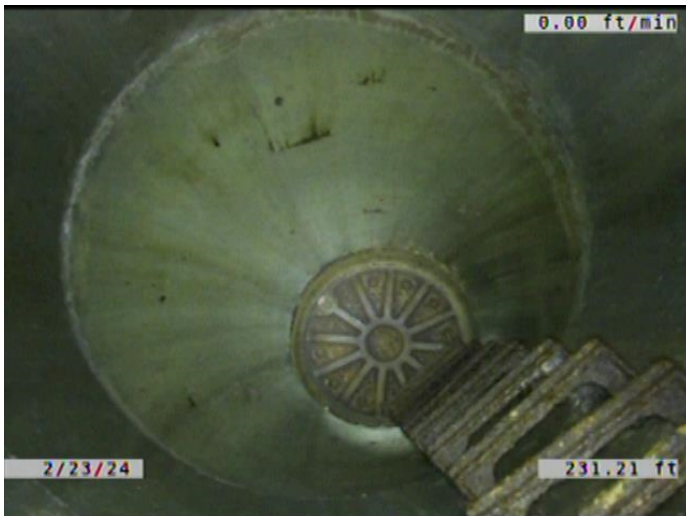
Code:	AMH
Description:	Manhole
Distance (ft):	231.2
Structural Grade:	0
O&M Grade:	0
Clock Start/From:	
Clock To:	
1st Value:	
2nd Value:	
Value Percent:	
Continuous Index:	
Within 8" of Joint:	NO
Remarks:	M-606-060
