## Profile/Photo Observation Report

Date:	<b>03/04/2024</b>	Weather:		Coding:	<b>PACP 7.0</b>
Pipe Length (ft):	<b>146.0</b>	Owner:	<b>City of Hobart</b>	Pre Clean:	<b>Heavy Cleaning</b>
P.O.#:		Surveyor:	<b>S. Bucklin</b>	PSR:	<b>P-606-061-062</b>
Customer:	<b>City of Hobart</b>	Clean Date:	<b>02/21/2024</b>	Shape:	<b>C</b>

Location Details:	<b>END OF THE DRIVEWAY AT 502 W 7</b>	Direction of Survey:	<b>Upstream</b>
US MH:	<b>M-606-061</b>	DS MH:	<b>M-606-062</b>
		Total Length Surveyed (ft):	<b>169.8</b>

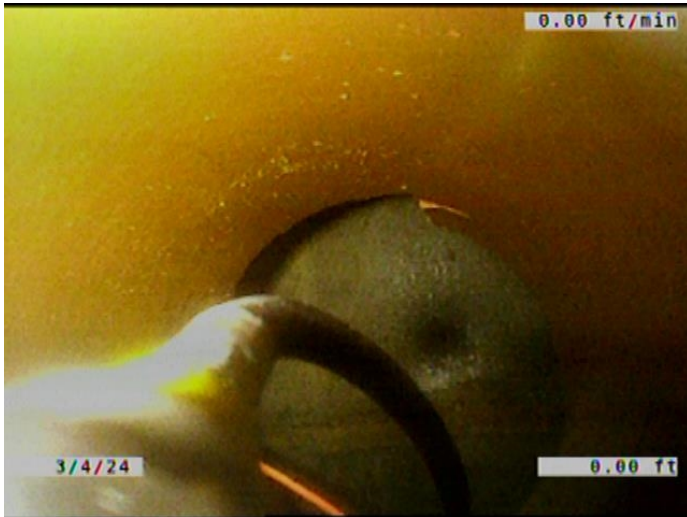
Code: **AMH**  
Description: **Manhole**

Distance (ft): **.0**  
Structural Grade: **0**  
O&M Grade: **0**  
Clock Start/From:  
Clock To:  
1st Value:  
2nd Value:  
Value Percent:  
Continuous Index:  
Within 8" of Joint: **NO**  
Remarks: **M-606-062**

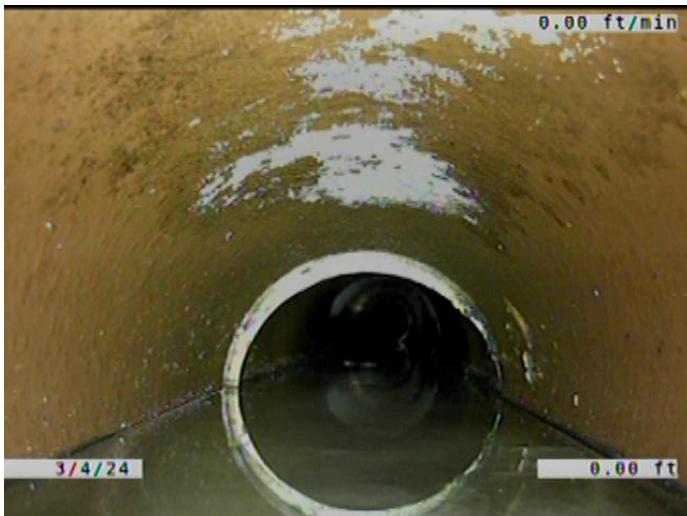
Code: **MWL**  
Description: **Miscellaneous Water Level**

Distance (ft): **.0**  
Structural Grade: **0**  
O&M Grade: **0**  
Clock Start/From:  
Clock To:  
1st Value:  
2nd Value:  
Value Percent: **5.000**  
Continuous Index:  
Within 8" of Joint: **NO**  
Remarks:

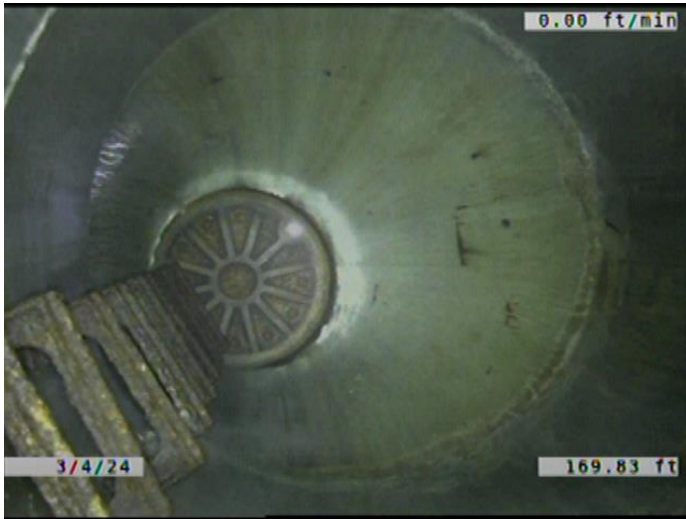
Code:	AMH
Description:	Manhole
Distance (ft):	169.8
Structural Grade:	0
O&M Grade:	0
Clock Start/From:	
Clock To:	
1st Value:	
2nd Value:	
Value Percent:	
Continuous Index:	
Within 8" of Joint:	NO
Remarks:	M-606-061
