Profile/Photo Observation Report

Date:	02/28/2024	Weather:		Coding:	PACP 7.0
Pipe Length (ft):	112.0	Owner:	City of Hobart	Pre Clean:	Heavy Cleaning
P.O.#:		Surveyor:	S. Bucklin	PSR:	P-606-064-063
Customer:	City of Hobart	Clean Date:	02/16/2024	Shape:	C

Street:	W 7TH ST	Flow Control:	Not Controlled
City:	Hobart, IN	Year Renewed:	
Location:	Easement/Right of Way	Tape/Media #:	
Purpose:	Sewer System Evaluation Survey (SS	Dia/Height:	12"
Use:	Sanitary Sewage Pipe	Material:	VCP
Drain Area:		Lining:	None
Category:	NA		
Comment:			
Location Details:		Direction of Survey:	Downstream
US MH:	M-606-063	DS MH:	M-606-064
		Total Length Surveyed (ft):	111.3

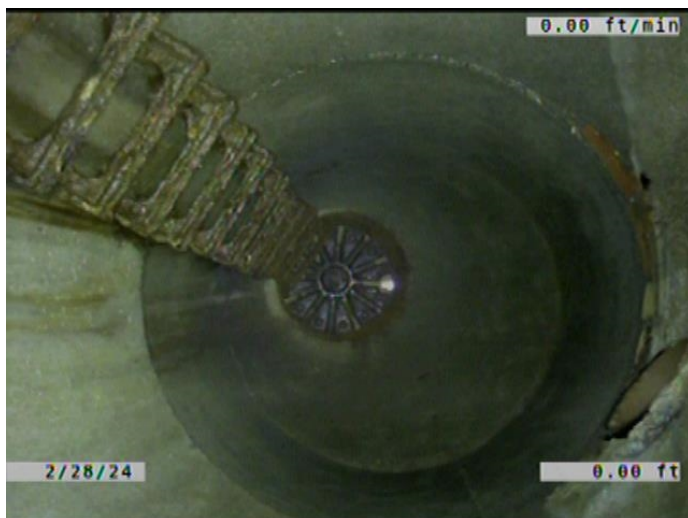
Code:	AMH
Description:	Manhole
Distance (ft):	.0
Structural Grade:	0
O&M Grade:	0
Clock Start/From:	
Clock To:	
1st Value:	
2nd Value:	
Value Percent:	
Continuous Index:	
Within 8" of Joint:	NO
Remarks:	M-606-063

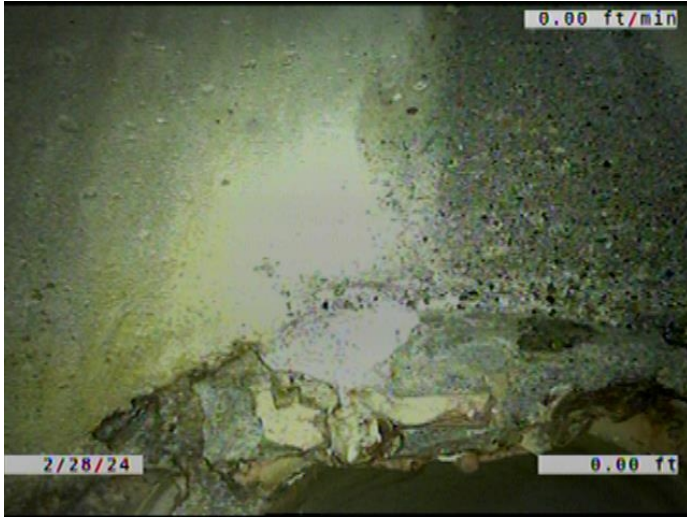
Code: **MWL**
Description: **Miscellaneous Water Level**

Distance (ft): **.0**
Structural Grade: **0**
O&M Grade: **0**
Clock Start/From:
Clock To:
1st Value:
2nd Value:
Value Percent: **10.000**
Continuous Index:
Within 8" of Joint: **NO**
Remarks:

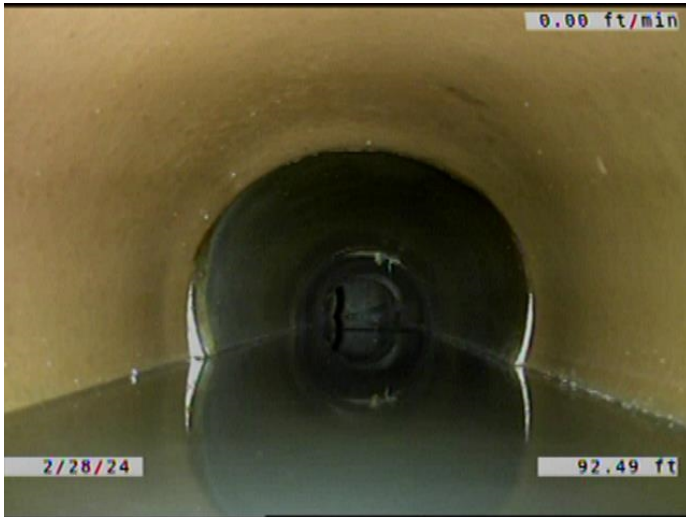
Code: **MWL**
Description: **Miscellaneous Water Level**

Distance (ft): **92.5**
Structural Grade: **0**
O&M Grade: **0**
Clock Start/From:
Clock To:
1st Value:
2nd Value:
Value Percent: **20.000**
Continuous Index:
Within 8" of Joint: **NO**
Remarks:

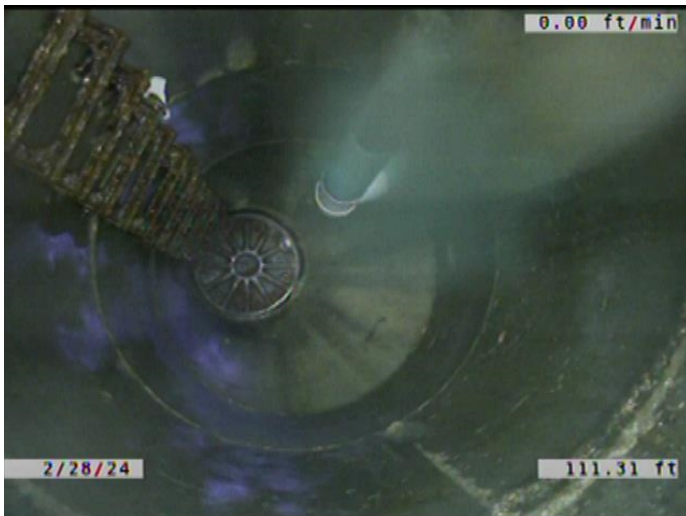
Code: **AMH**
 Description: **Manhole**

Distance (ft): **111.3**
 Structural Grade: **0**
 O&M Grade: **0**
 Clock Start/From:
 Clock To:
 1st Value:
 2nd Value:
 Value Percent:
 Continuous Index:
 Within 8" of Joint: **NO**
 Remarks: **M-606-064**
