Profile/Photo Observation Report

Date:	02/16/2024	Weather:		Coding:	PACP 7.0
Pipe Length (ft):	170.0	Owner:	City of Hobart	Pre Clean:	Heavy Cleaning
P.O.#:	YES502259	Surveyor:	S. Bucklin	PSR:	P-606-065-064
Customer:	City of Hobart	Clean Date:	12/08/2023	Shape:	C

Street:	S PENNSYLVANIA ST	Flow Control:	Not Controlled
City:	Hobart, IN	Year Renewed:	
Location:	Easement/Right of Way	Tape/Media #:	
Purpose:	Routine Assessment	Dia/Height:	10"
Use:	Sanitary Sewage Pipe	Material:	VCP
Drain Area:		Lining:	None
Category:	NA		
Comment:

Location Details:		Direction of Survey:	Downstream
US MH:	M-606-064	DS MH:	M-606-065
		Total Length Surveyed (ft):	165.4

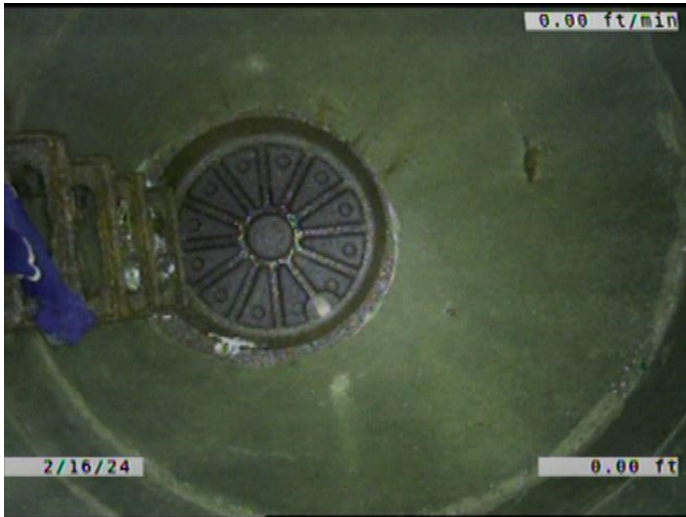
Code: **AMH**
Description: **Manhole**

Distance (ft): **.0**
Structural Grade: **0**
O&M Grade: **0**
Clock Start/From:
Clock To:
1st Value:
2nd Value:
Value Percent:
Continuous Index:
Within 8" of Joint: **NO**
Remarks: **M-606-064**

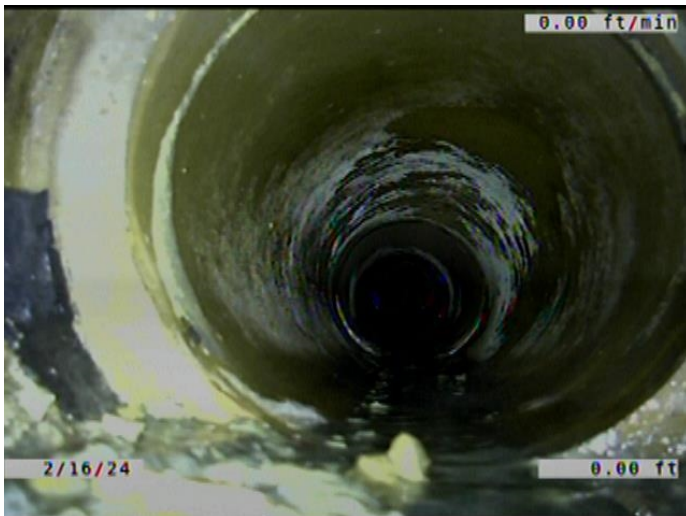
Code: **MWL**
Description: **Miscellaneous Water Level**

Distance (ft): **.0**
Structural Grade: **0**
O&M Grade: **0**
Clock Start/From:
Clock To:
1st Value:
2nd Value:
Value Percent: **5.000**
Continuous Index:
Within 8" of Joint: **NO**
Remarks:

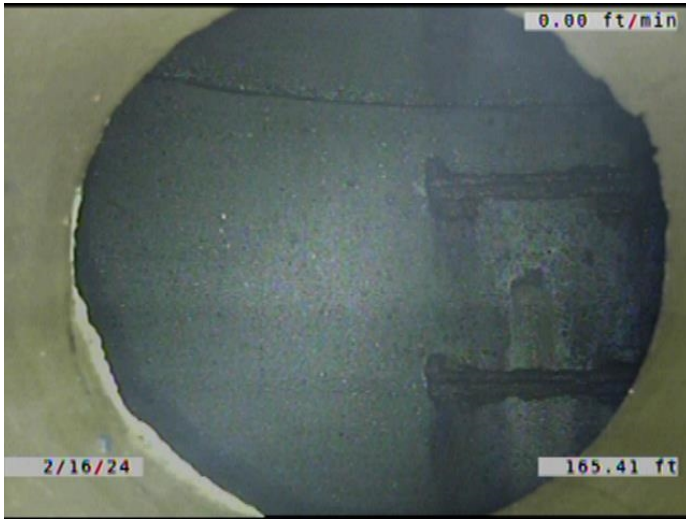
Code:	AMH
Description:	Manhole
Distance (ft):	165.4
Structural Grade:	0
O&M Grade:	0
Clock Start/From:	
Clock To:	
1st Value:	
2nd Value:	
Value Percent:	
Continuous Index:	
Within 8" of Joint:	NO
Remarks:	M-606-065
