Profile/Photo Observation Report

Date:	02/28/2024	Weather:		Coding:	PACP 7.0
Pipe Length (ft):	170.0	Owner:	City of Hobart	Pre Clean:	Heavy Cleaning
P.O.#:		Surveyor:	S. Bucklin	PSR:	P-606-067-064
Customer:	City of Hobart	Clean Date:	12/09/2023	Shape:	C

Street:	W 7TH ST	Flow Control:	Not Controlled
City:	Hobart, IN	Year Renewed:	
Location:	Easement/Right of Way	Tape/Media #:	
Purpose:	Sewer System Evaluation Survey (SS	Dia/Height:	12"
Use:	Sanitary Sewage Pipe	Material:	VCP
Drain Area:		Lining:	None
Category:	NA		
Comment:			
Location Details:		Direction of Survey:	Downstream
US MH:	M-606-064	DS MH:	M-606-067
		Total Length Surveyed (ft):	170.0

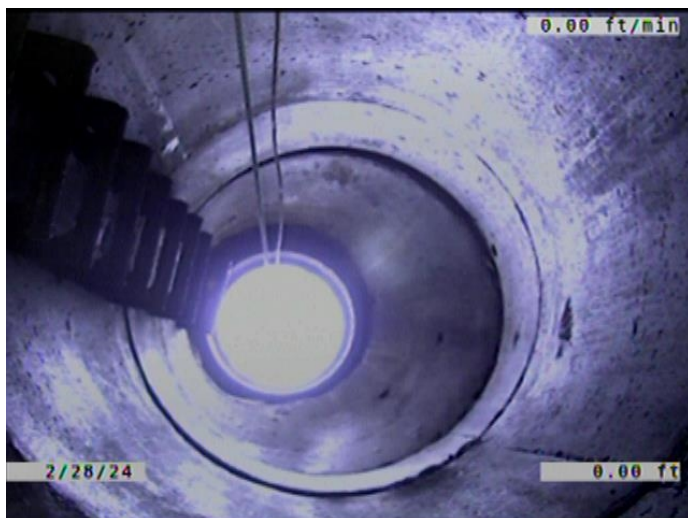
Code: **AMH**
 Description: **Manhole**

Distance (ft): **.0**
 Structural Grade: **0**
 O&M Grade: **0**
 Clock Start/From:
 Clock To:
 1st Value:
 2nd Value:
 Value Percent:
 Continuous Index:
 Within 8" of Joint: **NO**
 Remarks: **M-606-064**

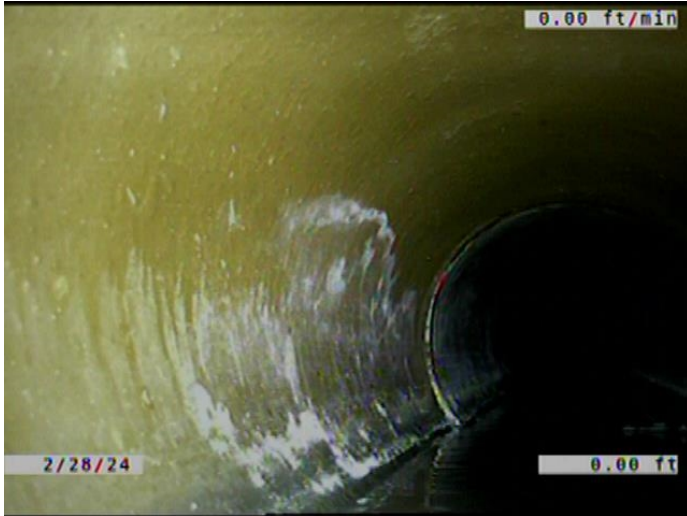
Code: **MWL**
Description: **Miscellaneous Water Level**

Distance (ft): **.0**
Structural Grade: **0**
O&M Grade: **0**
Clock Start/From:
Clock To:
1st Value:
2nd Value:
Value Percent: **10.000**
Continuous Index:
Within 8" of Joint: **NO**
Remarks:

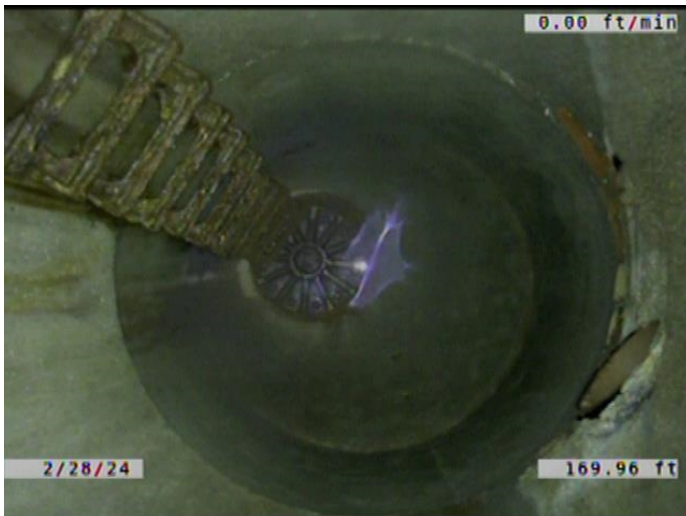
Code: **AMH**
 Description: **Manhole**

Distance (ft): **170.0**
 Structural Grade: **0**
 O&M Grade: **0**
 Clock Start/From:
 Clock To:
 1st Value:
 2nd Value:
 Value Percent:
 Continuous Index:
 Within 8" of Joint: **NO**
 Remarks: **M-606-067**
