## Profile/Photo Observation Report

Date:	<b>02/05/2022</b>	Weather:		Coding:	<b>PACP 7.0</b>
Pipe Length (ft):	<b>154.7</b>	Owner:	<b>City of Hobart</b>	Pre Clean:	<b>Heavy Cleaning</b>
P.O.#:	<b>YES502259</b>	Surveyor:	<b>S. Bucklin</b>	PSR:	<b>P-606-076-075</b>
Customer:	<b>City of Hobart</b>	Clean Date:	<b>02/01/2022</b>	Shape:	<b>C</b>

Street:	<b>South Connection Street</b>	Flow Control:	<b>Not Controlled</b>
City:	<b>Hobart, IN</b>	Year Renewed:	
Location:	<b>Easement/Right of Way</b>	Tape/Media #:	
Purpose:	<b>Routine Assessment</b>	Dia/Height:	<b>12"</b>
Use:	<b>Sanitary Sewage Pipe</b>	Material:	<b>VCP</b>
Drain Area:		Lining:	<b>None</b>
Category:	<b>NA</b>

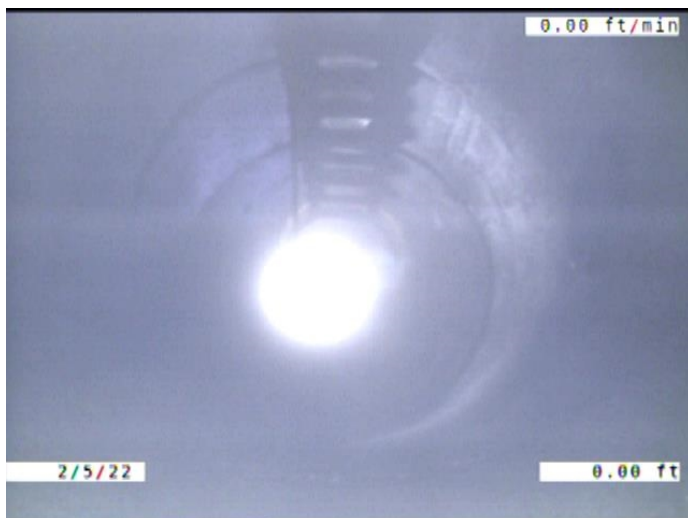
Code: **AMH**  
 Description: **Manhole**

Distance (ft): **.0**  
 Structural Grade: **0**  
 O&M Grade: **0**  
 Clock Start/From:  
 Clock To:  
 1st Value:  
 2nd Value:  
 Value Percent:  
 Continuous Index:  
 Within 8" of Joint: **NO**  
 Remarks: **M-606-075**

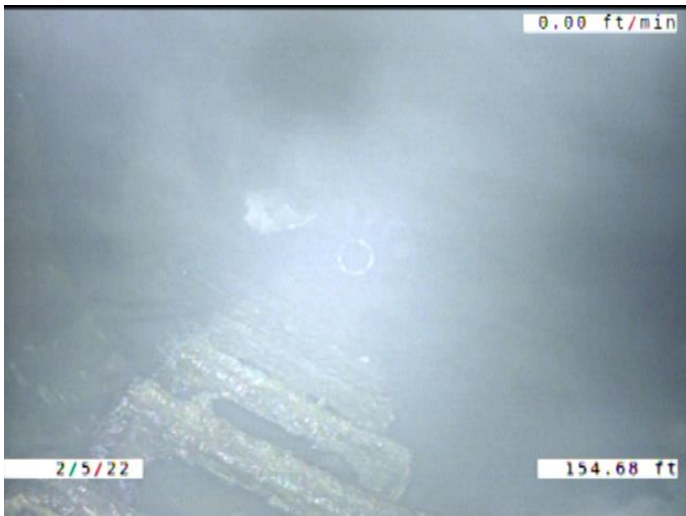
Code:	<b>AMH</b>
Description:	<b>Manhole</b>
Distance (ft):	<b>154.7</b>
Structural Grade:	<b>0</b>
O&M Grade:	<b>0</b>
Clock Start/From:	
Clock To:	
1st Value:	
2nd Value:	
Value Percent:	
Continuous Index:	
Within 8" of Joint:	<b>NO</b>
Remarks:	<b>M-606-076</b>
