Profile/Photo Observation Report

Date:	02/24/2024	Weather:		Coding:	PACP 7.0
Pipe Length (ft):	132.0	Owner:	City of Hobart	Pre Clean:	Heavy Cleaning
P.O.#:	YES502259	Surveyor:	S. Bucklin	PSR:	P-606-080-078
Customer:	City of Hobart	Clean Date:	12/01/2023	Shape:	C

Street:	S PENNSYLVANIA ST	Flow Control:	Not Controlled
City:	Hobart, IN	Year Renewed:	
Location:	Easement/Right of Way	Tape/Media #:	
Purpose:	Sewer System Evaluation Survey (SS	Dia/Height:	10"
Use:	Sanitary Sewage Pipe	Material:	VCP
Drain Area:		Lining:	None
Category:	NA		
Comment:			
Location Details:		Direction of Survey:	Downstream
US MH:	M-606-078	DS MH:	M-606-080
		Total Length Surveyed (ft):	72.2

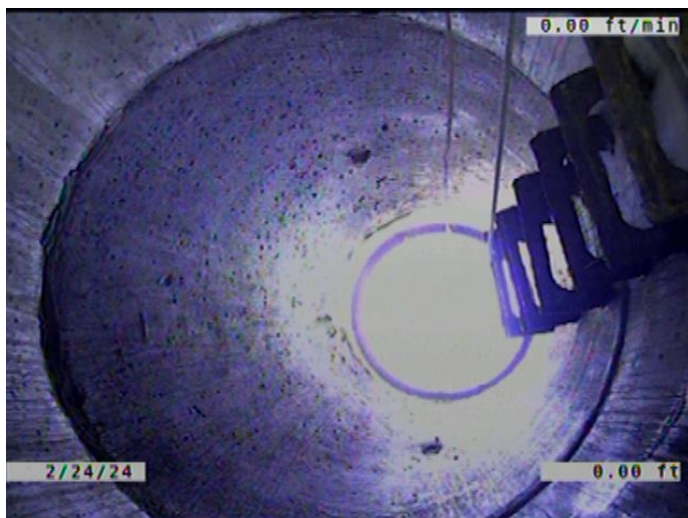
Code: **AMH**
Description: **Manhole**

Distance (ft): **.0**
Structural Grade: **0**
O&M Grade: **0**
Clock Start/From:
Clock To:
1st Value:
2nd Value:
Value Percent:
Continuous Index:
Within 8" of Joint: **NO**
Remarks: **M-606-078**

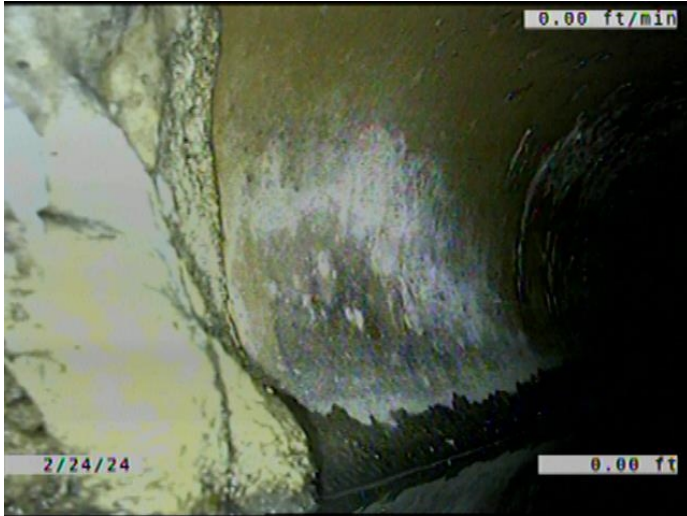
Code: **MWL**
Description: **Miscellaneous Water Level**

Distance (ft): **.0**
Structural Grade: **0**
O&M Grade: **0**
Clock Start/From:
Clock To:
1st Value:
2nd Value:
Value Percent: **5.000**
Continuous Index:
Within 8" of Joint: **NO**
Remarks:
