## Profile/Photo Observation Report

Street:	<b>S PENNSYLVANIA ST</b>	Flow Control:	<b>Not Controlled</b>
City:	<b>Hobart, IN</b>	Year Renewed:	
Location:	<b>Yard</b>	Tape/Media #:	
Purpose:	<b>Routine Assessment</b>	Dia/Height:	<b>10"</b>
Use:	<b>Sanitary</b>	Material:	<b>VCP</b>
Drain Area:	<b>NA</b>	Lining:	
Category:	<b>NA</b>		
Comment:	<b>Flow direction is marked wrong.</b>

Location Details:		Direction of Survey:	<b>Downstream</b>
US MH:	<b>M-606-080</b>	DS MH:	<b>M-606-081</b>
		Total Length Surveyed (ft):	<b>153.5</b>

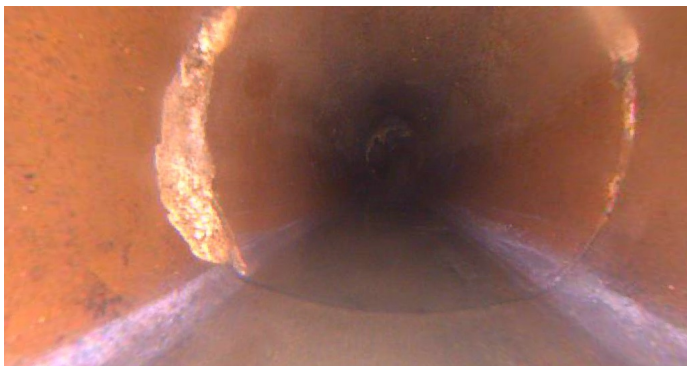
Code: **AMH**  
 Description: **Manhole**  
 Distance (ft): **.0**  
 Structural Grade: **0**  
 O&M Grade: **0**  
 Clock Start/From:  
 Clock To:  
 1st Value:  
 2nd Value:  
 Value Percent:  
 Continuous Index:  
 Within 8" of Joint: **NO**  
 Remarks: **M-606-080**
