Profile/Photo Observation Report

Date:	02/29/2024	Weather:		Coding:	PACP 7.0
Pipe Length (ft):	85.1	Owner:	City of Hobart	Pre Clean:	Heavy Cleaning
P.O.#:		Surveyor:	S. Bucklin	PSR:	M-606-084-M-606-083
Customer:	City of Hobart	Clean Date:	11/29/2023	Shape:	C

Street:	NORTH LAKE SHORE	Flow Control:	Not Controlled
City:	Hobart, IN	Year Renewed:	
Location:	Local rural streets with light traffic, t	Tape/Media #:	
Purpose:	Sewer System Evaluation Survey (SS	Dia/Height:	10"
Use:	Sanitary Sewage Pipe	Material:	VCP
Drain Area:		Lining:	None
Category:	NA		
Comment:			
Location Details:		Direction of Survey:	Downstream
US MH:	M-606-084	DS MH:	M-606-083
		Total Length Surveyed (ft):	172.4

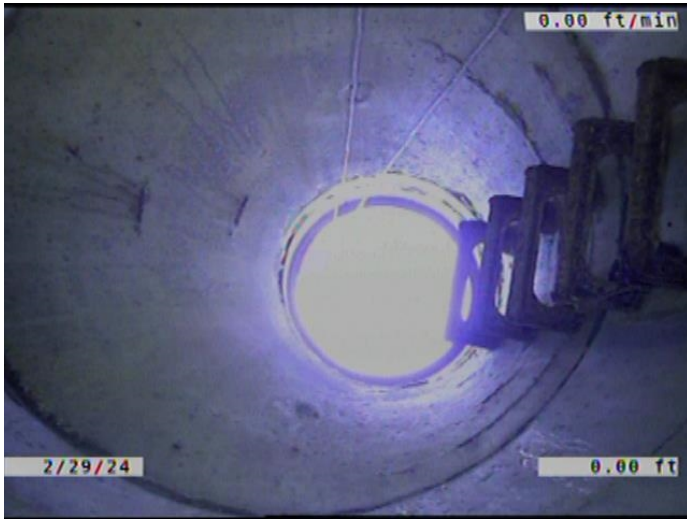
Code: **AMH**
Description: **Manhole**

Distance (ft): **.0**
Structural Grade: **0**
O&M Grade: **0**
Clock Start/From:
Clock To:
1st Value:
2nd Value:
Value Percent:
Continuous Index:
Within 8" of Joint: **NO**
Remarks: **M-606-084**

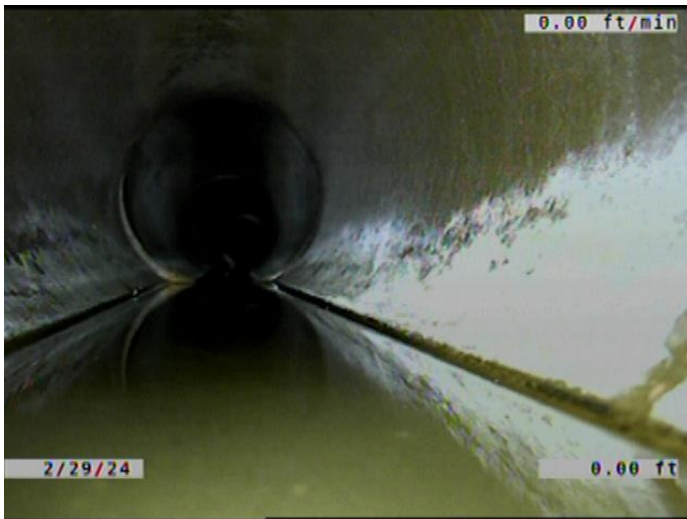
Code: **MWL**
Description: **Miscellaneous Water Level**

Distance (ft): **.0**
Structural Grade: **0**
O&M Grade: **0**
Clock Start/From:
Clock To:
1st Value:
2nd Value:
Value Percent: **5.000**
Continuous Index:
Within 8" of Joint: **NO**
Remarks:

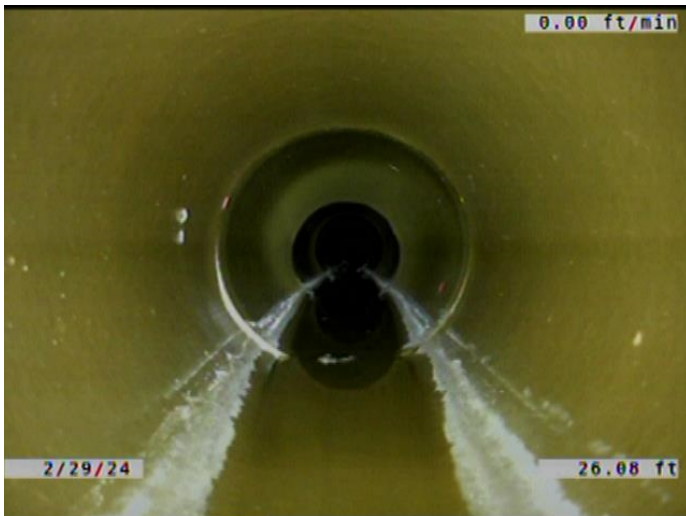
Code: **MWLS**
Description: **Miscellaneous Water Level Sag**

Distance (ft): **26.1**
Structural Grade: **2**
O&M Grade: **0**
Clock Start/From:
Clock To:
1st Value:
2nd Value:
Value Percent: **5.000**
Continuous Index: **S02**
Within 8" of Joint: **NO**
Remarks:

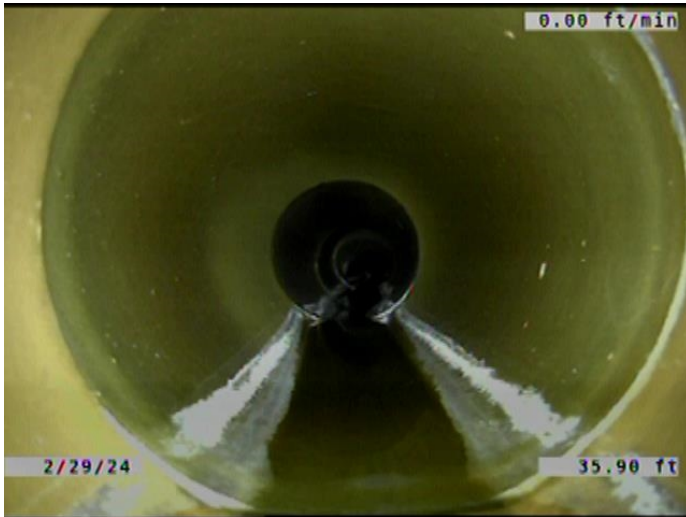
Code: **MWLS**
Description: **Miscellaneous Water Level Sag**

Distance (ft): **35.9**
Structural Grade: **2**
O&M Grade: **0**
Clock Start/From:
Clock To:
1st Value:
2nd Value:
Value Percent: **5.000**
Continuous Index: **F02**
Within 8" of Joint: **NO**
Remarks:

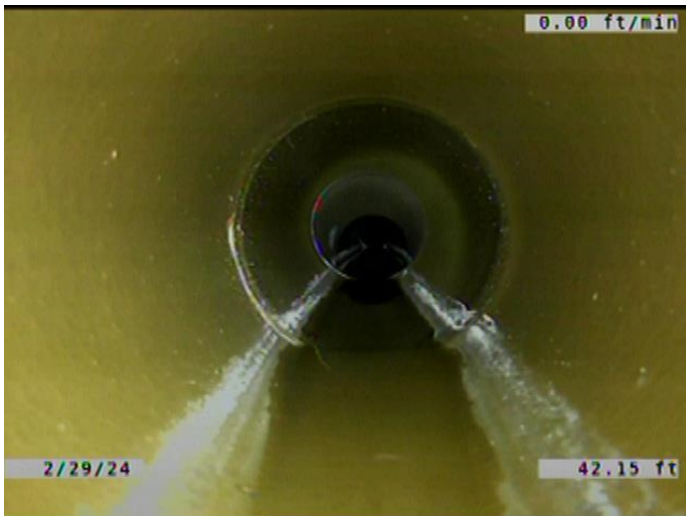
Code: **MWLS**
Description: **Miscellaneous Water Level Sag**

Distance (ft): **42.1**
Structural Grade: **2**
O&M Grade: **0**
Clock Start/From:
Clock To:
1st Value:
2nd Value:
Value Percent: **5.000**
Continuous Index: **S03**
Within 8" of Joint: **NO**
Remarks:

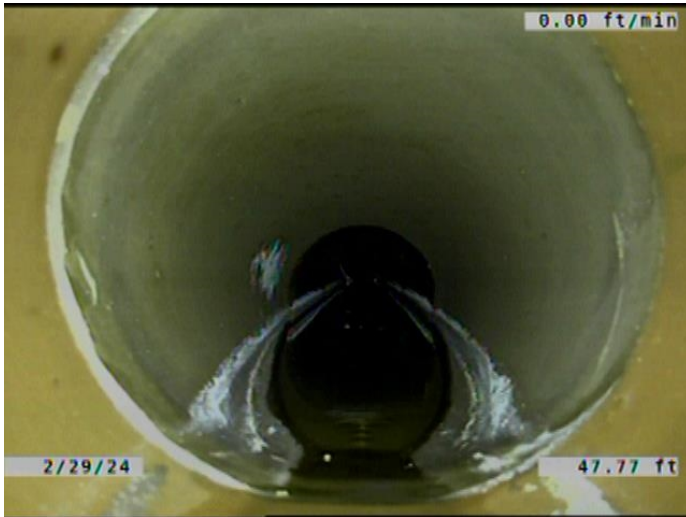
Code: **MWLS**
Description: **Miscellaneous Water Level Sag**

Distance (ft): **47.8**
Structural Grade: **2**
O&M Grade: **0**
Clock Start/From:
Clock To:
1st Value:
2nd Value:
Value Percent: **5.000**
Continuous Index: **F03**
Within 8" of Joint: **NO**
Remarks:

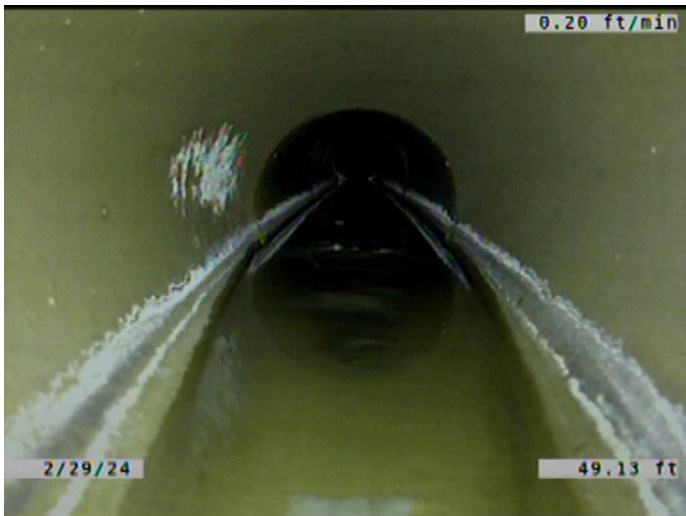
Code: **MWLS**
Description: **Miscellaneous Water Level Sag**

Distance (ft): **49.1**
Structural Grade: **2**
O&M Grade: **0**
Clock Start/From:
Clock To:
1st Value:
2nd Value:
Value Percent: **15.000**
Continuous Index: **S04**
Within 8" of Joint: **NO**
Remarks:

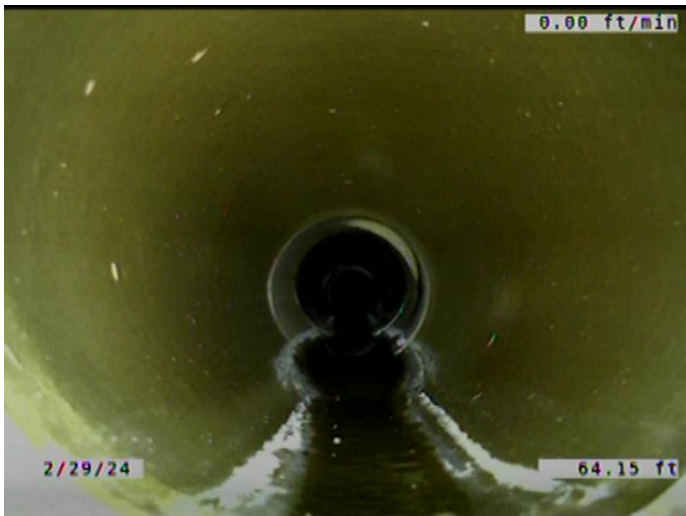
64.1	MWLS(F04)	Miscellaneous Water Level Sag	936	S 2
65.3	JOMD	Joint Offset Medium Defective	1024	S 3
65.3	JAM	Joint Angular Medium	1069	S 3
66.4	MWLS	Miscellaneous Water Level Sag	1093	S 2

Code: **MWLS**
Description: **Miscellaneous Water Level Sag**

Distance (ft): **64.1**
Structural Grade: **2**
O&M Grade: **0**
Clock Start/From:
Clock To:
1st Value:
2nd Value:
Value Percent: **15.000**
Continuous Index: **F04**
Within 8" of Joint: **NO**
Remarks:

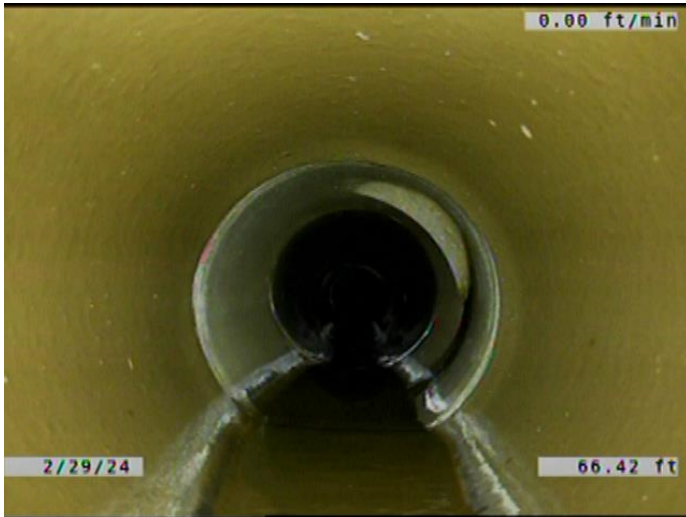
Code: **MWLS**
Description: **Miscellaneous Water Level Sag**

Distance (ft): **66.4**
Structural Grade: **2**
O&M Grade: **0**
Clock Start/From:
Clock To:
1st Value:
2nd Value:
Value Percent: **5.000**
Continuous Index:
Within 8" of Joint: **NO**
Remarks:

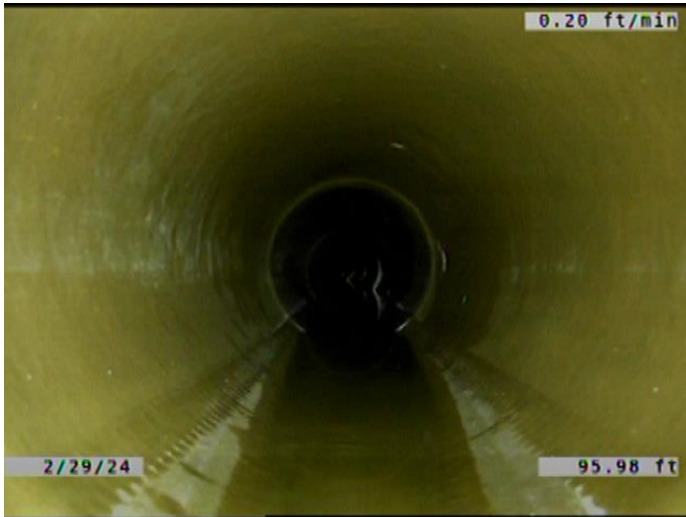
87.9	FM	Fracture Multiple	1361	S 4
87.9	ISB	Infiltration Stain Barrel	1372	M 1
92.0	TFC	Tap Factory Capped	1474	NA
96.0	MWLS(S06)	Miscellaneous Water Level Sag	1509	S 2

Code: **MWLS**
Description: **Miscellaneous Water Level Sag**

Distance (ft): **96.0**
Structural Grade: **2**
O&M Grade: **0**
Clock Start/From:
Clock To:
1st Value:
2nd Value:
Value Percent: **10.000**
Continuous Index: **S06**
Within 8" of Joint: **NO**
Remarks:

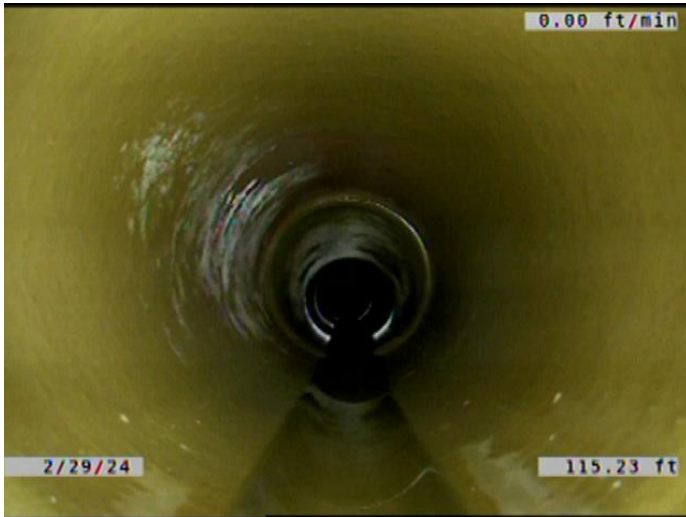
104.7	DAE	Deposits Attached Encrustation	1567	M 2
104.7	DAE	Deposits Attached Encrustation	1608	M 2
104.7	SZ	Surface Damage Other	1621	NA
115.2	MWLS(F06)	Miscellaneous Water Level Sag	1680	S 2

Code: **MWLS**
Description: **Miscellaneous Water Level Sag**

Distance (ft): **115.2**
Structural Grade: **2**
O&M Grade: **0**
Clock Start/From:
Clock To:
1st Value:
2nd Value:
Value Percent: **10.000**
Continuous Index: **F06**
Within 8" of Joint: **NO**
Remarks:

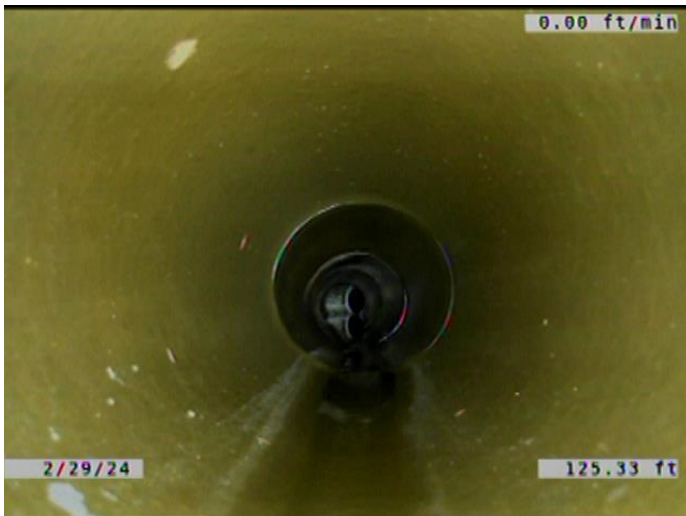
Code: **MGO**
Description: **Miscellaneous General Observation**

Distance (ft): **125.3**
Structural Grade: **0**
O&M Grade: **0**
Clock Start/From:
Clock To:
1st Value:
2nd Value:
Value Percent:
Continuous Index:
Within 8" of Joint: **NO**
Remarks: **FOOTAGE COUNTER GOT OFF.
GOING BACK TO KNOWN GOOD DIS**

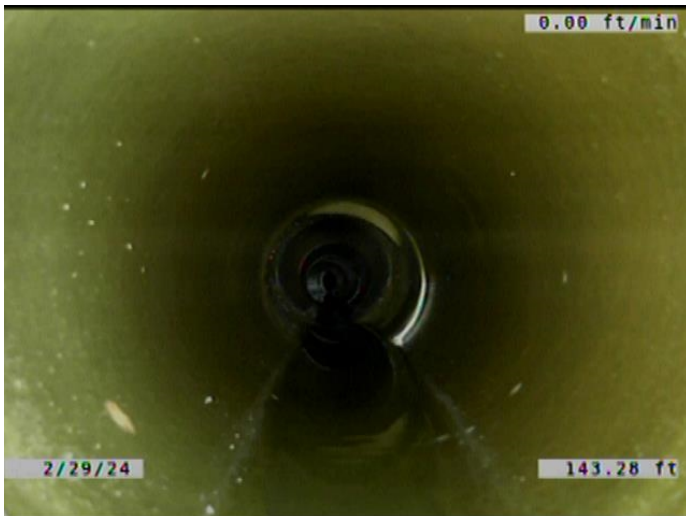
Code: **MWLS**
Description: **Miscellaneous Water Level Sag**

Distance (ft): **143.3**
Structural Grade: **2**
O&M Grade: **0**
Clock Start/From:
Clock To:
1st Value:
2nd Value:
Value Percent: **5.000**
Continuous Index: **S08**
Within 8" of Joint: **NO**
Remarks:

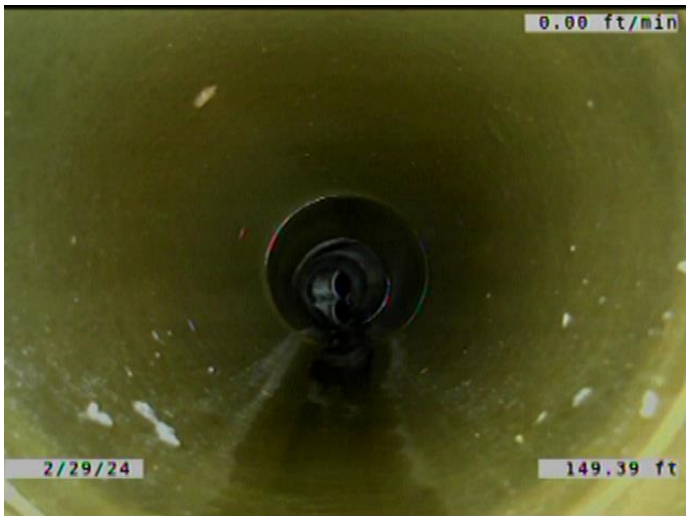
Code: **MWLS**
Description: **Miscellaneous Water Level Sag**

Distance (ft): **149.4**
Structural Grade: **2**
O&M Grade: **0**
Clock Start/From:
Clock To:
1st Value:
2nd Value:
Value Percent: **5.000**
Continuous Index: **F08**
Within 8" of Joint: **NO**
Remarks:

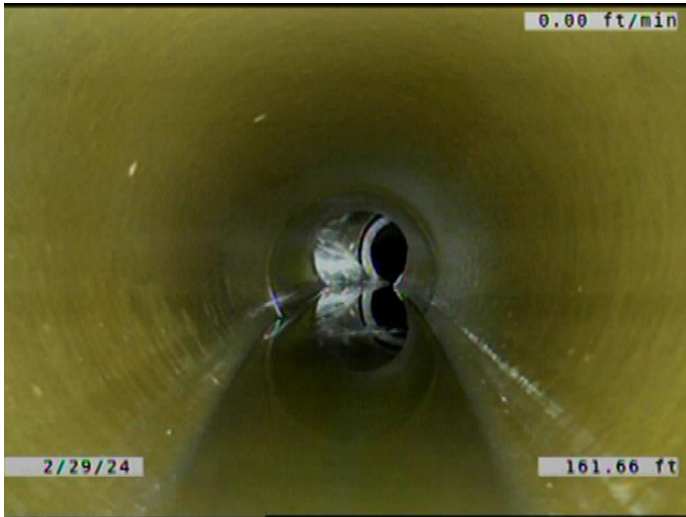
Code: **MWLS**
Description: **Miscellaneous Water Level Sag**

Distance (ft): **161.7**
Structural Grade: **2**
O&M Grade: **0**
Clock Start/From:
Clock To:
1st Value:
2nd Value:
Value Percent: **15.000**
Continuous Index: **S09**
Within 8" of Joint: **NO**
Remarks:

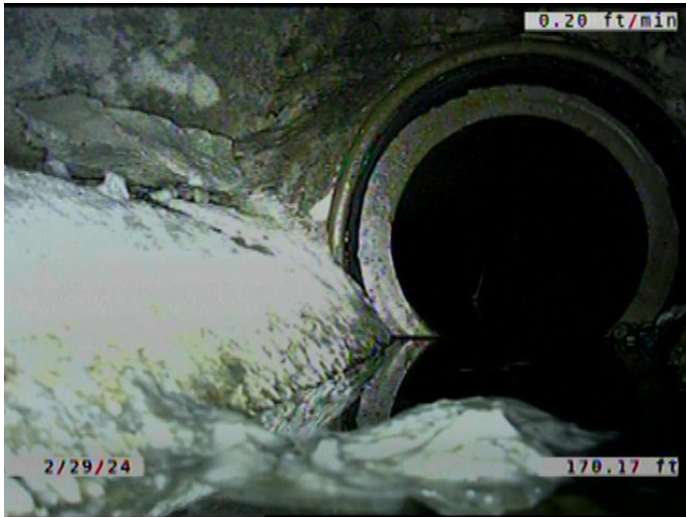
169.8	DAE(F07)	Deposits Attached Encrustation	2766	M 2
170.2	MWLS(F09)	Miscellaneous Water Level Sag	2778	S 2
172.4	AMH	Manhole	2873	NA

Code: **MWLS**
 Description: **Miscellaneous Water Level Sag**

Distance (ft): **170.2**
 Structural Grade: **2**
 O&M Grade: **0**
 Clock Start/From:
 Clock To:
 1st Value:
 2nd Value:
 Value Percent: **15.000**
 Continuous Index: **F09**
 Within 8" of Joint: **NO**
 Remarks:

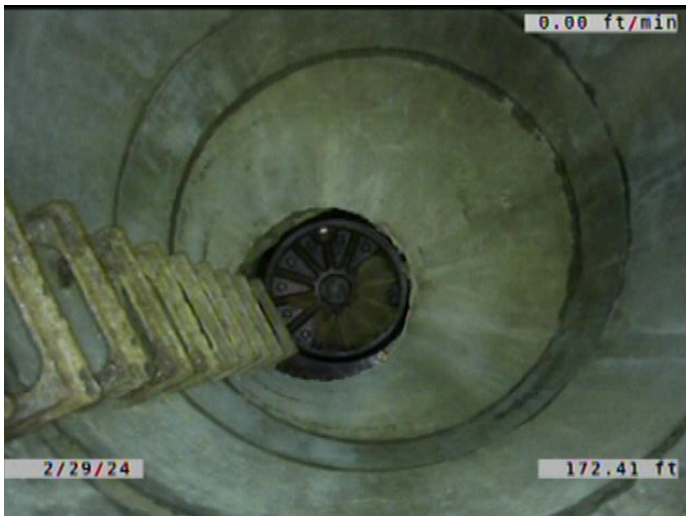
Code: **AMH**
 Description: **Manhole**

Distance (ft): **172.4**
 Structural Grade: **0**
 O&M Grade: **0**
 Clock Start/From:
 Clock To:
 1st Value:
 2nd Value:
 Value Percent:
 Continuous Index:
 Within 8" of Joint: **NO**
 Remarks: **M-606-083**
