Profile/Photo Observation Report

Date:	02/04/2022	Weather:		Coding:	PACP 7.0
Pipe Length (ft):	254.1	Owner:	City of Hobart	Pre Clean:	Heavy Cleaning
P.O.#:	YES502259	Surveyor:	S. Bucklin	PSR:	P-606-086-085
Customer:	City of Hobart	Clean Date:	01/31/2022	Shape:	C

Street:	North Lake Shore Drive	Flow Control:	Not Controlled
City:	Hobart, IN	Year Renewed:	
Location:	Local rural streets with light traffic, t	Tape/Media #:	
Purpose:	Routine Assessment	Dia/Height:	12"
Use:	Sanitary Sewage Pipe	Material:	VCP
Drain Area:		Lining:	None
Category:	NA		
Comment:			
Location Details:		Direction of Survey:	Downstream
US MH:	M-606-085	DS MH:	M-606-086
		Total Length Surveyed (ft):	254.1

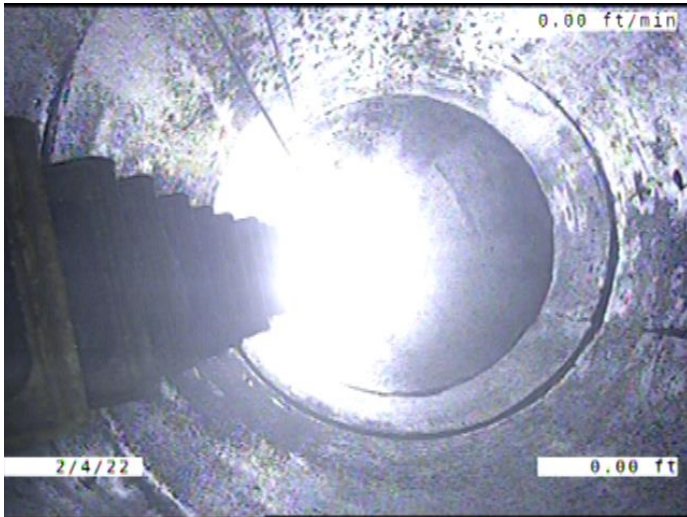
Code: **AMH**
Description: **Manhole**

Distance (ft): **.0**
Structural Grade: **0**
O&M Grade: **0**
Clock Start/From:
Clock To:
1st Value:
2nd Value:
Value Percent:
Continuous Index:
Within 8" of Joint: **NO**
Remarks: **M-606-085**

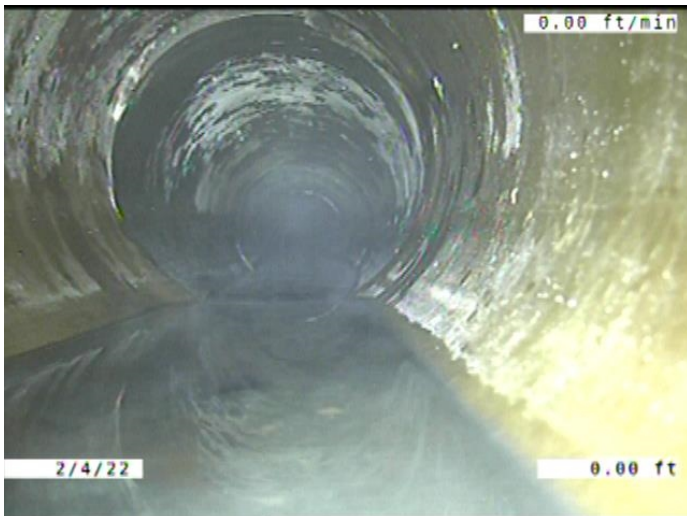
Code: **MWL**
Description: **Miscellaneous Water Level**

Distance (ft): **.0**
Structural Grade: **0**
O&M Grade: **0**
Clock Start/From:
Clock To:
1st Value:
2nd Value:
Value Percent: **5.000**
Continuous Index:
Within 8" of Joint: **NO**
Remarks:

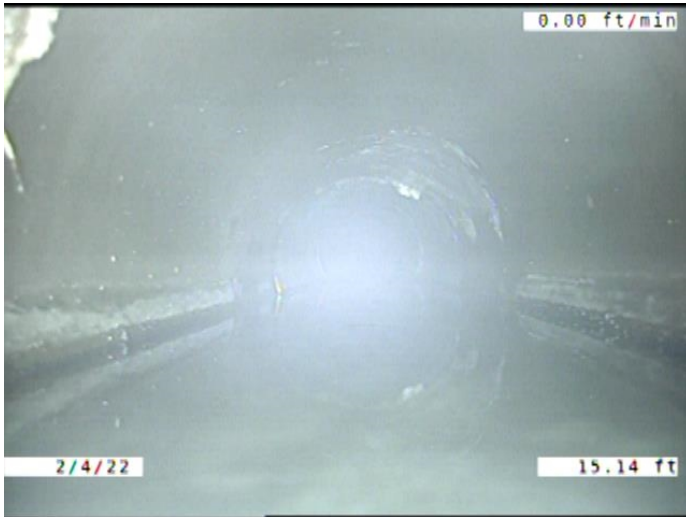
Code: **MWL**
 Description: **Miscellaneous Water Level**

Distance (ft): **15.1**
 Structural Grade: **0**
 O&M Grade: **0**
 Clock Start/From:
 Clock To:
 1st Value:
 2nd Value:
 Value Percent: **15.000**
 Continuous Index:
 Within 8" of Joint: **NO**
 Remarks:

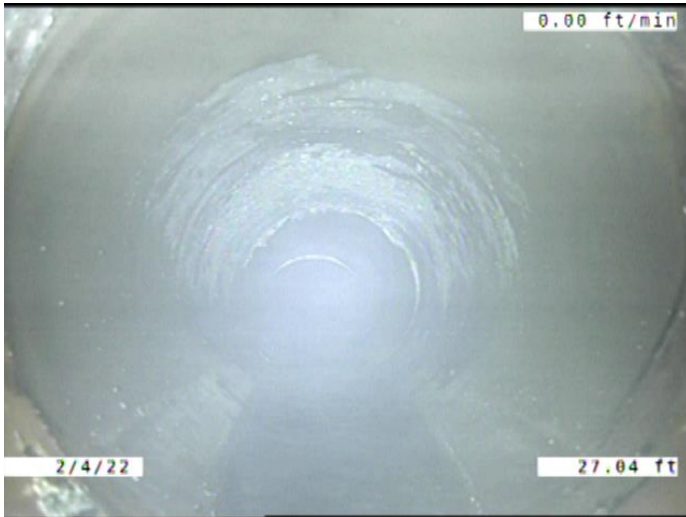
Code: **MWL**
 Description: **Miscellaneous Water Level**

Distance (ft): **27.0**
 Structural Grade: **0**
 O&M Grade: **0**
 Clock Start/From:
 Clock To:
 1st Value:
 2nd Value:
 Value Percent: **5.000**
 Continuous Index:
 Within 8" of Joint: **NO**
 Remarks:

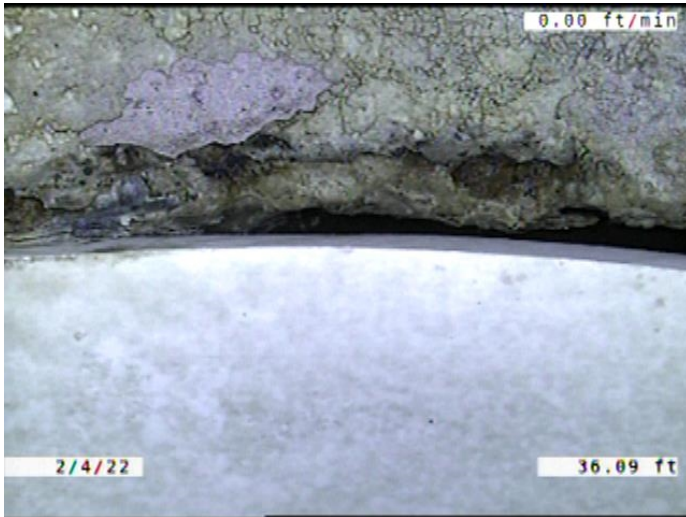
Code: **MMC**
Description: **Miscellaneous Material Change**

Distance (ft): **36.1**
Structural Grade: **0**
O&M Grade: **0**
Clock Start/From:
Clock To:
1st Value:
2nd Value:
Value Percent:
Continuous Index:
Within 8" of Joint: **NO**
Remarks: **VCP TO PVC**

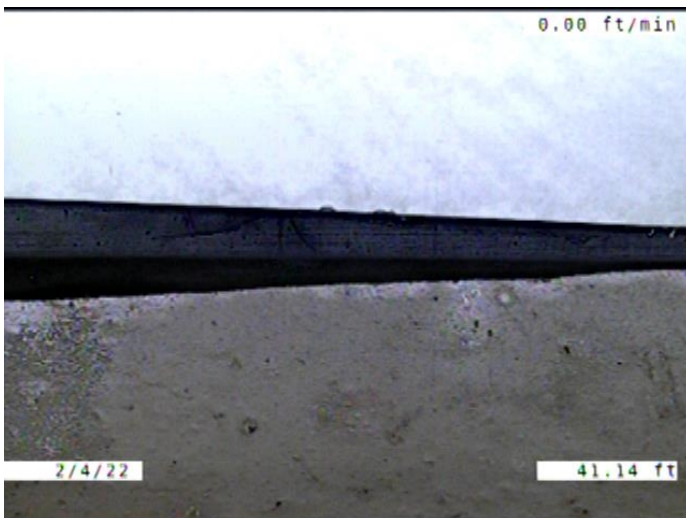
Code: **MMC**
Description: **Miscellaneous Material Change**

Distance (ft): **41.1**
Structural Grade: **0**
O&M Grade: **0**
Clock Start/From:
Clock To:
1st Value:
2nd Value:
Value Percent:
Continuous Index:
Within 8" of Joint: **NO**
Remarks: **PVC TO VCP**

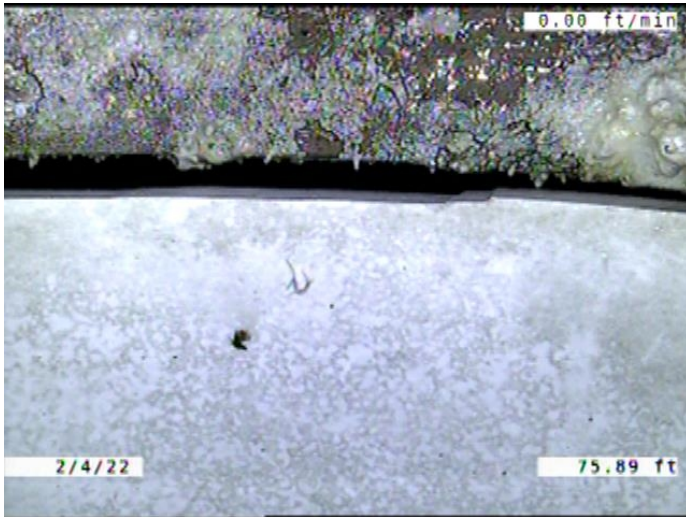
Code: **MMC**
 Description: **Miscellaneous Material Change**

Distance (ft): **75.9**
 Structural Grade: **0**
 O&M Grade: **0**
 Clock Start/From:
 Clock To:
 1st Value:
 2nd Value:
 Value Percent:
 Continuous Index:
 Within 8" of Joint: **NO**
 Remarks: **VCP TO PVC**

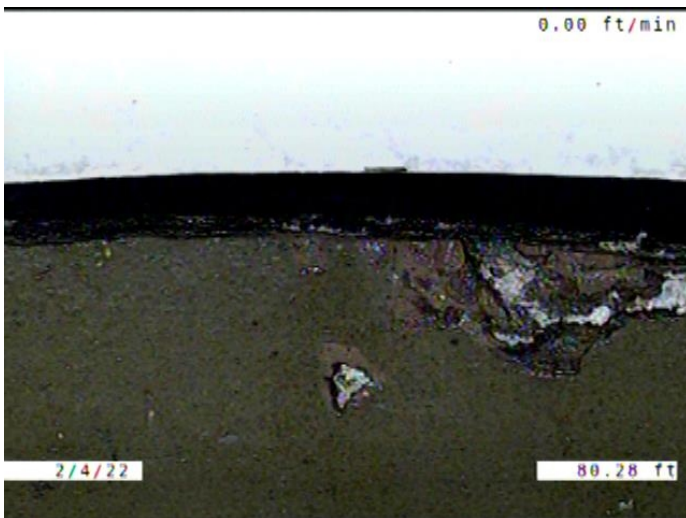
Code: **MMC**
 Description: **Miscellaneous Material Change**

Distance (ft): **80.3**
 Structural Grade: **0**
 O&M Grade: **0**
 Clock Start/From:
 Clock To:
 1st Value:
 2nd Value:
 Value Percent:
 Continuous Index:
 Within 8" of Joint: **NO**
 Remarks: **PVC TO VCP**

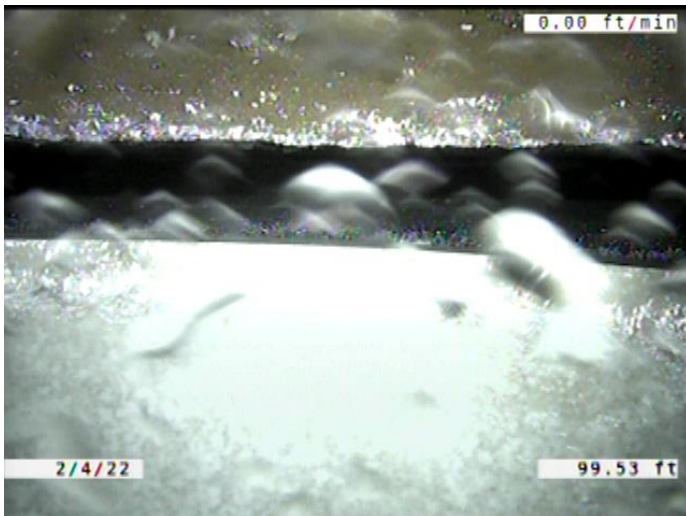
Code: **MMC**
 Description: **Miscellaneous Material Change**

Distance (ft): **99.5**
 Structural Grade: **0**
 O&M Grade: **0**
 Clock Start/From:
 Clock To:
 1st Value:
 2nd Value:
 Value Percent:
 Continuous Index:
 Within 8" of Joint: **NO**
 Remarks: **VCP TO PVC**

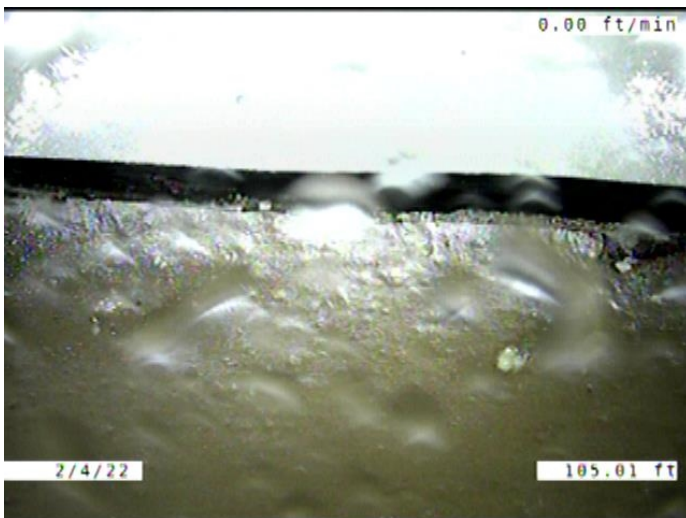
Code: **MMC**
 Description: **Miscellaneous Material Change**

Distance (ft): **105.0**
 Structural Grade: **0**
 O&M Grade: **0**
 Clock Start/From:
 Clock To:
 1st Value:
 2nd Value:
 Value Percent:
 Continuous Index:
 Within 8" of Joint: **NO**
 Remarks: **PVC TO VCP**

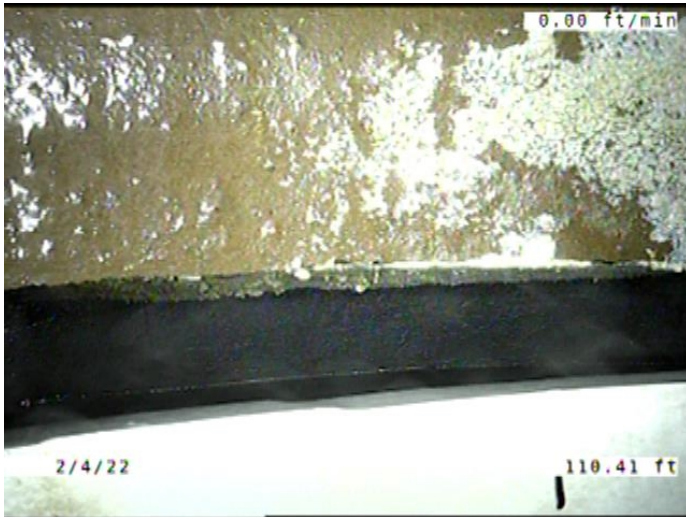
Code: **MMC**
 Description: **Miscellaneous Material Change**

Distance (ft): **110.4**
 Structural Grade: **0**
 O&M Grade: **0**
 Clock Start/From:
 Clock To:
 1st Value:
 2nd Value:
 Value Percent:
 Continuous Index:
 Within 8" of Joint: **NO**
 Remarks: **VCP TO PVC**

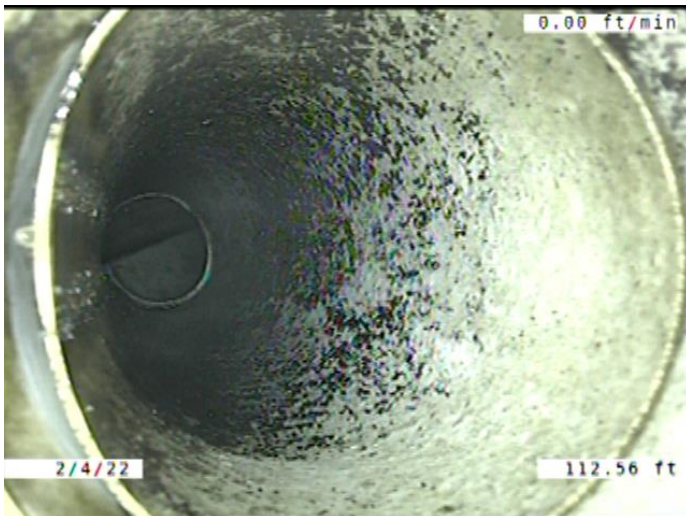
Code: **TF**
 Description: **Tap Factory**

Distance (ft): **112.6**
 Structural Grade: **0**
 O&M Grade: **0**
 Clock Start/From: **11**
 Clock To:
 1st Value: **6.000**
 2nd Value:
 Value Percent:
 Continuous Index:
 Within 8" of Joint: **YES**
 Remarks:

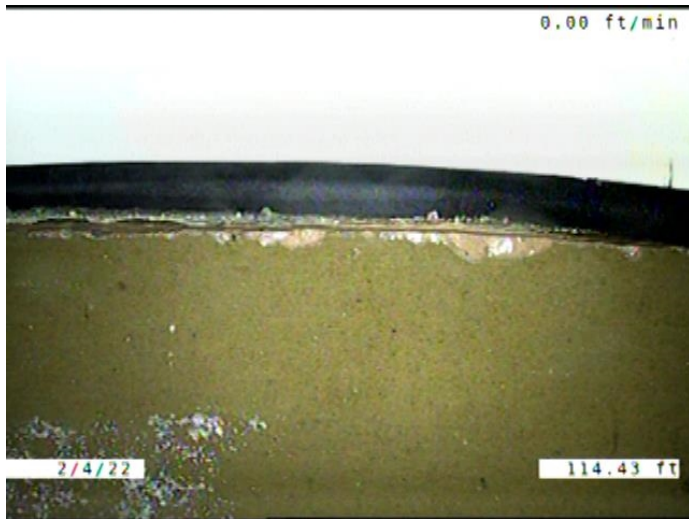
Code: **MMC**
Description: **Miscellaneous Material Change**

Distance (ft): **114.4**
Structural Grade: **0**
O&M Grade: **0**
Clock Start/From:
Clock To:
1st Value:
2nd Value:
Value Percent:
Continuous Index:
Within 8" of Joint: **NO**
Remarks: **PVC TO VCP**

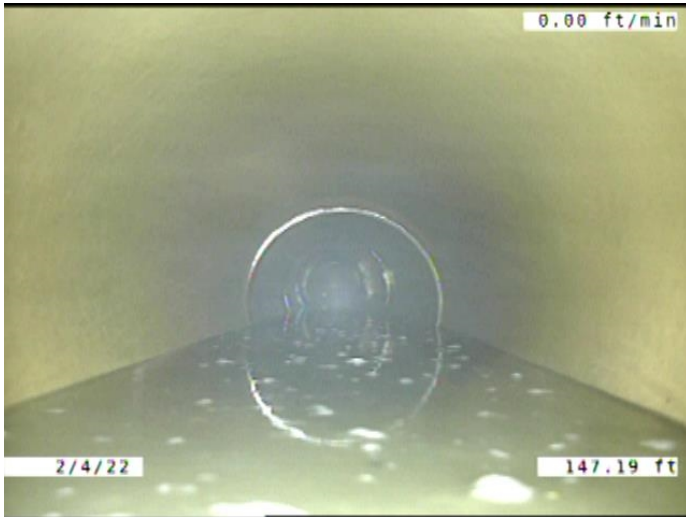
Code: **MWL**
Description: **Miscellaneous Water Level**

Distance (ft): **147.2**
Structural Grade: **0**
O&M Grade: **0**
Clock Start/From:
Clock To:
1st Value:
2nd Value:
Value Percent: **15.000**
Continuous Index:
Within 8" of Joint: **NO**
Remarks:
