## Profile/Photo Observation Report

Date:	<b>02/05/2022</b>	Weather:		Coding:	<b>PACP 7.0</b>
Pipe Length (ft):	<b>84.6</b>	Owner:	<b>City of Hobart</b>	Pre Clean:	<b>Heavy Cleaning</b>
P.O.#:	<b>YES502259</b>	Surveyor:	<b>S. Bucklin</b>	PSR:	<b>P-606-084-085</b>
Customer:	<b>City of Hobart</b>	Clean Date:	<b>01/31/2022</b>	Shape:	<b>C</b>

Street:	<b>North Lake Shore Drive</b>	Flow Control:	<b>Not Controlled</b>
City:	<b>Hobart, IN</b>	Year Renewed:	
Location:	<b>Local rural streets with light traffic, t</b>	Tape/Media #:	
Purpose:	<b>Routine Assessment</b>	Dia/Height:	<b>10"</b>
Use:	<b>Sanitary Sewage Pipe</b>	Material:	<b>VCP</b>
Drain Area:		Lining:	<b>None</b>
Category:	<b>NA</b>		
Comment:			
Location Details:		Direction of Survey:	<b>Upstream</b>
US MH:	<b>M-606-085</b>	DS MH:	<b>M-606-084</b>
		Total Length Surveyed (ft):	<b>84.6</b>

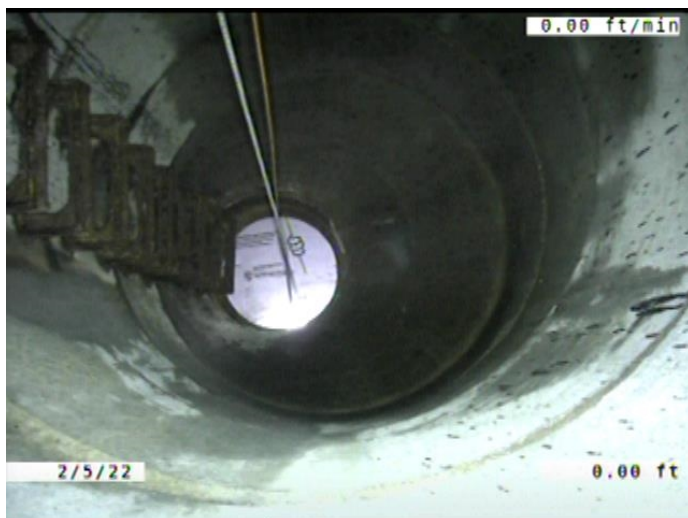
Code: **AMH**  
 Description: **Manhole**

Distance (ft): **.0**  
 Structural Grade: **0**  
 O&M Grade: **0**  
 Clock Start/From:  
 Clock To:  
 1st Value:  
 2nd Value:  
 Value Percent:  
 Continuous Index:  
 Within 8" of Joint: **NO**  
 Remarks: **M-606-084**

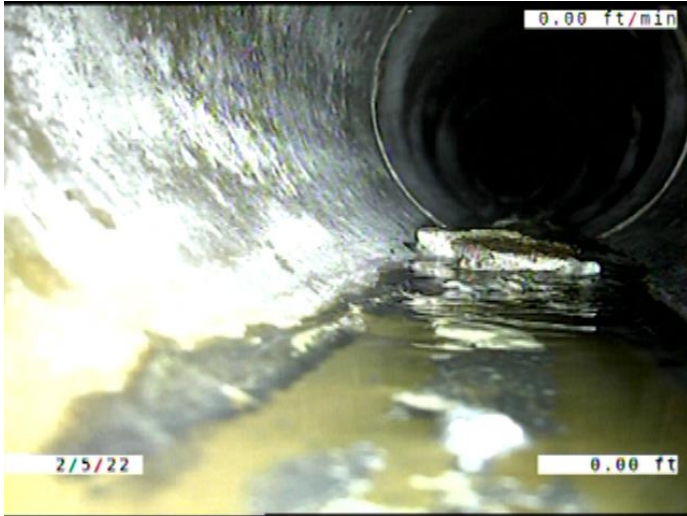
Code: **MWL**  
Description: **Miscellaneous Water Level**

Distance (ft): **.0**  
Structural Grade: **0**  
O&M Grade: **0**  
Clock Start/From:  
Clock To:  
1st Value:  
2nd Value:  
Value Percent: **5.000**  
Continuous Index:  
Within 8" of Joint: **NO**  
Remarks:

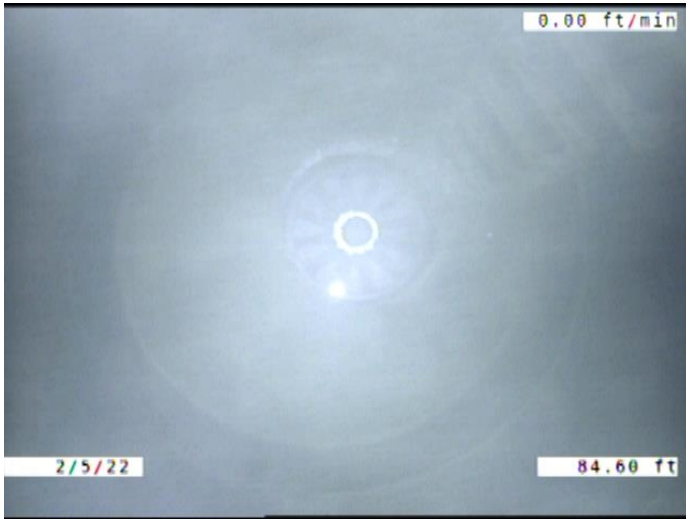
Code:	AMH
Description:	Manhole
Distance (ft):	84.6
Structural Grade:	0
O&M Grade:	0
Clock Start/From:	
Clock To:	
1st Value:	
2nd Value:	
Value Percent:	
Continuous Index:	
Within 8" of Joint:	NO
Remarks:	M-606-085
