Profile/Photo Observation Report

Date:	04/07/2018	Weather:		Coding:	PACP 6.0
Pipe Length (ft):	167.4	Owner:	NA	Pre Clean:	No Pre-Cleaning
P.O.#:		Surveyor:	Jen Costello	PSR:	P-606-095-093
Customer:		Clean Date:	01/01/1900	Shape:	C

Street:	N LAKE SHORE DR	Flow Control:	Not Controlled
City:	Hobart, IN	Year Renewed:	
Location:	Yard	Tape/Media #:	
Purpose:	Routine Assessment	Dia/Height:	10"
Use:	Sanitary	Material:	VCP
Drain Area:	NA	Lining:	
Category:	NA		
Comment:	P_C obstruction, flow direction is marked wrong.		
Location Details:		Direction of Survey:	Upstream
US MH:	M-606-093	DS MH:	M-606-095
		Total Length Surveyed (ft):	22.6

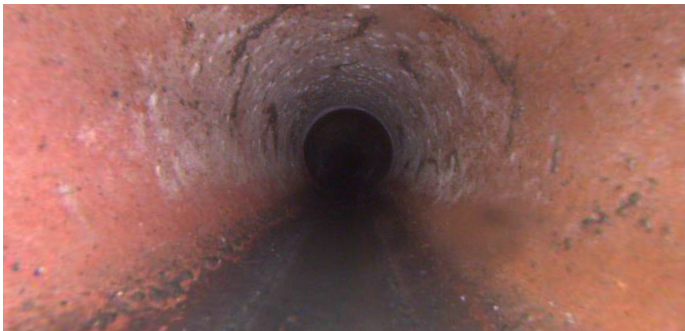
Code: **AMH**
Description: **Manhole**

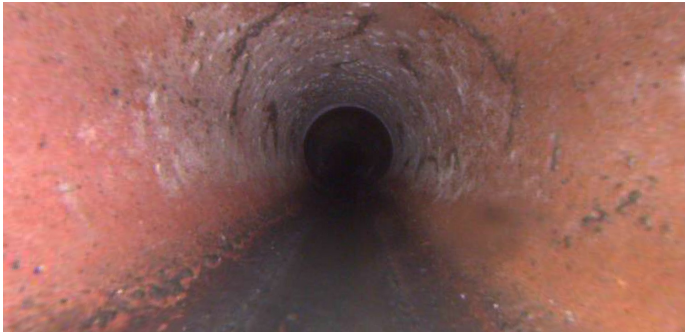
Code:	MWL
Description:	Water Level

Distance (ft):	.0
Structural Grade:	0
O&M Grade:	0
Clock Start/From:	
Clock To:	
1st Value:	
2nd Value:	
Value Percent:	5.000
Continuous Index:	
Within 8" of Joint:	NO
Remarks:
