Profile/Photo Observation Report

Date:	04/07/2018	Weather:		Coding:	PACP 6.0
Pipe Length (ft):	167.4	Owner:	NA	Pre Clean:	No Pre-Cleaning
P.O.#:		Surveyor:	Jen Costello	PSR:	P-606-095-093
Customer:		Clean Date:	01/01/1900	Shape:	C

Street:	FOXCROFT STREET	Flow Control:	Not Controlled
City:	Hobart, IN	Year Renewed:	
Location:	Yard	Tape/Media #:	
Purpose:	Routine Assessment	Dia/Height:	10"
Use:	Sanitary	Material:	VCP
Drain Area:	NA	Lining:	
Category:	NA		
Comment:	P_C obstruction, flow direction is marked wrong.		
Location Details:		Direction of Survey:	Upstream
US MH:	M-606-093	DS MH:	M-606-095
		Total Length Surveyed (ft):	22.6

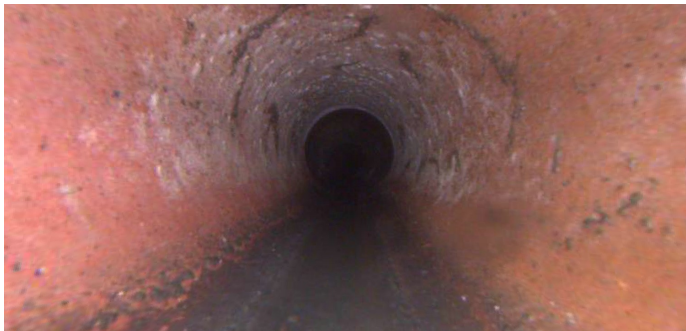
Code: **AMH**
Description: **Manhole**

Distance (ft): **.0**
Structural Grade: **0**
O&M Grade: **0**
Clock Start/From:
Clock To:
1st Value:
2nd Value:
Value Percent:
Continuous Index:
Within 8" of Joint: **NO**
Remarks: **M-606-095**

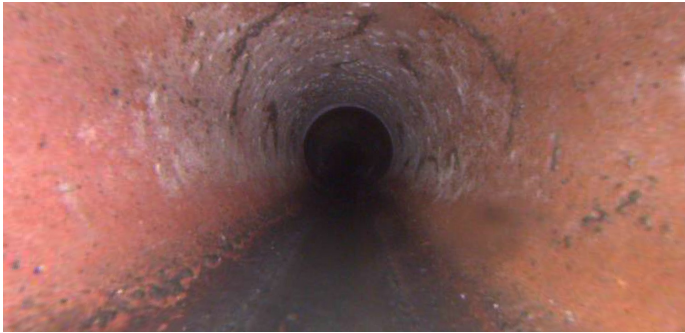
Code:	MWL
Description:	Water Level

Distance (ft):	.0
Structural Grade:	0
O&M Grade:	0
Clock Start/From:	
Clock To:	
1st Value:	
2nd Value:	
Value Percent:	5.000
Continuous Index:	
Within 8" of Joint:	NO
Remarks:
