Profile/Photo Observation Report

Date:	01/30/2022	Weather:		Coding:	PACP 7.0
Pipe Length (ft):	235.3	Owner:	City of Hobart	Pre Clean:	Heavy Cleaning
P.O.#:	YES502259	Surveyor:	S. Bucklin	PSR:	P-606-094-090
Customer:	City of Hobart	Clean Date:	01/30/2022	Shape:	C

Street:	North Lake Shore Drive	Flow Control:	Not Controlled
City:	Hobart, IN	Year Renewed:	
Location:	Local rural streets with light traffic, t	Tape/Media #:	
Purpose:	Routine Assessment	Dia/Height:	10"
Use:	Sanitary Sewage Pipe	Material:	VCP
Drain Area:		Lining:	None
Category:	NA		
Comment:			
Location Details:		Direction of Survey:	Upstream
US MH:	M-606-094	DS MH:	M-606-090
		Total Length Surveyed (ft):	235.3

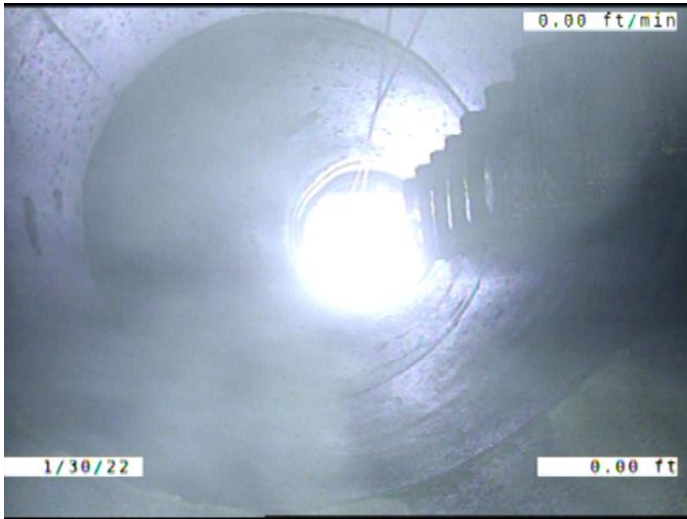
Code: **AMH**
 Description: **Manhole**

Distance (ft): **.0**
 Structural Grade: **0**
 O&M Grade: **0**
 Clock Start/From:
 Clock To:
 1st Value:
 2nd Value:
 Value Percent:
 Continuous Index:
 Within 8" of Joint: **NO**
 Remarks: **M-606-090**

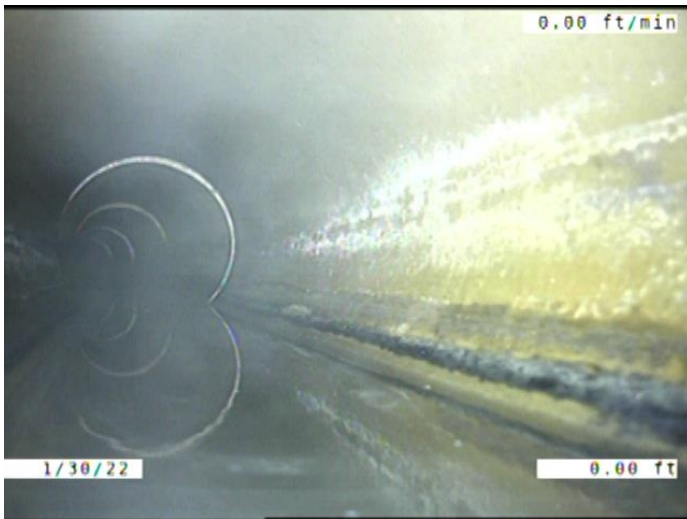
Code: **MWL**
 Description: **Miscellaneous Water Level**

Distance (ft): **.0**
 Structural Grade: **0**
 O&M Grade: **0**
 Clock Start/From:
 Clock To:
 1st Value:
 2nd Value:
 Value Percent: **5.000**
 Continuous Index:
 Within 8" of Joint: **NO**
 Remarks:

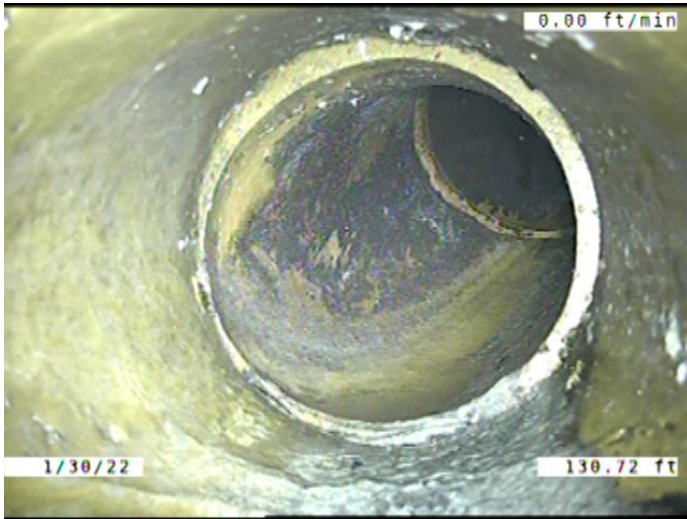
Code: **TF**
 Description: **Tap Factory**

Distance (ft): **130.7**
 Structural Grade: **0**
 O&M Grade: **0**
 Clock Start/From: **12**
 Clock To:
 1st Value: **4.000**
 2nd Value:
 Value Percent:
 Continuous Index:
 Within 8" of Joint: **YES**
 Remarks:

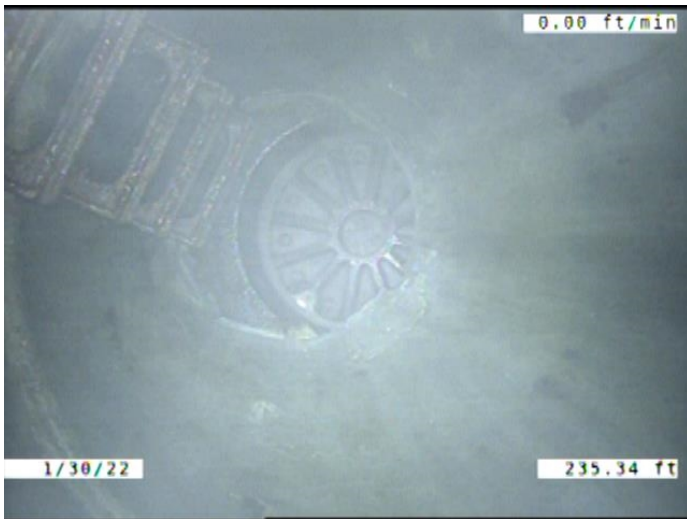
Code: **AMH**
 Description: **Manhole**

Distance (ft): **235.3**
 Structural Grade: **0**
 O&M Grade: **0**
 Clock Start/From:
 Clock To:
 1st Value:
 2nd Value:
 Value Percent:
 Continuous Index:
 Within 8" of Joint: **NO**
 Remarks: **M-606-094**
