Profile/Photo Observation Report

Street:	South Wisconsin Street	Flow Control:	Not Controlled
City:	Hobart, IN	Year Renewed:	
Location:	Sidewalk	Tape/Media #:	DEP207
Purpose:	Routine Assessment	Dia/Height:	15"
Use:	Sanitary	Material:	PVC
Drain Area:		Lining:	
Category:	NA		
Comment:	YES501824 Submittal 2		
Location Details:		Direction of Survey:	Downstream
US MH:	M-607-058	DS MH:	M-607-057
		Total Length Surveyed (ft):	399.3

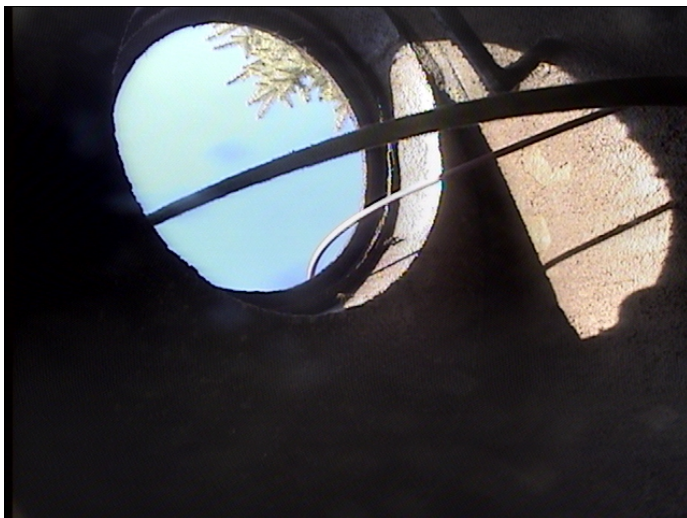
Code: **AMH**
 Description: **Manhole**

Distance (ft): **.0**
 Structural Grade: **0**
 O&M Grade: **0**
 Clock Start/From:
 Clock To:
 1st Value:
 2nd Value:
 Value Percent:
 Continuous Index:
 Within 8" of Joint: **NO**
 Remarks: **M-607-058**

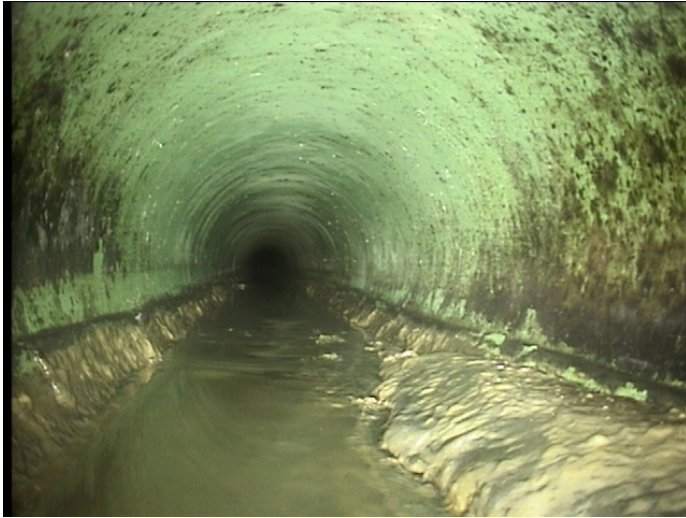
Code: **MWL**
Description: **Water Level**

Distance (ft): **.0**
Structural Grade: **0**
O&M Grade: **0**
Clock Start/From:
Clock To:
1st Value:
2nd Value:
Value Percent: **5.000**
Continuous Index:
Within 8" of Joint: **NO**
Remarks:

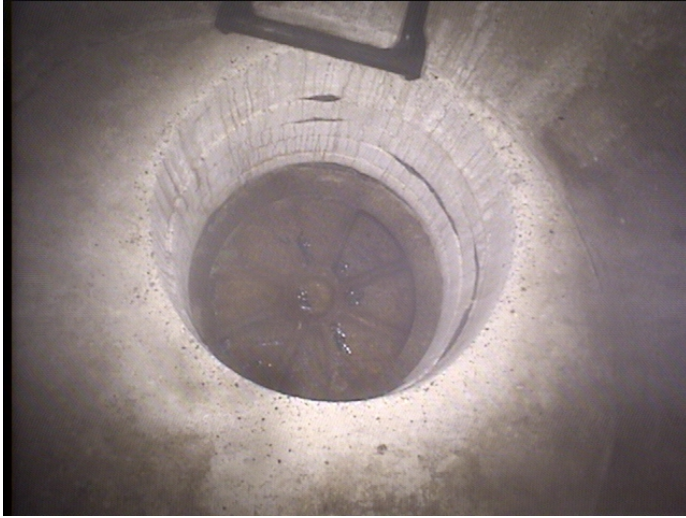
Code: **AMH**
Description: **Manhole**

Distance (ft): **399.3**
Structural Grade: **0**
O&M Grade: **0**
Clock Start/From:
Clock To:
1st Value:
2nd Value:
Value Percent:
Continuous Index:
Within 8" of Joint: **NO**
Remarks: **M-607-057**
