## Profile/Photo Observation Report

Street:	<b>WASHINGTON ST</b>	Flow Control:	<b>Not Controlled</b>
City:	<b>Hobart, IN</b>	Year Renewed:	
Location:	<b>Light Highway</b>	Tape/Media #:	
Purpose:	<b>Routine Assessment</b>	Dia/Height:	<b>10"</b>
Use:	<b>Sanitary</b>	Material:	<b>PVC</b>
Drain Area:	<b>NA</b>	Lining:	
Category:	<b>NA</b>		
Comment:	<b>Flow direction wrong</b>		
Location Details:		Direction of Survey:	<b>Upstream</b>
US MH:	<b>M-607-077</b>	DS MH:	<b>M-608-041</b>
		Total Length Surveyed (ft):	<b>349.9</b>

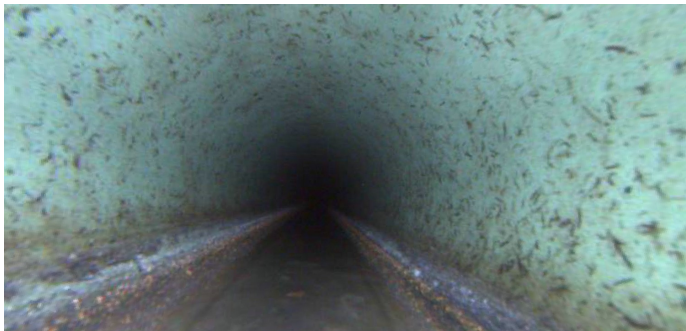
Position	Code	Observation	Video (sec)	Grade
.0	AMH	Manhole	10	NA
.0	MWL	Water Level	21	NA
130.0	TF	Tap Factory	295	NA
325.2	MWL	Water Level	699	NA
347.3	DAE	Deposits Attached Encrustation	754	M 5
349.9	AMH	Manhole	771	NA
