Profile/Photo Observation Report

| Pipe Length (ft): | 343.5 | Owner: | City of Hobart | Pre Clean: | Heavy Cleaning |

| Street: | North Michigan Avenue | Flow Control: | Not Controlled |
| US MH: | M-704-013 | DS MH: | M-704-012 |

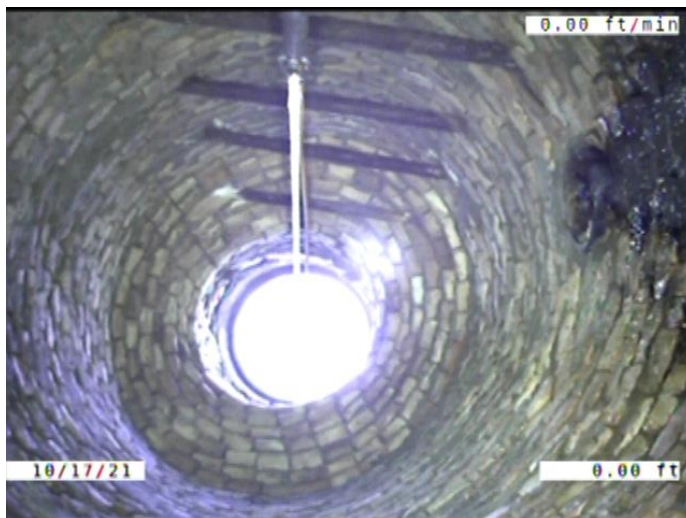
Code: **AMH**
Description: **Manhole**

Distance (ft): **.0**
Structural Grade: **0**
O&M Grade: **0**
Clock Start/From:
Clock To:
1st Value:
2nd Value:
Value Percent:
Continuous Index:
Within 8" of Joint: **NO**
Remarks: **M-704-013**

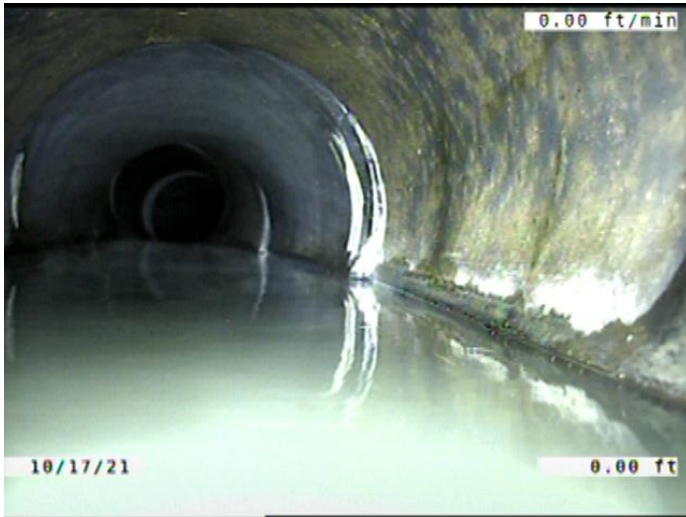
Code: **MWL**
 Description: **Miscellaneous Water Level**

Distance (ft): **.0**
 Structural Grade: **0**
 O&M Grade: **0**
 Clock Start/From:
 Clock To:
 1st Value:
 2nd Value:
 Value Percent: **10.000**
 Continuous Index:
 Within 8" of Joint: **NO**
 Remarks:

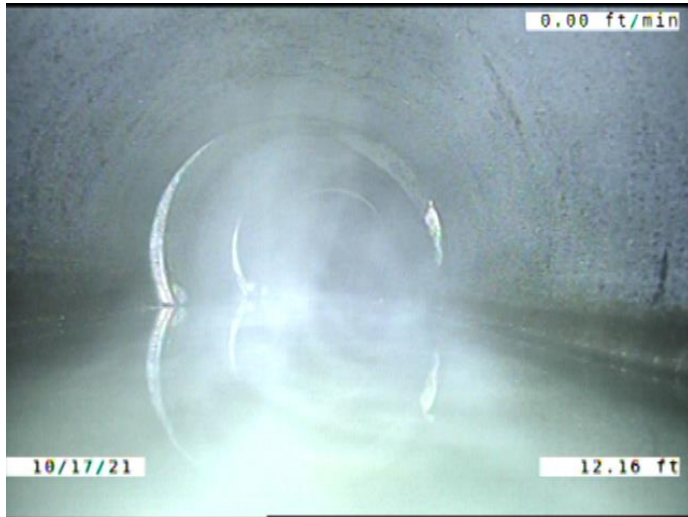
Code: **MWLS**
 Description: **Miscellaneous Water Level Sag**

Distance (ft): **12.2**
 Structural Grade: **2**
 O&M Grade: **0**
 Clock Start/From:
 Clock To:
 1st Value:
 2nd Value:
 Value Percent: **15.000**
 Continuous Index: **S01**
 Within 8" of Joint: **NO**
 Remarks:

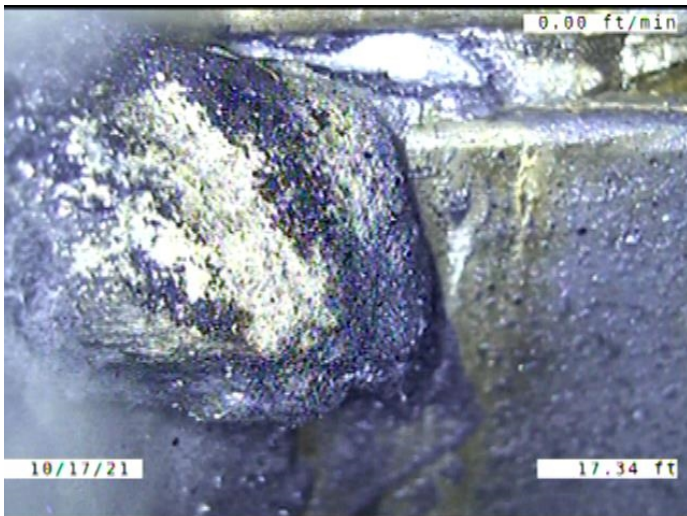
Code: **DAE**
 Description: **Deposits Attached Encrustation**

Distance (ft): **17.3**
 Structural Grade: **0**
 O&M Grade: **2**
 Clock Start/From: **8**
 Clock To: **9**
 1st Value:
 2nd Value:
 Value Percent: **5.000**
 Continuous Index:
 Within 8" of Joint: **YES**
 Remarks:

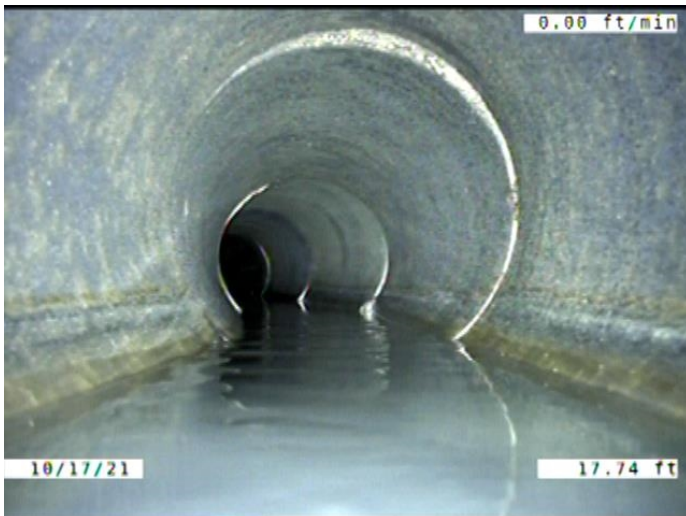
Code: **MWLS**
 Description: **Miscellaneous Water Level Sag**

Distance (ft): **17.7**
 Structural Grade: **2**
 O&M Grade: **0**
 Clock Start/From:
 Clock To:
 1st Value:
 2nd Value:
 Value Percent: **15.000**
 Continuous Index: **F01**
 Within 8" of Joint: **NO**
 Remarks:

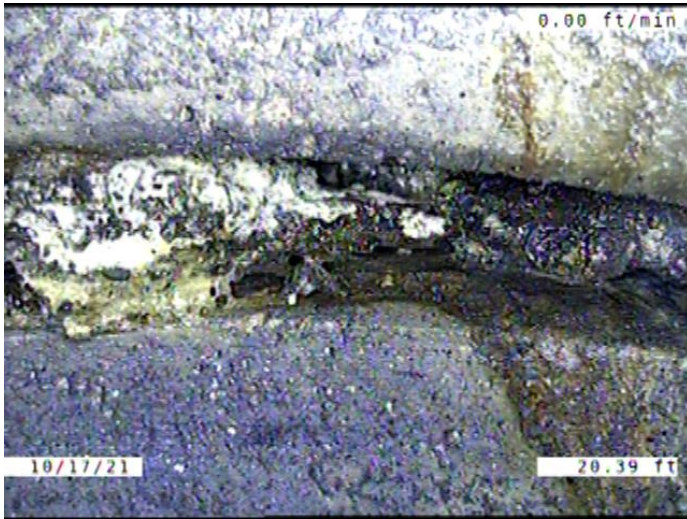
Code: **DAE**
 Description: **Deposits Attached Encrustation**

Distance (ft): **20.4**
 Structural Grade: **0**
 O&M Grade: **2**
 Clock Start/From: **12**
 Clock To: **4**
 1st Value:
 2nd Value:
 Value Percent: **5.000**
 Continuous Index: **S02**
 Within 8" of Joint: **YES**
 Remarks:

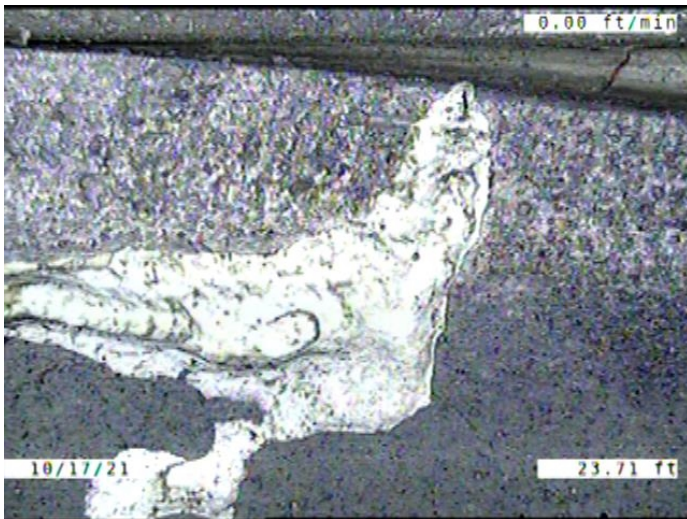
Code: **DAE**
 Description: **Deposits Attached Encrustation**

Distance (ft): **23.7**
 Structural Grade: **0**
 O&M Grade: **2**
 Clock Start/From: **9**
 Clock To: **11**
 1st Value:
 2nd Value:
 Value Percent: **5.000**
 Continuous Index: **S03**
 Within 8" of Joint: **YES**
 Remarks:

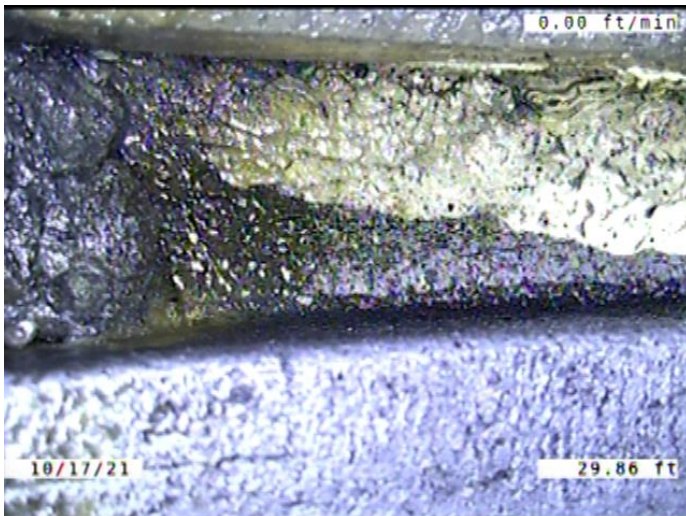
Code: **JAM**
Description: **Joint Angular Medium**

Distance (ft): **29.9**
Structural Grade: **3**
O&M Grade: **0**
Clock Start/From:
Clock To:
1st Value:
2nd Value:
Value Percent:
Continuous Index:
Within 8" of Joint: **NO**
Remarks:

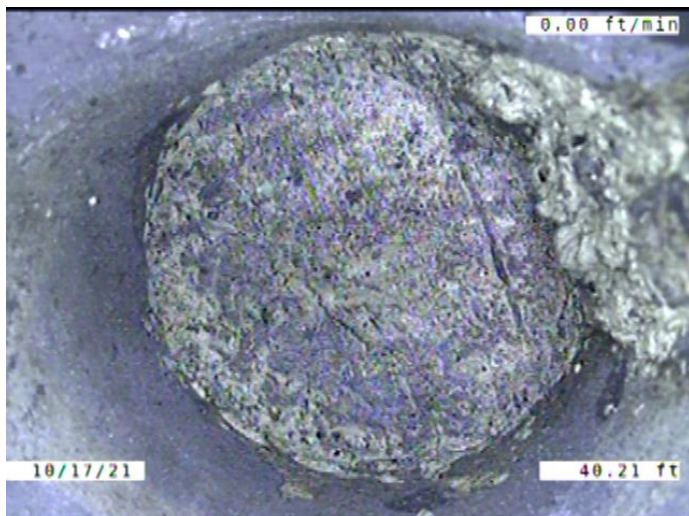
Code: **TFC**
 Description: **Tap Factory Capped**

Distance (ft): **40.2**
 Structural Grade: **0**
 O&M Grade: **0**
 Clock Start/From: **2**
 Clock To:
 1st Value: **4.000**
 2nd Value:
 Value Percent:
 Continuous Index:
 Within 8" of Joint: **YES**
 Remarks:

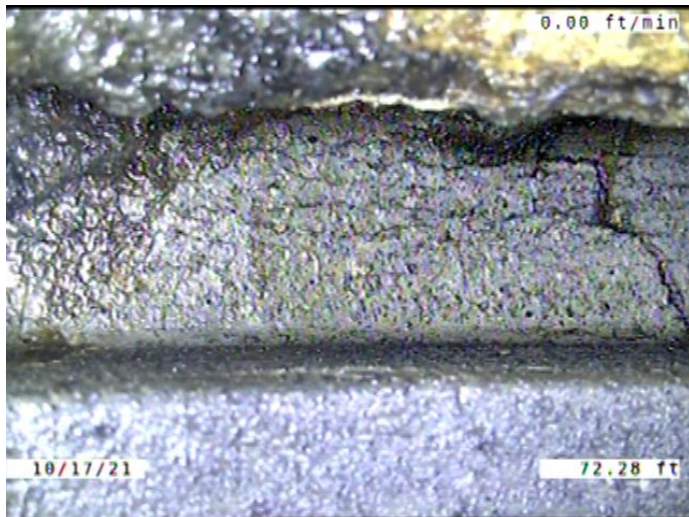
Code: **JAM**
 Description: **Joint Angular Medium**

Distance (ft): **72.3**
 Structural Grade: **3**
 O&M Grade: **0**
 Clock Start/From:
 Clock To:
 1st Value:
 2nd Value:
 Value Percent:
 Continuous Index: **S05**
 Within 8" of Joint: **NO**
 Remarks:

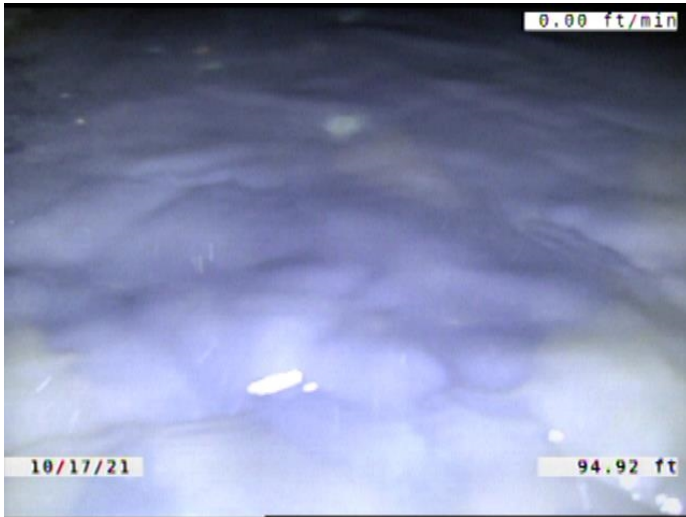
Code: **DSF**
 Description: **Deposits Settled Fine**

Distance (ft): **94.9**
 Structural Grade: **0**
 O&M Grade: **2**
 Clock Start/From: **4**
 Clock To: **8**
 1st Value:
 2nd Value:
 Value Percent: **5.000**
 Continuous Index: **S06**
 Within 8" of Joint: **YES**
 Remarks:

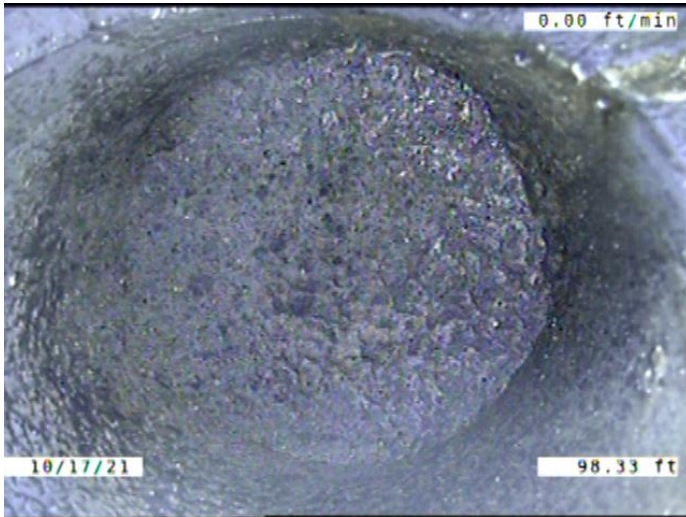
Code: **TFC**
 Description: **Tap Factory Capped**

Distance (ft): **98.3**
 Structural Grade: **0**
 O&M Grade: **0**
 Clock Start/From: **1**
 Clock To:
 1st Value: **4.000**
 2nd Value:
 Value Percent:
 Continuous Index:
 Within 8" of Joint: **YES**
 Remarks:

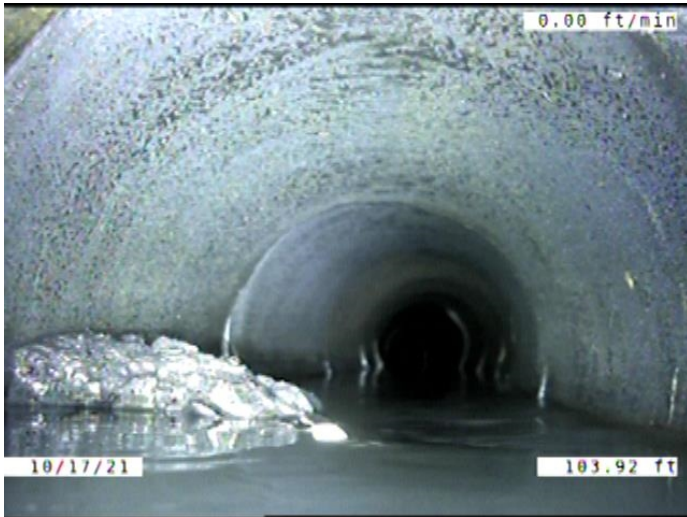
Code: **DSC**
 Description: **Deposits Settled Hard/Compacted**

Distance (ft): **103.9**
 Structural Grade: **0**
 O&M Grade: **2**
 Clock Start/From: **5**
 Clock To: **9**
 1st Value:
 2nd Value:
 Value Percent: **10.000**
 Continuous Index:
 Within 8" of Joint: **YES**
 Remarks:

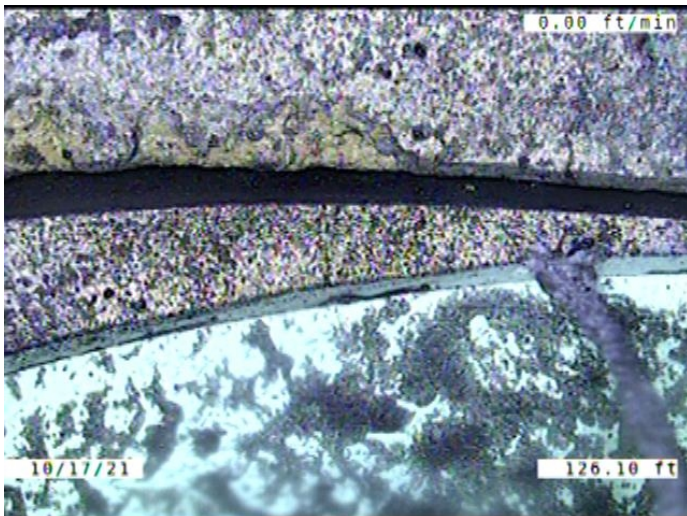
Code: **MMC**
 Description: **Miscellaneous Material Change**

Distance (ft): **126.1**
 Structural Grade: **0**
 O&M Grade: **0**
 Clock Start/From:
 Clock To:
 1st Value:
 2nd Value:
 Value Percent:
 Continuous Index:
 Within 8" of Joint: **NO**
 Remarks: **VCP TO PVC**

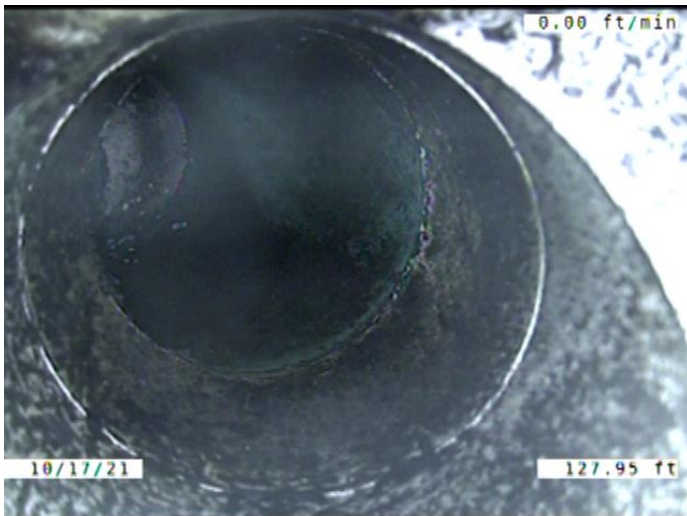
Code: **TF**
 Description: **Tap Factory**

Distance (ft): **127.9**
 Structural Grade: **0**
 O&M Grade: **0**
 Clock Start/From: **12**
 Clock To:
 1st Value: **4.000**
 2nd Value:
 Value Percent:
 Continuous Index:
 Within 8" of Joint: **YES**
 Remarks:

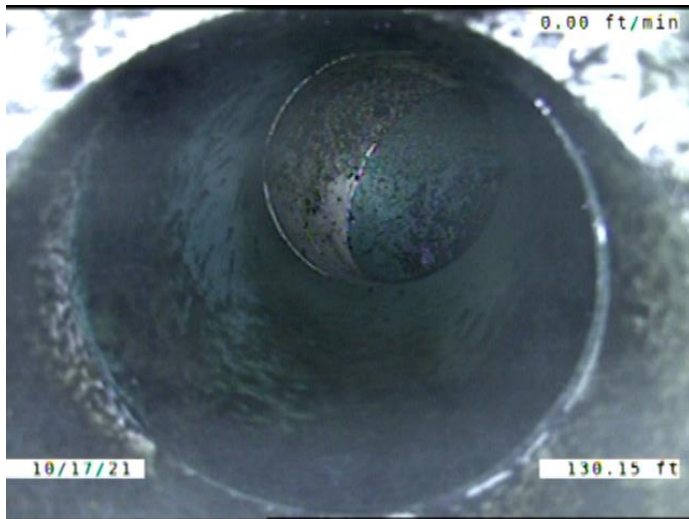
Code: **TF**
 Description: **Tap Factory**

Distance (ft): **130.1**
 Structural Grade: **0**
 O&M Grade: **0**
 Clock Start/From: **1**
 Clock To:
 1st Value: **4.000**
 2nd Value:
 Value Percent:
 Continuous Index:
 Within 8" of Joint: **YES**
 Remarks:

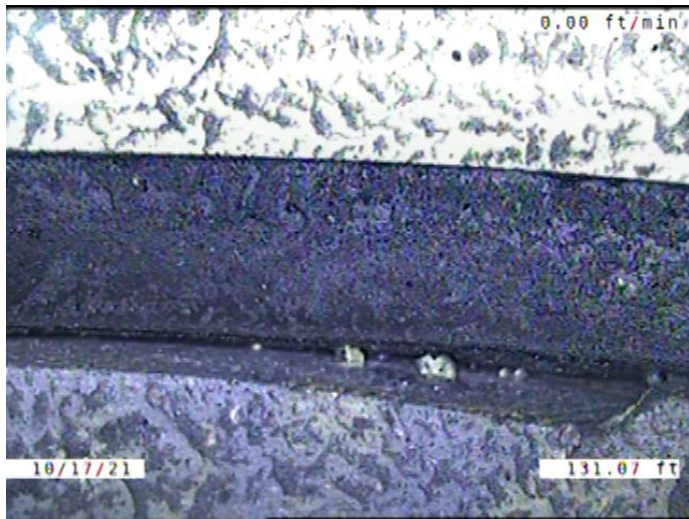
Code: **MMC**
 Description: **Miscellaneous Material Change**

Distance (ft): **131.1**
 Structural Grade: **0**
 O&M Grade: **0**
 Clock Start/From:
 Clock To:
 1st Value:
 2nd Value:
 Value Percent:
 Continuous Index:
 Within 8" of Joint: **NO**
 Remarks: **PVC TO VCP**

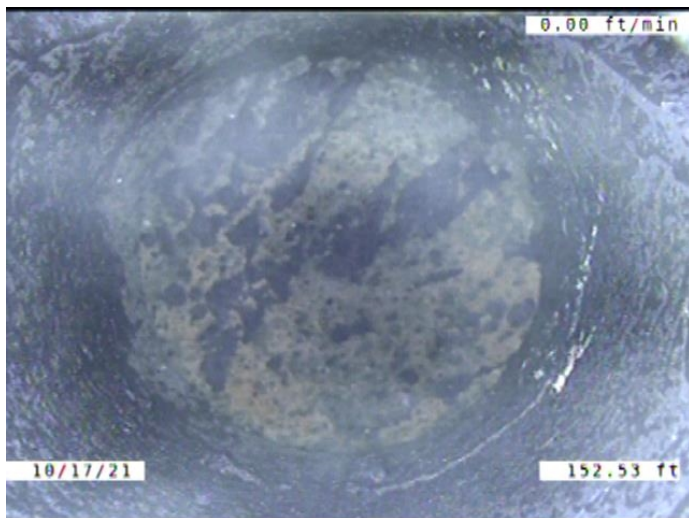
| Code: | TFC |
| Description: | Tap Factory Capped |

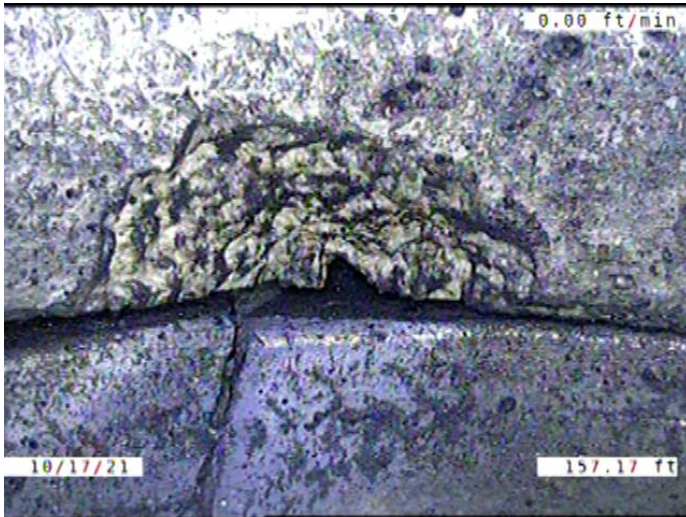
Code: **SSS**
 Description: **Surface Damage Surface Spalling**

Distance (ft): **157.2**
 Structural Grade: **2**
 O&M Grade: **0**
 Clock Start/From: **12**
 Clock To:
 1st Value:
 2nd Value:
 Value Percent:
 Continuous Index:
 Within 8" of Joint: **YES**
 Remarks:

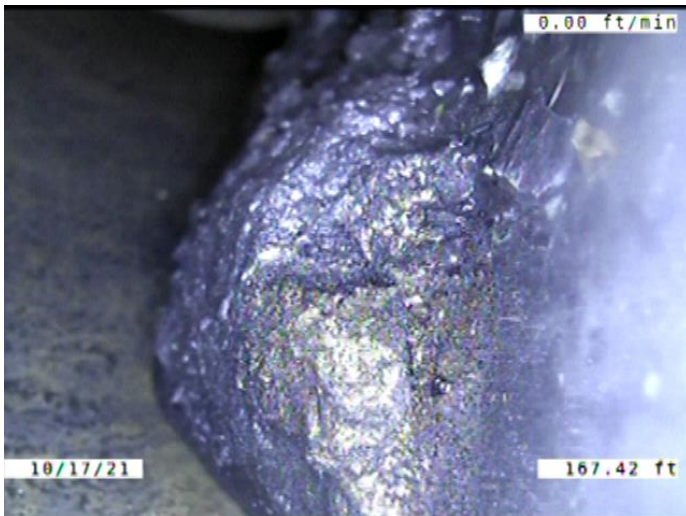
Code: **DSC**
 Description: **Deposits Settled Hard/Compacted**

Distance (ft): **167.4**
 Structural Grade: **0**
 O&M Grade: **2**
 Clock Start/From: **6**
 Clock To: **8**
 1st Value:
 2nd Value:
 Value Percent: **5.000**
 Continuous Index:
 Within 8" of Joint: **YES**
 Remarks:

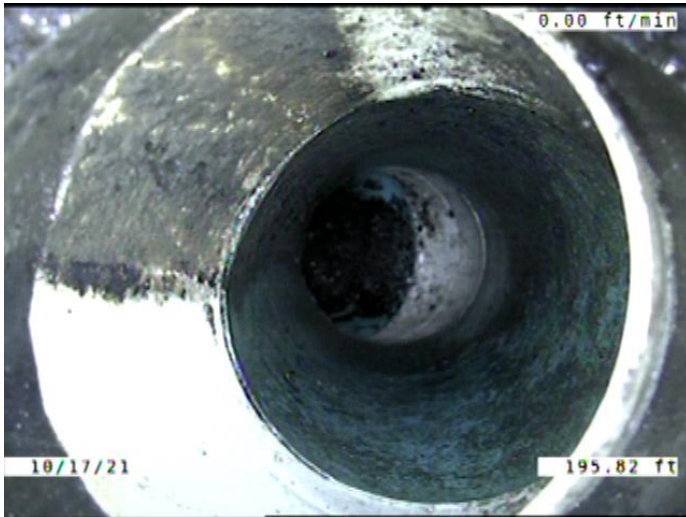
Code: **TF**
 Description: **Tap Factory**

Distance (ft): **195.8**
 Structural Grade: **0**
 O&M Grade: **0**
 Clock Start/From: **11**
 Clock To:
 1st Value: **4.000**
 2nd Value:
 Value Percent:
 Continuous Index:
 Within 8" of Joint: **YES**
 Remarks:

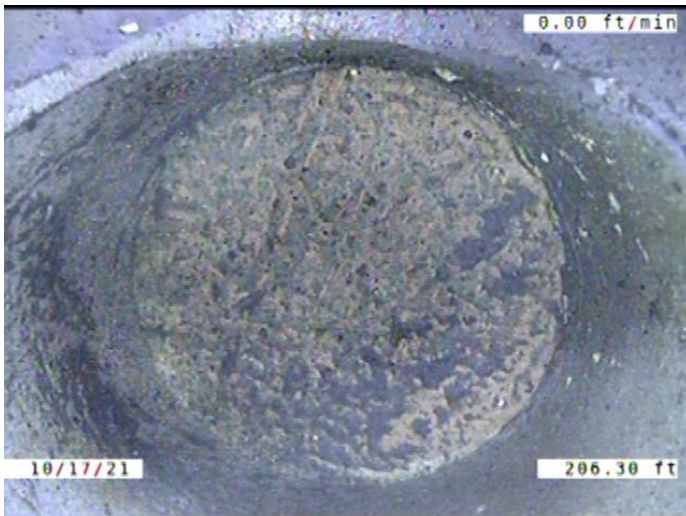
Code: **TFC**
Description: **Tap Factory Capped**

Distance (ft): **206.3**
Structural Grade: **0**
O&M Grade: **0**
Clock Start/From: **1**
Clock To:
1st Value: **4.000**
2nd Value:
Value Percent:
Continuous Index:
Within 8" of Joint: **YES**
Remarks:

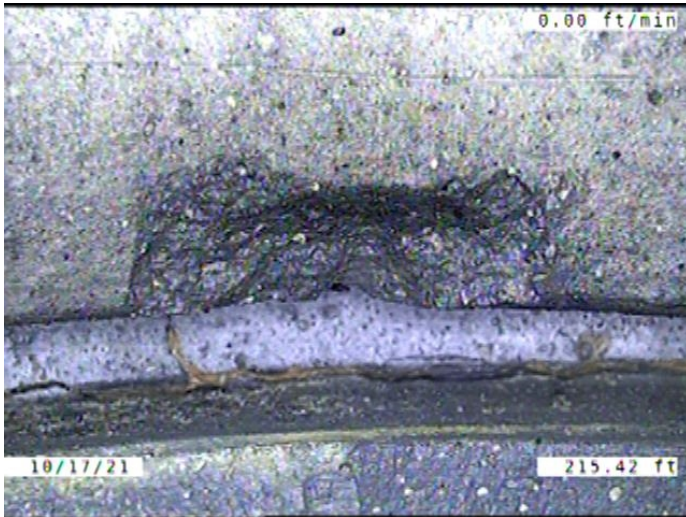
Code: **SSS**
Description: **Surface Damage Surface Spalling**

Distance (ft): **215.4**
Structural Grade: **2**
O&M Grade: **0**
Clock Start/From: **11**
Clock To:
1st Value:
2nd Value:
Value Percent:
Continuous Index:
Within 8" of Joint: **YES**
Remarks: **A PIECE CHIPPED AWAY FROM THE JOINT**

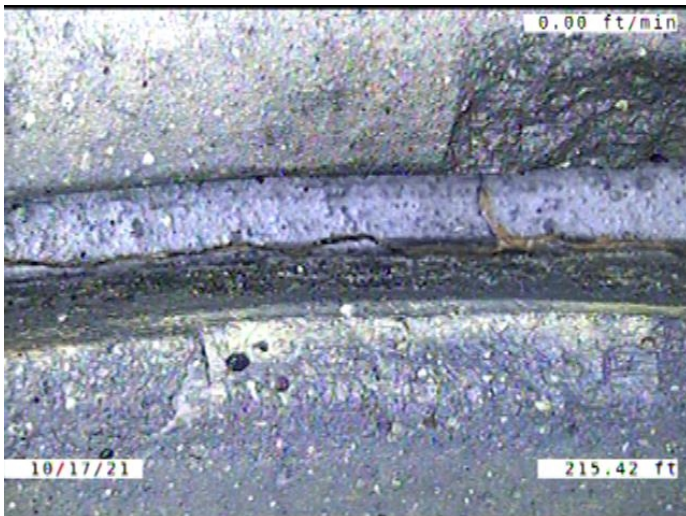
Code: **FM**
Description: **Fracture Multiple**

Distance (ft): **215.4**
Structural Grade: **4**
O&M Grade: **0**
Clock Start/From: **9**
Clock To: **1**
1st Value:
2nd Value:
Value Percent:
Continuous Index:
Within 8" of Joint: **YES**
Remarks:

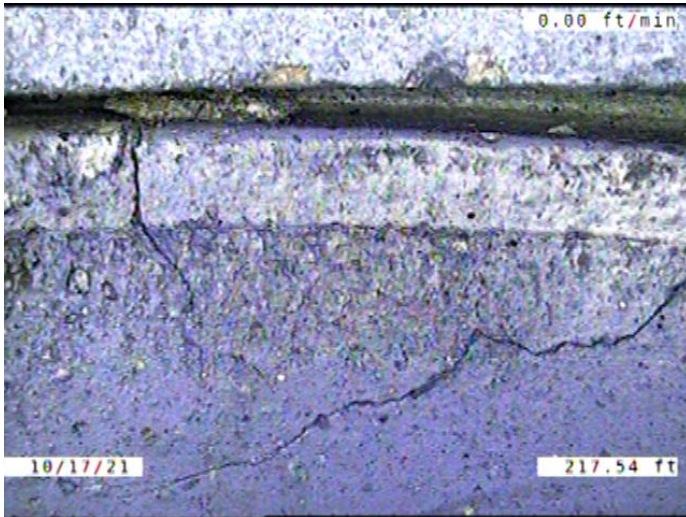
Code: **FM**
 Description: **Fracture Multiple**

Distance (ft): **217.5**
 Structural Grade: **4**
 O&M Grade: **0**
 Clock Start/From: **9**
 Clock To: **4**
 1st Value:
 2nd Value:
 Value Percent:
 Continuous Index:
 Within 8" of Joint: **YES**
 Remarks:

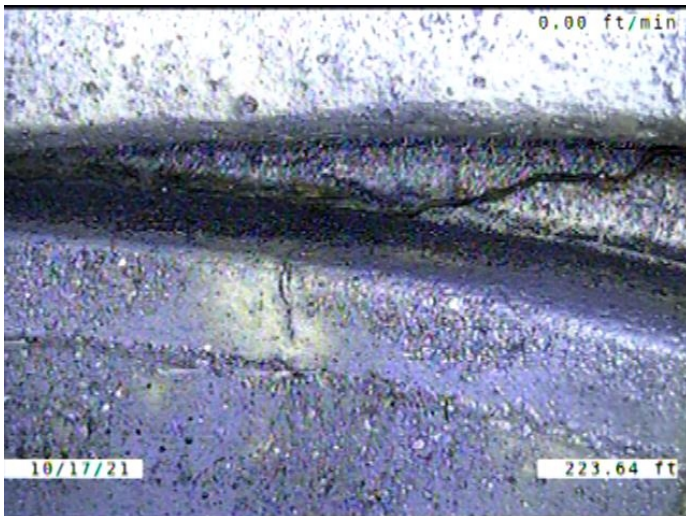
Code: **FM**
 Description: **Fracture Multiple**

Distance (ft): **223.6**
 Structural Grade: **4**
 O&M Grade: **0**
 Clock Start/From: **1**
 Clock To: **3**
 1st Value:
 2nd Value:
 Value Percent:
 Continuous Index:
 Within 8" of Joint: **YES**
 Remarks:

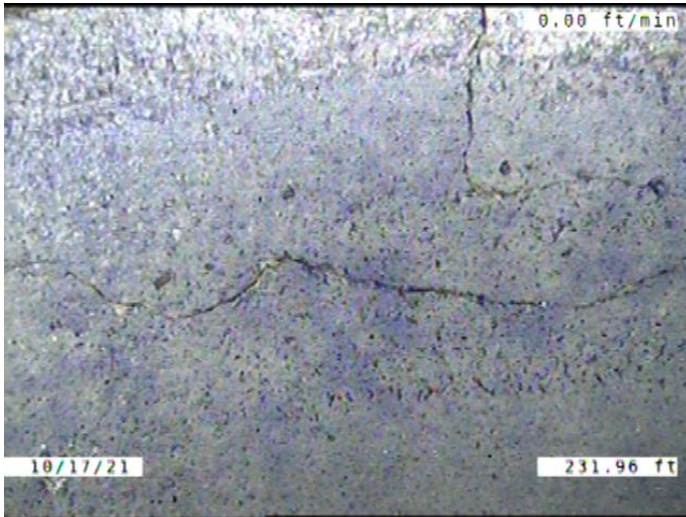
Code: **CM**
Description: **Crack Multiple**

Distance (ft): **232.0**
Structural Grade: **3**
O&M Grade: **0**
Clock Start/From: **9**
Clock To: **1**
1st Value:
2nd Value:
Value Percent:
Continuous Index:
Within 8" of Joint: **YES**
Remarks:

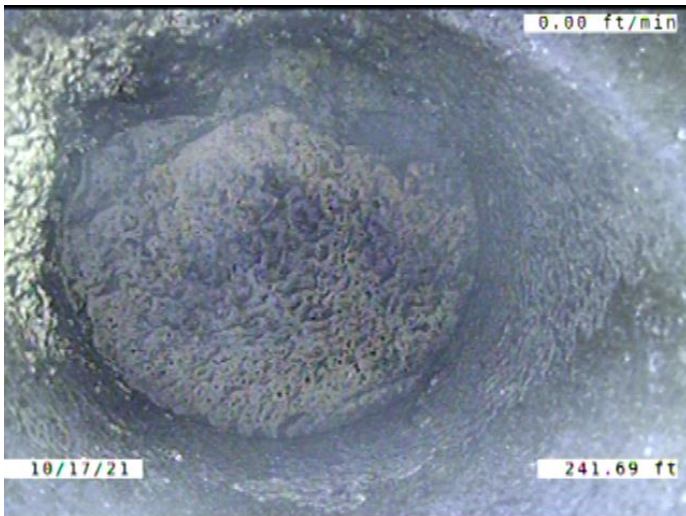
Code: **TFC**
Description: **Tap Factory Capped**

Distance (ft): **241.7**
Structural Grade: **0**
O&M Grade: **0**
Clock Start/From: **11**
Clock To:
1st Value: **4.000**
2nd Value:
Value Percent:
Continuous Index:
Within 8" of Joint: **YES**
Remarks: **ENCRUSTATION AROUND THE CAP.**

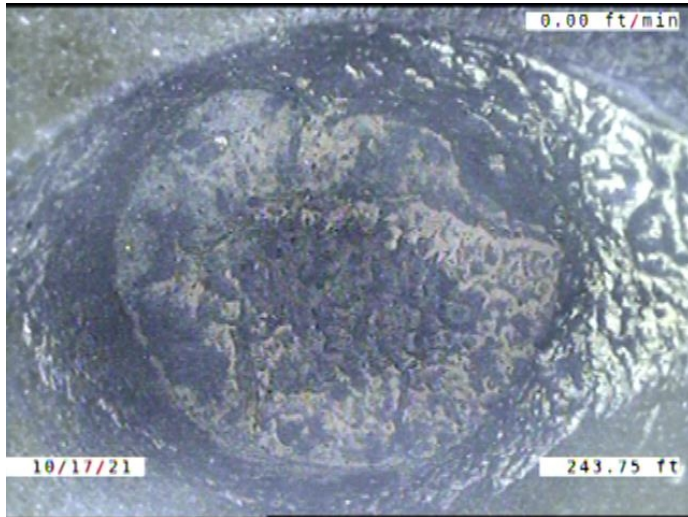
Code: **TFC**
Description: **Tap Factory Capped**

Distance (ft): **243.7**
Structural Grade: **0**
O&M Grade: **0**
Clock Start/From: **1**
Clock To:
1st Value: **4.000**
2nd Value:
Value Percent:
Continuous Index:
Within 8" of Joint: **YES**
Remarks: **ENCRUSTATION AROUND THE CAP.**

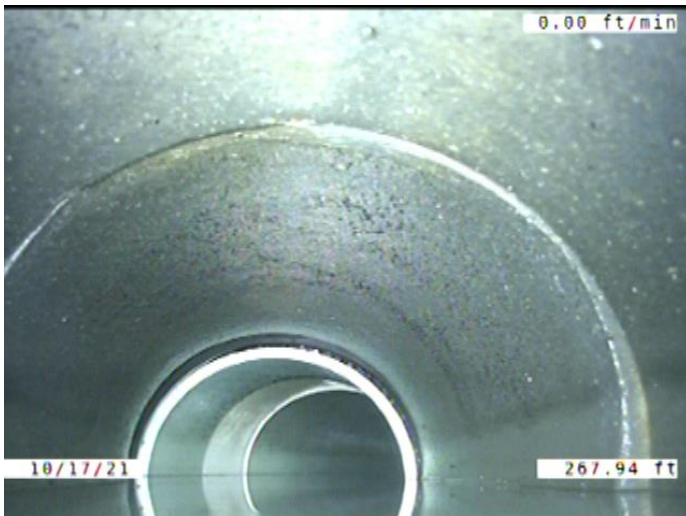
Code: **MWL**
Description: **Miscellaneous Water Level**

Distance (ft): **267.9**
Structural Grade: **0**
O&M Grade: **0**
Clock Start/From:
Clock To:
1st Value:
2nd Value:
Value Percent: **30.000**
Continuous Index:
Within 8" of Joint: **NO**
Remarks:

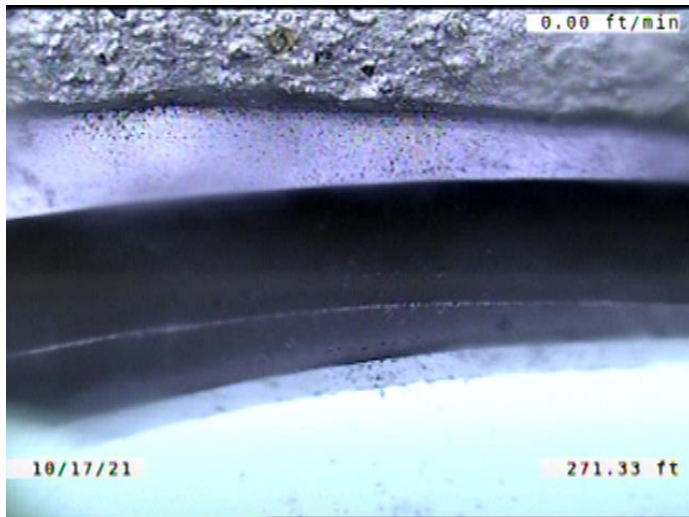
Code: **MMC**
 Description: **Miscellaneous Material Change**

Distance (ft): **271.3**
 Structural Grade: **0**
 O&M Grade: **0**
 Clock Start/From:
 Clock To:
 1st Value:
 2nd Value:
 Value Percent:
 Continuous Index:
 Within 8" of Joint: **NO**
 Remarks: **VCP TO PVC**

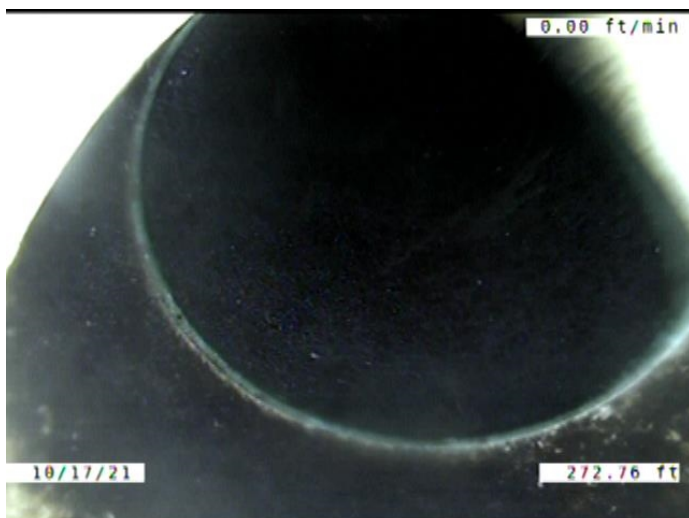
Code: **TF**
 Description: **Tap Factory**

Distance (ft): **272.8**
 Structural Grade: **0**
 O&M Grade: **0**
 Clock Start/From: **1**
 Clock To:
 1st Value: **4.000**
 2nd Value:
 Value Percent:
 Continuous Index:
 Within 8" of Joint: **YES**
 Remarks:

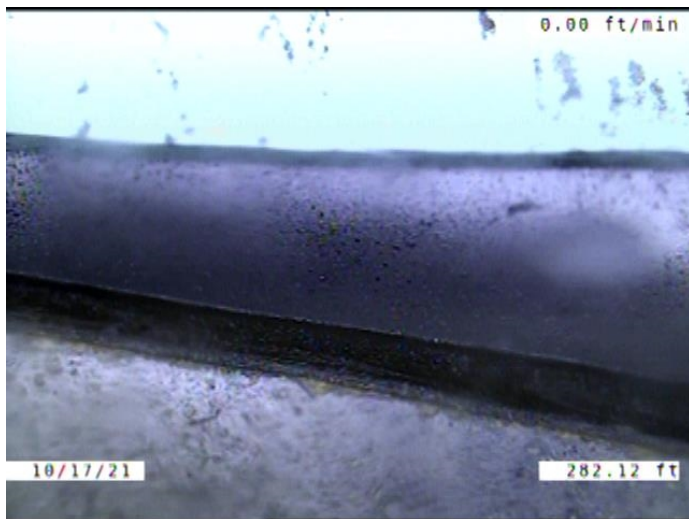
Code: **MMC**
Description: **Miscellaneous Material Change**

Distance (ft): **282.1**
Structural Grade: **0**
O&M Grade: **0**
Clock Start/From:
Clock To:
1st Value:
2nd Value:
Value Percent:
Continuous Index:
Within 8" of Joint: **NO**
Remarks: **PVC TO VCP**

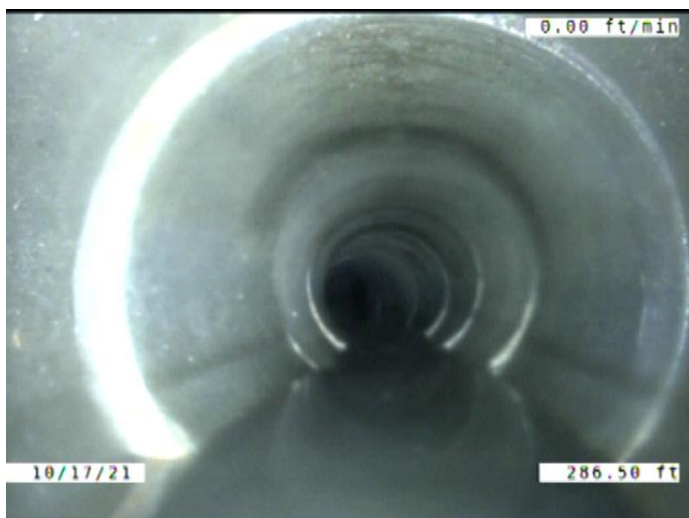
Code: **MWL**
Description: **Miscellaneous Water Level**

Distance (ft): **286.5**
Structural Grade: **0**
O&M Grade: **0**
Clock Start/From:
Clock To:
1st Value:
2nd Value:
Value Percent: **5.000**
Continuous Index:
Within 8" of Joint: **NO**
Remarks:

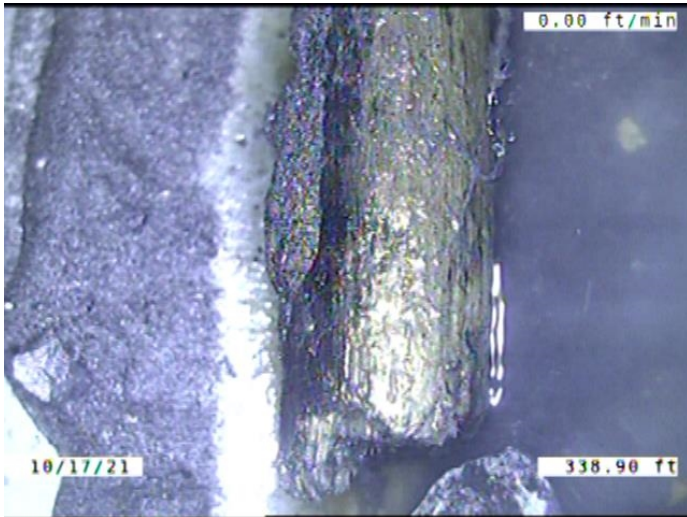
Code: **OBZ**
 Description: **Obstruction Other**

Distance (ft): **338.9**
 Structural Grade: **0**
 O&M Grade: **2**
 Clock Start/From: **7**
 Clock To:
 1st Value:
 2nd Value:
 Value Percent: **5.000**
 Continuous Index:
 Within 8" of Joint: **YES**
 Remarks: **STICK**

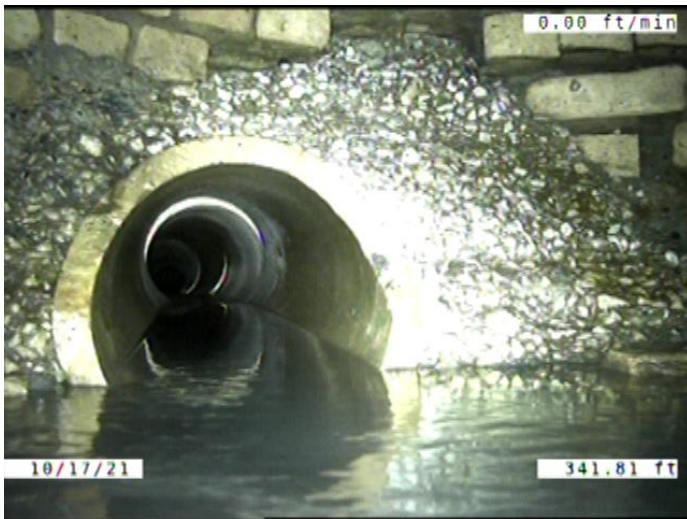
Code: **DAE**
 Description: **Deposits Attached Encrustation**

Distance (ft): **341.8**
 Structural Grade: **0**
 O&M Grade: **2**
 Clock Start/From: **12**
 Clock To: **4**
 1st Value:
 2nd Value:
 Value Percent: **5.000**
 Continuous Index: **F02**
 Within 8" of Joint: **YES**
 Remarks:

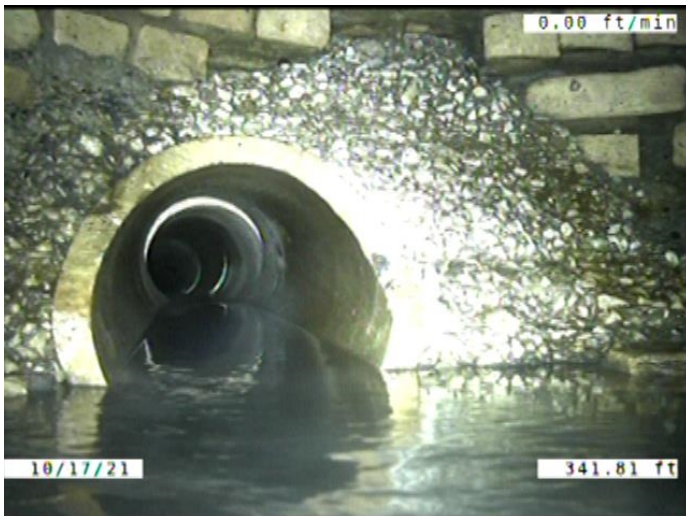
Code: **JAM**
 Description: **Joint Angular Medium**

Distance (ft): **341.8**
 Structural Grade: **3**
 O&M Grade: **0**
 Clock Start/From:
 Clock To:
 1st Value:
 2nd Value:
 Value Percent:
 Continuous Index: **F05**
 Within 8" of Joint: **NO**
 Remarks:

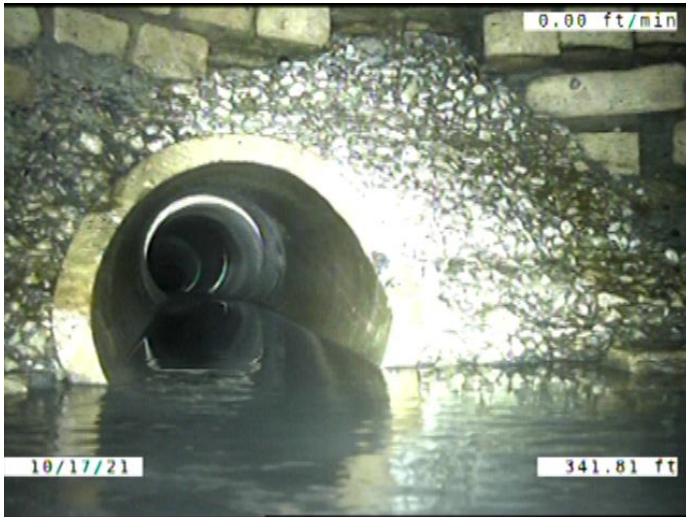
Code: **DAE**
 Description: **Deposits Attached Encrustation**

Distance (ft): **341.8**
 Structural Grade: **0**
 O&M Grade: **2**
 Clock Start/From: **9**
 Clock To: **11**
 1st Value:
 2nd Value:
 Value Percent: **5.000**
 Continuous Index: **F03**
 Within 8" of Joint: **YES**
 Remarks:
