Profile/Photo Observation Report

Date:	10/17/2021	Weather:		Coding:	PACP 7.0
Pipe Length (ft):	343.5	Owner:	City of Hobart	Pre Clean:	Heavy Cleaning
P.O.#:	YES502259	Surveyor:	S. Bucklin	PSR:	P-704-013-012
Customer:	City of Hobart	Clean Date:	10/13/2021	Shape:	C

Street:	North Michigan Avenue	Flow Control:	Not Controlled
City:	Hobart, IN	Year Renewed:	
Location:	Local rural streets with light traffic, t	Tape/Media #:	
Purpose:	Routine Assessment	Dia/Height:	12"
Use:	Sanitary Sewage Pipe	Material:	VCP
Drain Area:		Lining:	
Category:	NA		
Comment:			
Location Details:		Direction of Survey:	Downstream
US MH:	M-704-013	DS MH:	M-704-012
		Total Length Surveyed (ft):	343.5

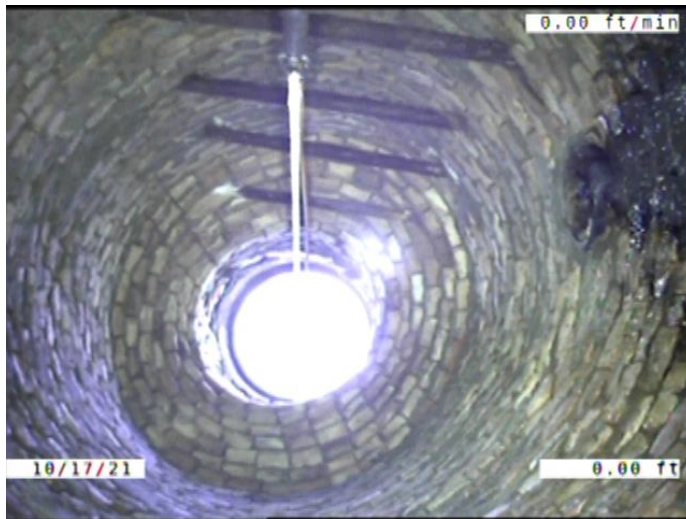
Code: **AMH**
Description: **Manhole**

Distance (ft): **.0**
Structural Grade: **0**
O&M Grade: **0**
Clock Start/From:
Clock To:
1st Value:
2nd Value:
Value Percent:
Continuous Index:
Within 8" of Joint: **NO**
Remarks: **M-704-013**

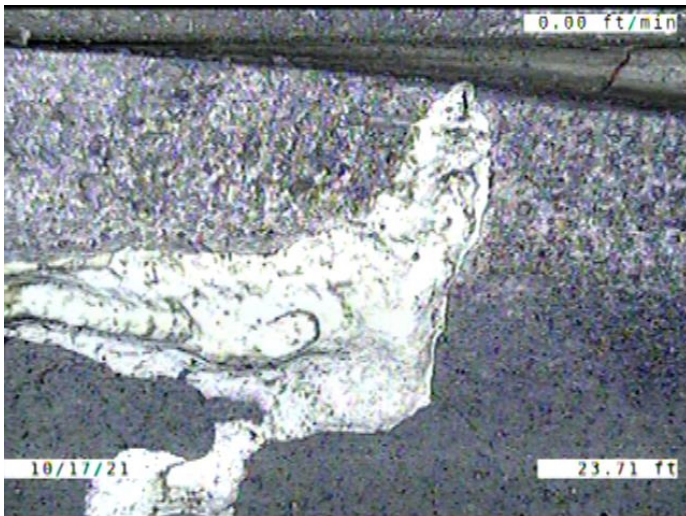
Code: **DAE**
 Description: **Deposits Attached Encrustation**

Distance (ft): **23.7**
 Structural Grade: **0**
 O&M Grade: **2**
 Clock Start/From: **9**
 Clock To: **11**
 1st Value:
 2nd Value:
 Value Percent: **5.000**
 Continuous Index: **S03**
 Within 8" of Joint: **YES**
 Remarks:

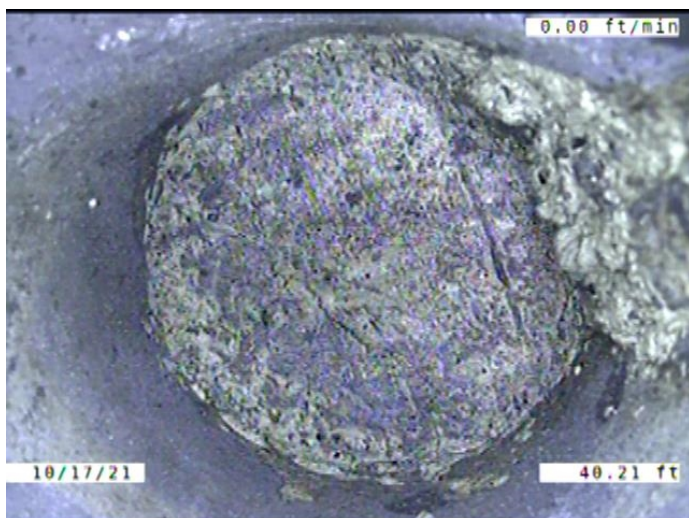
Code: **TFC**
 Description: **Tap Factory Capped**

Distance (ft): **40.2**
 Structural Grade: **0**
 O&M Grade: **0**
 Clock Start/From: **2**
 Clock To:
 1st Value: **4.000**
 2nd Value:
 Value Percent:
 Continuous Index:
 Within 8" of Joint: **YES**
 Remarks:

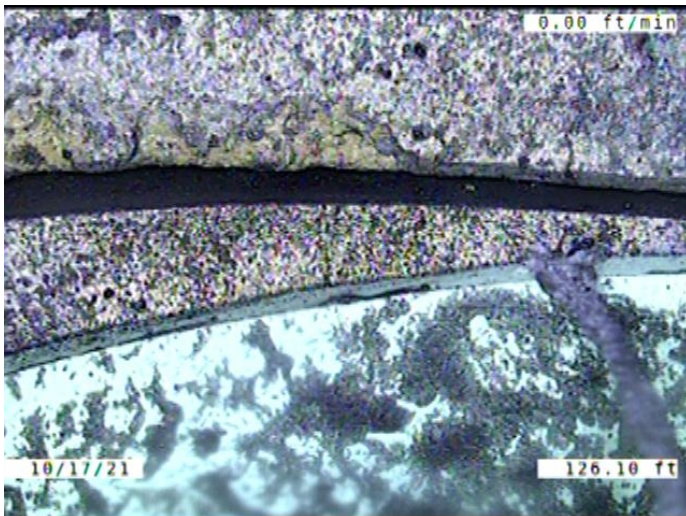
Code: **MMC**
 Description: **Miscellaneous Material Change**

Distance (ft): **126.1**
 Structural Grade: **0**
 O&M Grade: **0**
 Clock Start/From:
 Clock To:
 1st Value:
 2nd Value:
 Value Percent:
 Continuous Index:
 Within 8" of Joint: **NO**
 Remarks: **VCP TO PVC**

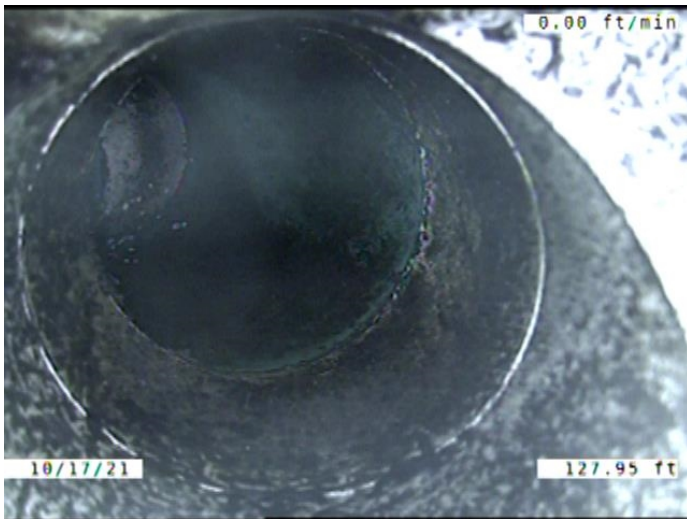
Code: **TF**
 Description: **Tap Factory**

Distance (ft): **127.9**
 Structural Grade: **0**
 O&M Grade: **0**
 Clock Start/From: **12**
 Clock To:
 1st Value: **4.000**
 2nd Value:
 Value Percent:
 Continuous Index:
 Within 8" of Joint: **YES**
 Remarks:

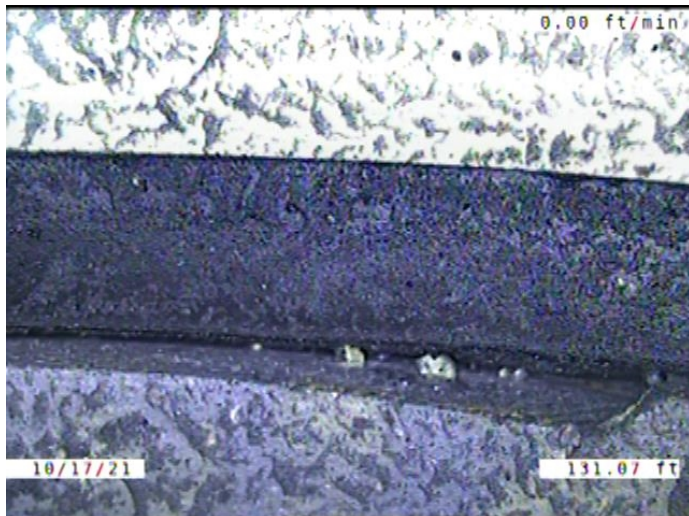
Code: **MMC**
 Description: **Miscellaneous Material Change**

Distance (ft): **131.1**
 Structural Grade: **0**
 O&M Grade: **0**
 Clock Start/From:
 Clock To:
 1st Value:
 2nd Value:
 Value Percent:
 Continuous Index:
 Within 8" of Joint: **NO**
 Remarks: **PVC TO VCP**

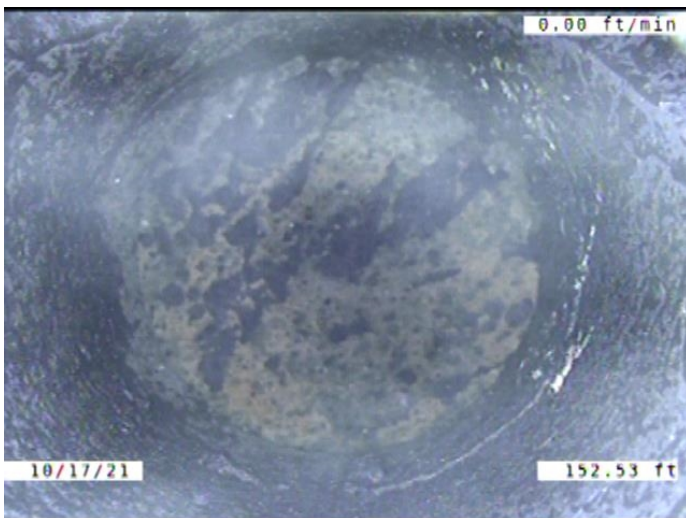
Code:	TFC
Description:	Tap Factory Capped
Distance (ft):	152.5
Structural Grade:	0
O&M Grade:	0
Clock Start/From:	1
Clock To:	
1st Value:	4.000
2nd Value:	
Value Percent:	
Continuous Index:	
Within 8" of Joint:	YES
Remarks:

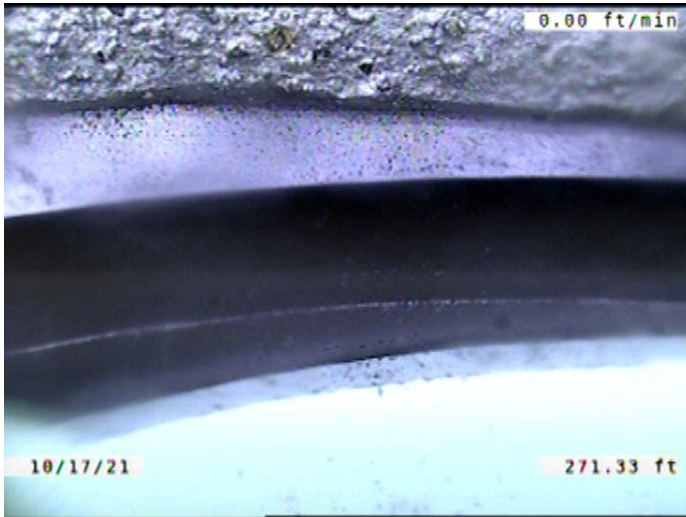
Code:	MMC
Description:	Miscellaneous Material Change
Distance (ft):	271.3
Structural Grade:	0
O&M Grade:	0
Clock Start/From:	
Clock To:	
1st Value:	
2nd Value:	
Value Percent:	
Continuous Index:	
Within 8" of Joint:	NO
Remarks:	VCP TO PVC

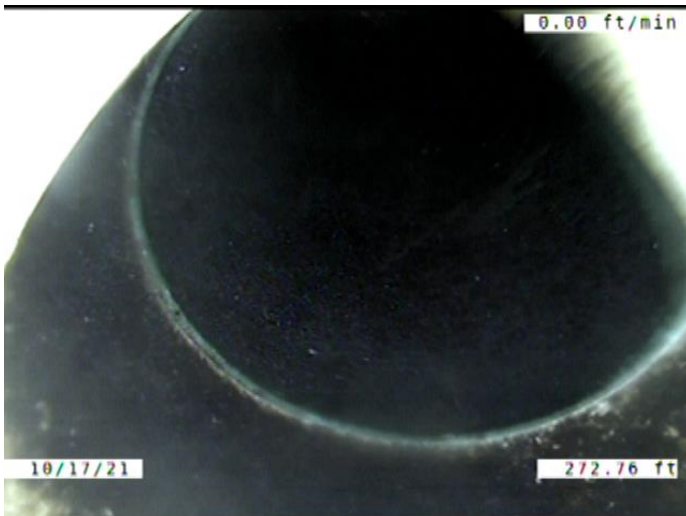
Code:	TF
Description:	Tap Factory
Distance (ft):	272.8
Structural Grade:	0
O&M Grade:	0
Clock Start/From:	1
Clock To:	
1st Value:	4.000
2nd Value:	
Value Percent:	
Continuous Index:	
Within 8" of Joint:	YES
Remarks:

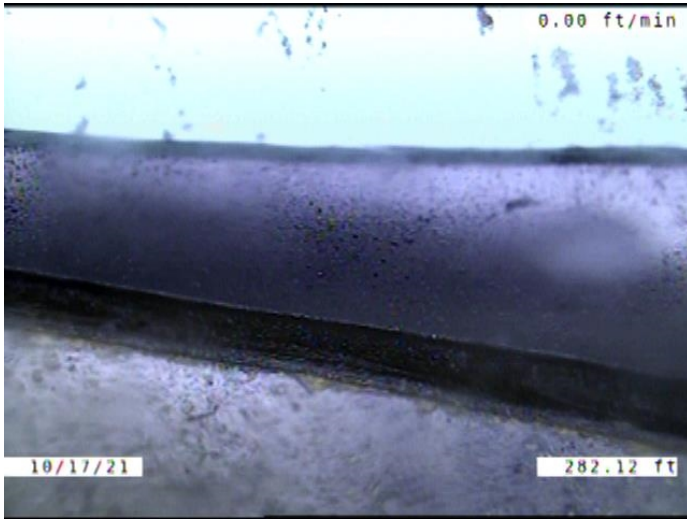
Code: **MMC**
Description: **Miscellaneous Material Change**

Distance (ft): **282.1**
Structural Grade: **0**
O&M Grade: **0**
Clock Start/From:
Clock To:
1st Value:
2nd Value:
Value Percent:
Continuous Index:
Within 8" of Joint: **NO**
Remarks: **PVC TO VCP**

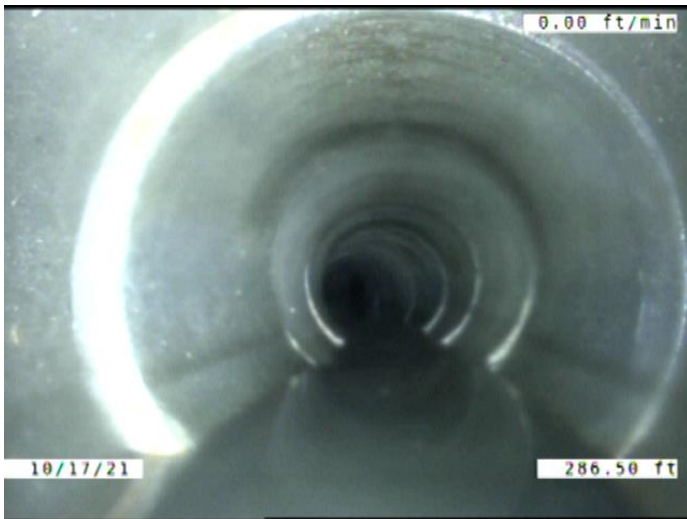
Code: **MWL**
Description: **Miscellaneous Water Level**

Distance (ft): **286.5**
Structural Grade: **0**
O&M Grade: **0**
Clock Start/From:
Clock To:
1st Value:
2nd Value:
Value Percent: **5.000**
Continuous Index:
Within 8" of Joint: **NO**
Remarks:

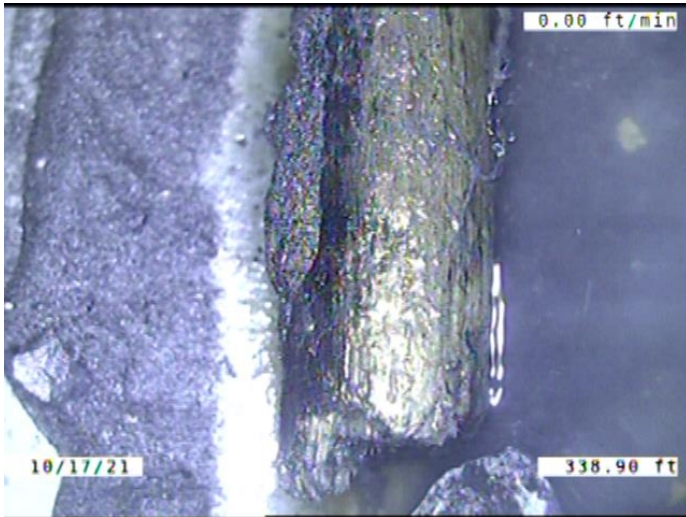
Code: **OBZ**
 Description: **Obstruction Other**

Distance (ft): **338.9**
 Structural Grade: **0**
 O&M Grade: **2**
 Clock Start/From: **7**
 Clock To:
 1st Value:
 2nd Value:
 Value Percent: **5.000**
 Continuous Index:
 Within 8" of Joint: **YES**
 Remarks: **STICK**

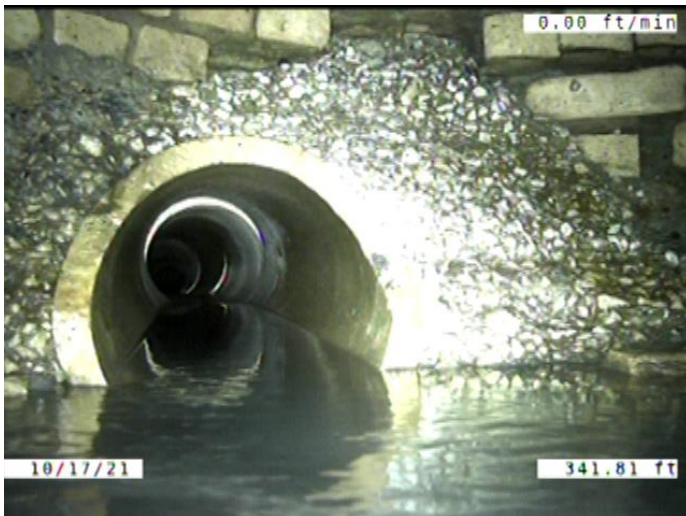
Code: **DAE**
 Description: **Deposits Attached Encrustation**

Distance (ft): **341.8**
 Structural Grade: **0**
 O&M Grade: **2**
 Clock Start/From: **12**
 Clock To: **4**
 1st Value:
 2nd Value:
 Value Percent: **5.000**
 Continuous Index: **F02**
 Within 8" of Joint: **YES**
 Remarks:

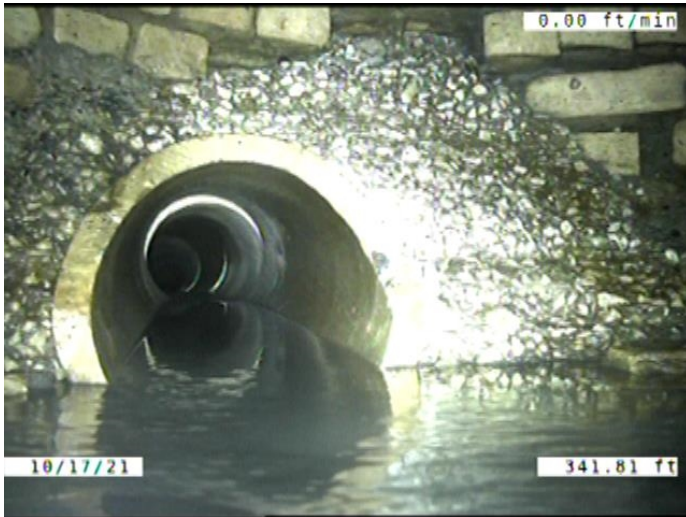
Code: **JAM**
Description: **Joint Angular Medium**

Distance (ft): **341.8**
Structural Grade: **3**
O&M Grade: **0**
Clock Start/From:
Clock To:
1st Value:
2nd Value:
Value Percent:
Continuous Index: **F05**
Within 8" of Joint: **NO**
Remarks:
