Street:	North Michigan Avenue		Flow Control:	Not Controlled	
City:	Hobart, IN		Year Renewed:		
Location:	Local rural streets with light traffic, t		Tape/Media #:		
Purpose:	Routine Assessment		Dia/Height:	12"	
Use:	Sanitary Sewage Pipe		Material:	VCP	
Drain Area:			Lining:		
Category:	NA				
Comment:					
Location Details:			Direction of Survey:	Downstream	
US MH:	M-704-014	DS MH:	M-704-013	Total Length Surveyed (ft):	262.2

**Thursday, December 30, 2021**

**M-704-013**

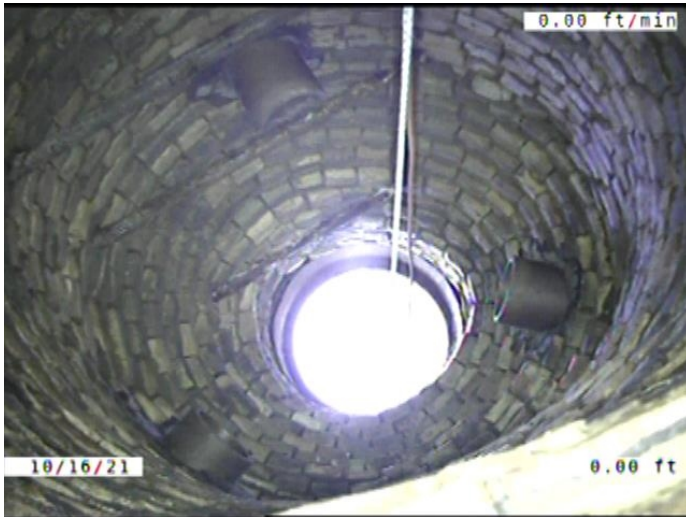
Code: **AMH**  
Description: **Manhole**

Distance (ft): **.0**  
Structural Grade: **0**  
O&M Grade: **0**  
Clock Start/From:  
Clock To:  
1st Value:  
2nd Value:  
Value Percent:  
Continuous Index:  
Within 8" of Joint: **NO**  
Remarks: **M-704-014**

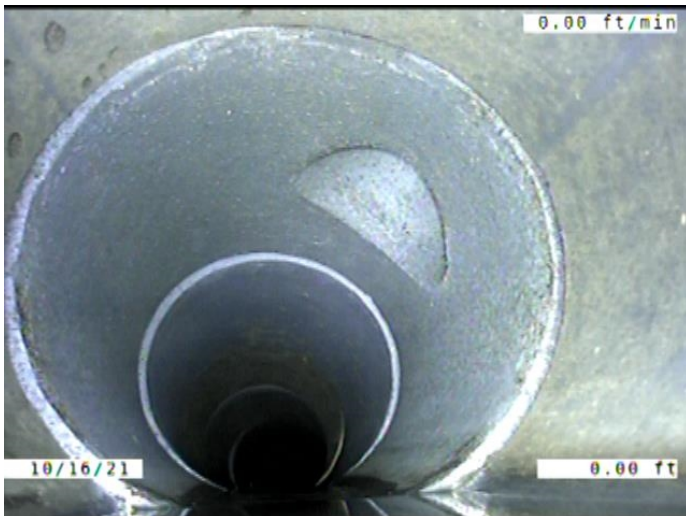
Code: **MWL**  
Description: **Miscellaneous Water Level**

Distance (ft): **.0**  
Structural Grade: **0**  
O&M Grade: **0**  
Clock Start/From:  
Clock To:  
1st Value:  
2nd Value:  
Value Percent: **5.000**  
Continuous Index:  
Within 8" of Joint: **NO**  
Remarks:

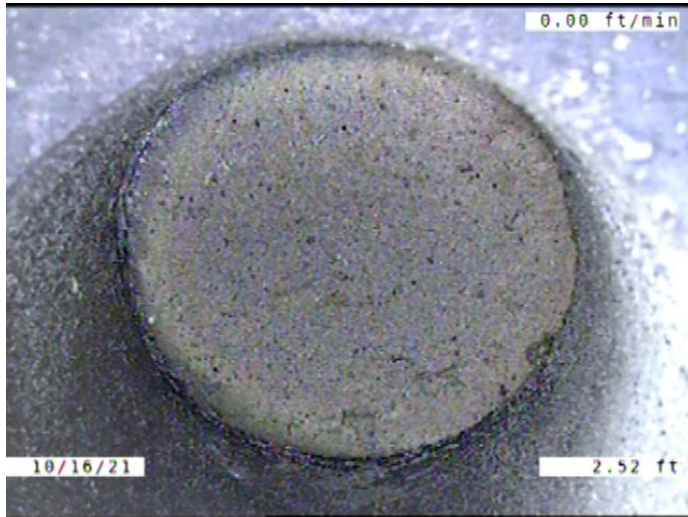
Code: **TFC**  
 Description: **Tap Factory Capped**

Distance (ft): **2.5**  
 Structural Grade: **0**  
 O&M Grade: **0**  
 Clock Start/From: **1**  
 Clock To:  
 1st Value: **4.000**  
 2nd Value:  
 Value Percent:  
 Continuous Index:  
 Within 8" of Joint: **YES**  
 Remarks:

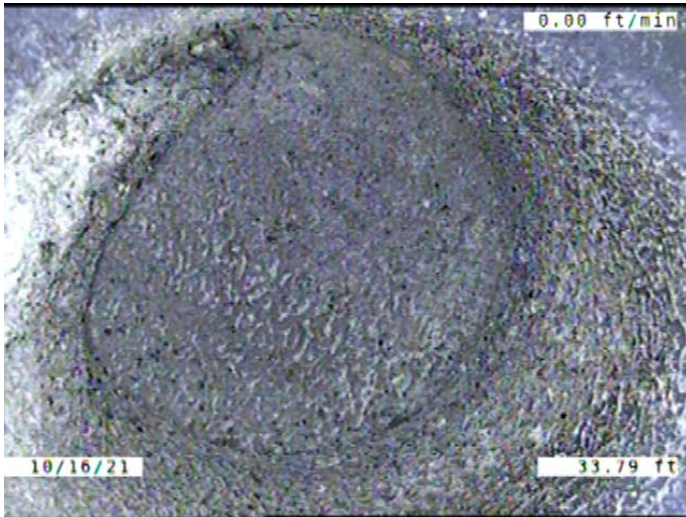
Code: **TFC**  
 Description: **Tap Factory Capped**

Distance (ft): **33.8**  
 Structural Grade: **0**  
 O&M Grade: **0**  
 Clock Start/From: **11**  
 Clock To:  
 1st Value: **4.000**  
 2nd Value:  
 Value Percent:  
 Continuous Index:  
 Within 8" of Joint: **YES**  
 Remarks:

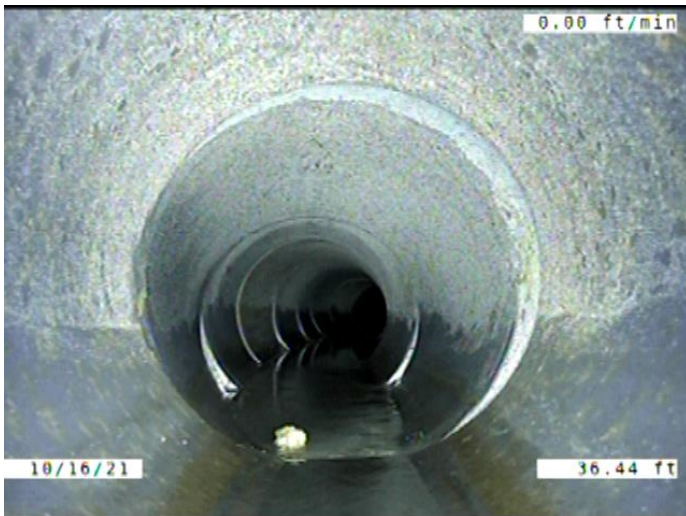
Code: **MWLS**  
 Description: **Miscellaneous Water Level Sag**

Distance (ft): **36.4**  
 Structural Grade: **2**  
 O&M Grade: **0**  
 Clock Start/From:  
 Clock To:  
 1st Value:  
 2nd Value:  
 Value Percent: **15.000**  
 Continuous Index: **F01**  
 Within 8" of Joint: **NO**  
 Remarks:

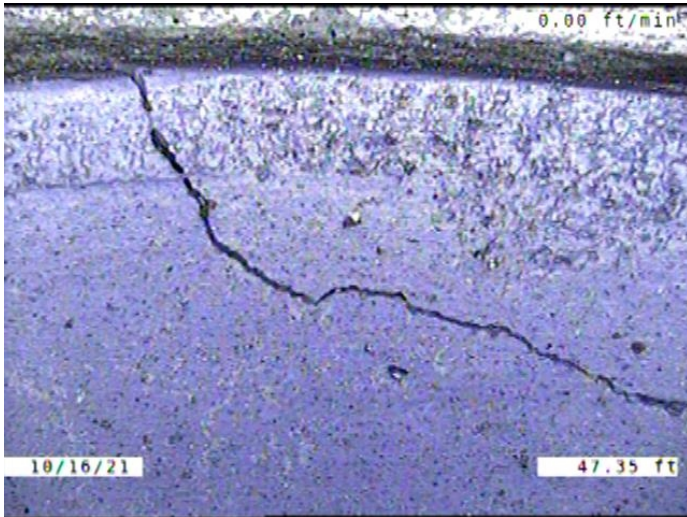
Code: **B**  
 Description: **Broken**

Distance (ft): **47.4**  
 Structural Grade: **4**  
 O&M Grade: **0**  
 Clock Start/From: **12**  
 Clock To: **3**  
 1st Value:  
 2nd Value:  
 Value Percent:  
 Continuous Index:  
 Within 8" of Joint: **YES**  
 Remarks:

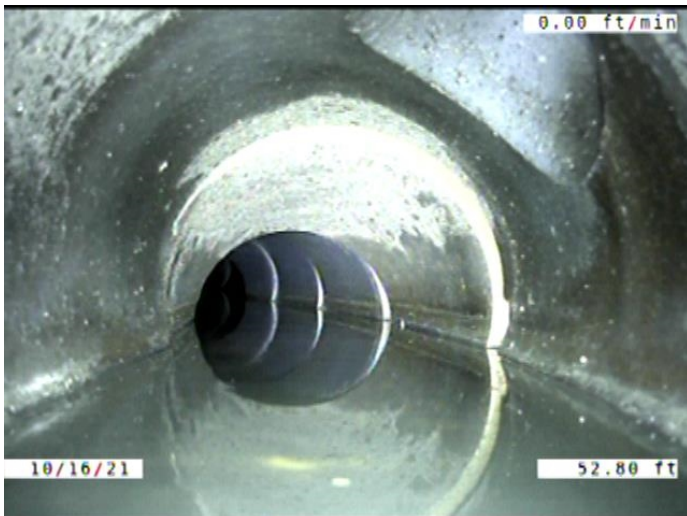
Code: **MWLS**  
 Description: **Miscellaneous Water Level Sag**

Distance (ft): **52.8**  
 Structural Grade: **2**  
 O&M Grade: **0**  
 Clock Start/From:  
 Clock To:  
 1st Value:  
 2nd Value:  
 Value Percent: **25.000**  
 Continuous Index: **S03**  
 Within 8" of Joint: **NO**  
 Remarks:

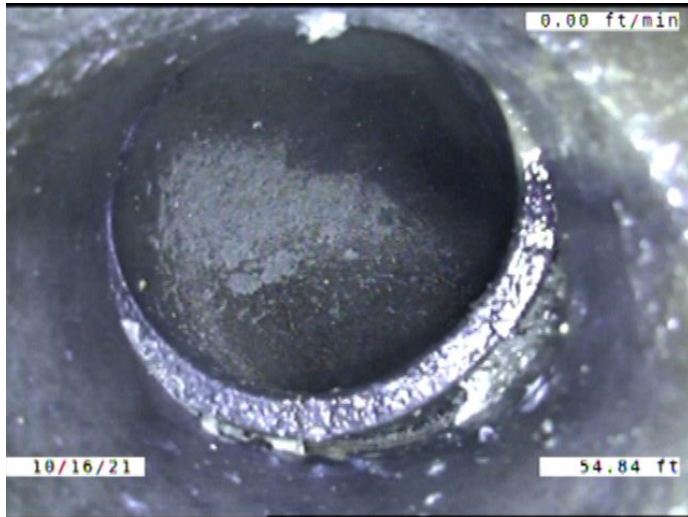
Code: **TF**  
 Description: **Tap Factory**

Distance (ft): **54.8**  
 Structural Grade: **0**  
 O&M Grade: **0**  
 Clock Start/From: **1**  
 Clock To:  
 1st Value: **4.000**  
 2nd Value:  
 Value Percent:  
 Continuous Index:  
 Within 8" of Joint: **YES**  
 Remarks:

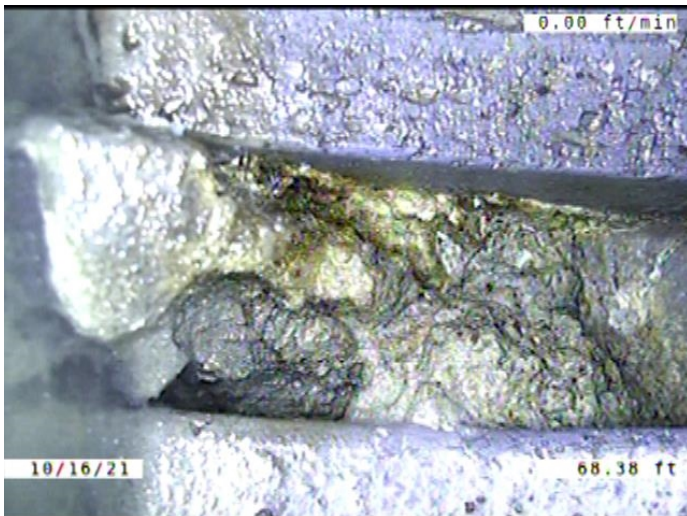
Code: **DAE**  
 Description: **Deposits Attached Encrustation**

Distance (ft): **68.4**  
 Structural Grade: **0**  
 O&M Grade: **2**  
 Clock Start/From: **3**  
 Clock To: **4**  
 1st Value:  
 2nd Value:  
 Value Percent: **5.000**  
 Continuous Index:  
 Within 8" of Joint: **YES**  
 Remarks:

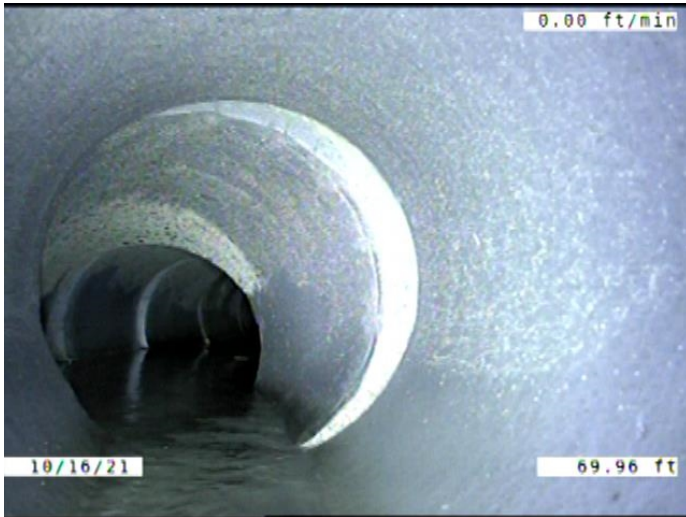
Code: **MWLS**  
 Description: **Miscellaneous Water Level Sag**

Distance (ft): **70.0**  
 Structural Grade: **2**  
 O&M Grade: **0**  
 Clock Start/From:  
 Clock To:  
 1st Value:  
 2nd Value:  
 Value Percent: **25.000**  
 Continuous Index: **F03**  
 Within 8" of Joint: **NO**  
 Remarks:

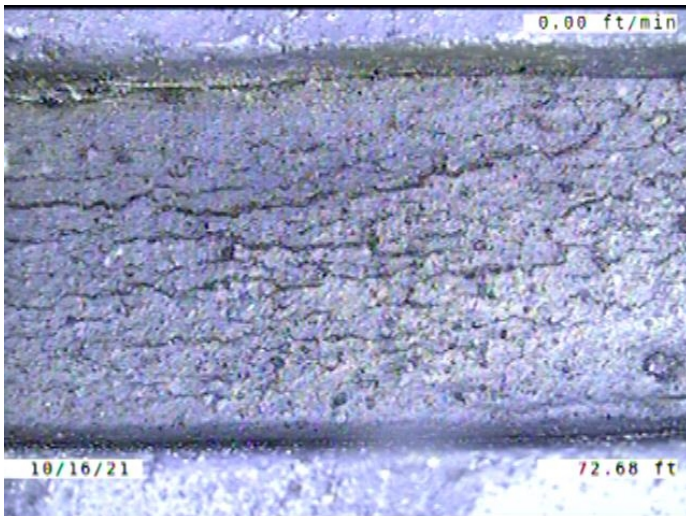
Code: **JAL**  
 Description: **Joint Angular Large**

Distance (ft): **72.7**  
 Structural Grade: **4**  
 O&M Grade: **0**  
 Clock Start/From:  
 Clock To:  
 1st Value:  
 2nd Value:  
 Value Percent:  
 Continuous Index: **S04**  
 Within 8" of Joint: **NO**  
 Remarks:

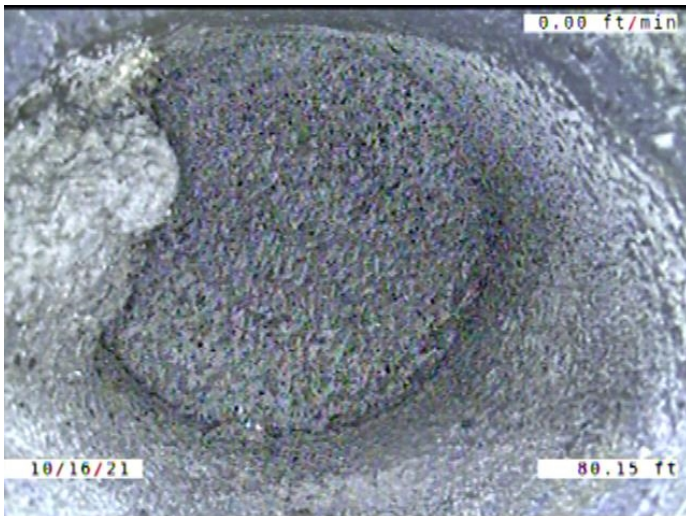
Code: **TFC**  
 Description: **Tap Factory Capped**

Distance (ft): **80.1**  
 Structural Grade: **0**  
 O&M Grade: **0**  
 Clock Start/From: **11**  
 Clock To:  
 1st Value: **4.000**  
 2nd Value:  
 Value Percent:  
 Continuous Index:  
 Within 8" of Joint: **YES**  
 Remarks:

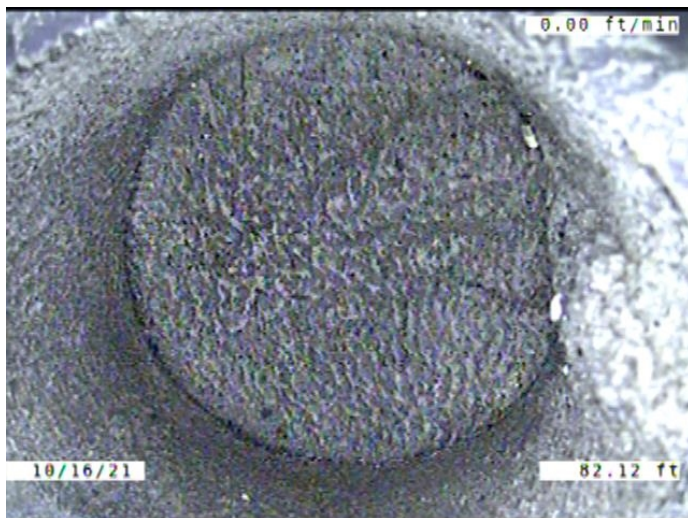
Code: **TFC**  
 Description: **Tap Factory Capped**

Distance (ft): **82.1**  
 Structural Grade: **0**  
 O&M Grade: **0**  
 Clock Start/From: **2**  
 Clock To:  
 1st Value: **4.000**  
 2nd Value:  
 Value Percent:  
 Continuous Index:  
 Within 8" of Joint: **YES**  
 Remarks:

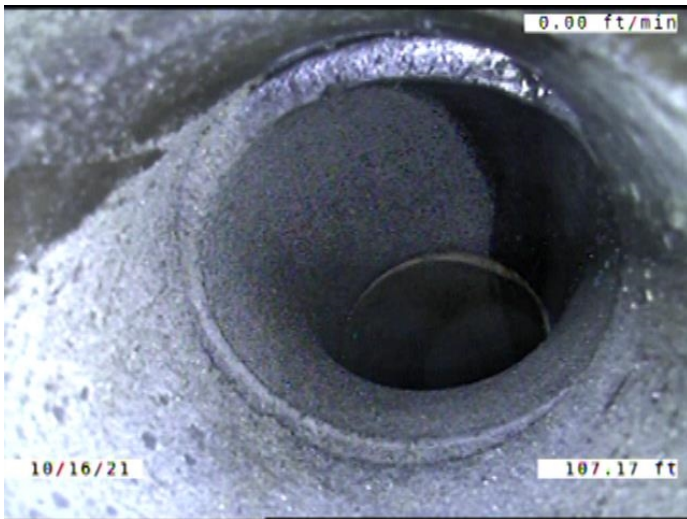
Code: **TF**  
Description: **Tap Factory**

Distance (ft): **107.2**  
Structural Grade: **0**  
O&M Grade: **0**  
Clock Start/From: **1**  
Clock To:  
1st Value: **4.000**  
2nd Value:  
Value Percent:  
Continuous Index:  
Within 8" of Joint: **YES**  
Remarks:

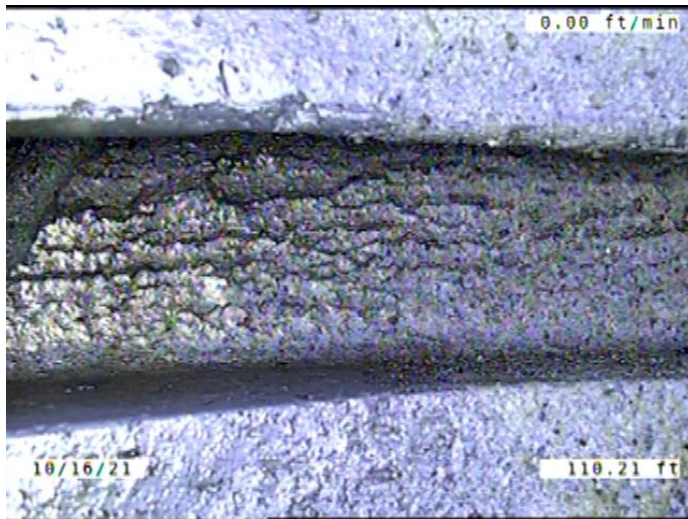
Code: **JAM**  
Description: **Joint Angular Medium**

Distance (ft): **110.2**  
Structural Grade: **3**  
O&M Grade: **0**  
Clock Start/From:  
Clock To:  
1st Value:  
2nd Value:  
Value Percent:  
Continuous Index: **S05**  
Within 8" of Joint: **NO**  
Remarks:

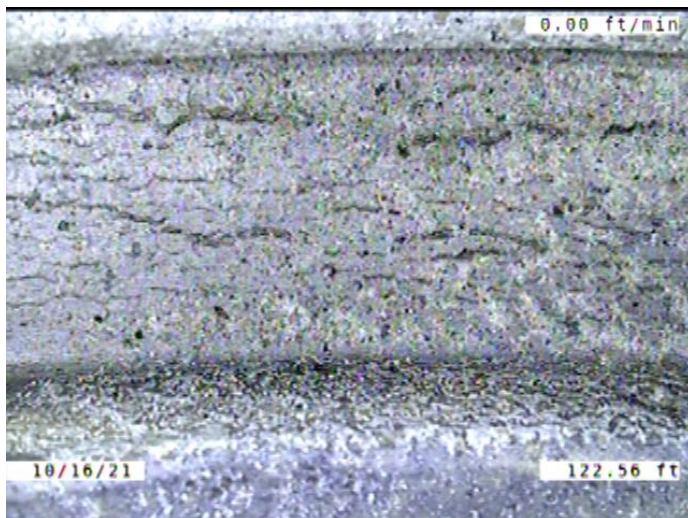
Code: **JAL**  
Description: **Joint Angular Large**

Distance (ft): **122.6**  
Structural Grade: **4**  
O&M Grade: **0**  
Clock Start/From:  
Clock To:  
1st Value:  
2nd Value:  
Value Percent:  
Continuous Index:  
Within 8" of Joint: **NO**  
Remarks:

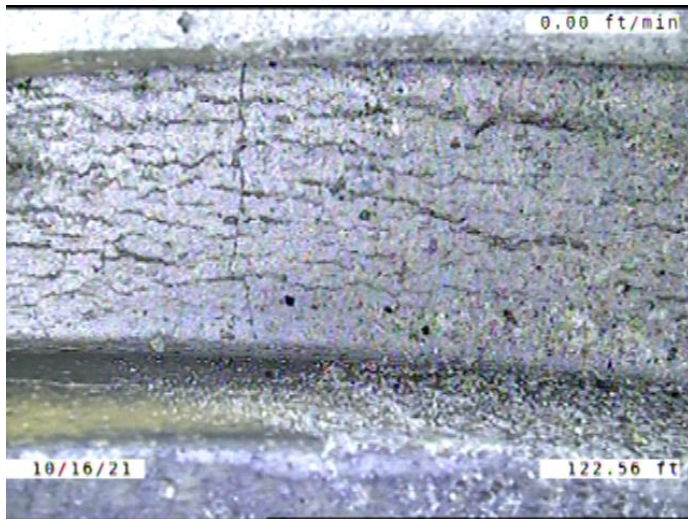
Code: **CL**  
 Description: **Crack Longitudinal**

Distance (ft): **122.6**  
 Structural Grade: **2**  
 O&M Grade: **0**  
 Clock Start/From: **9**  
 Clock To:  
 1st Value:  
 2nd Value:  
 Value Percent:  
 Continuous Index:  
 Within 8" of Joint: **YES**  
 Remarks:

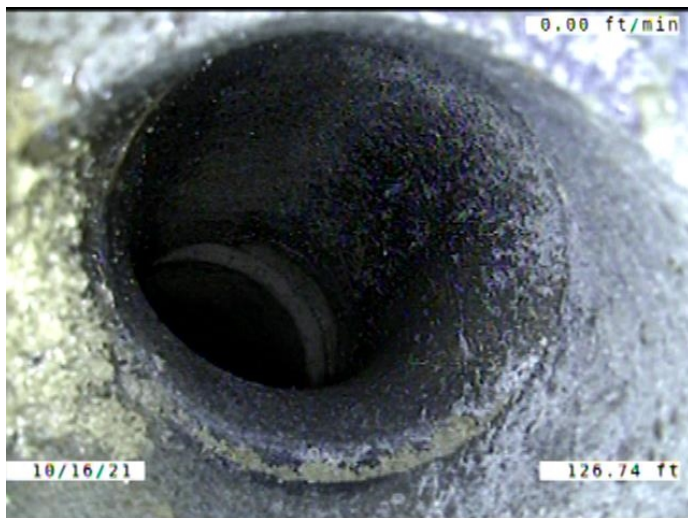
Code: **TF**  
 Description: **Tap Factory**

Distance (ft): **126.7**  
 Structural Grade: **0**  
 O&M Grade: **0**  
 Clock Start/From: **11**  
 Clock To:  
 1st Value: **4.000**  
 2nd Value:  
 Value Percent:  
 Continuous Index:  
 Within 8" of Joint: **YES**  
 Remarks:

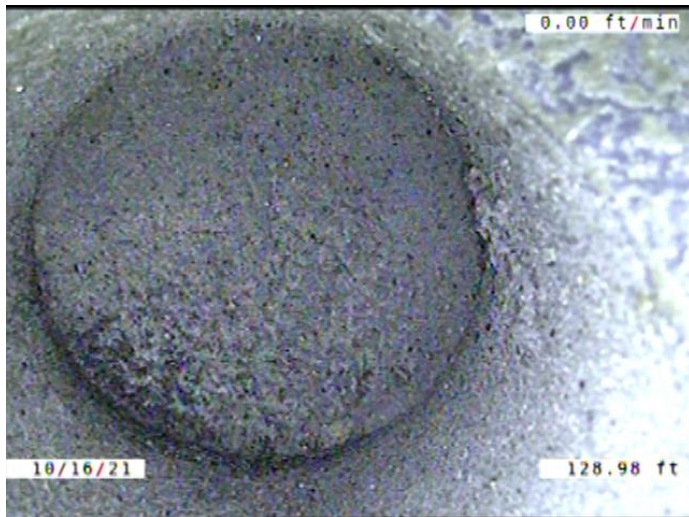
Code: **TFC**  
 Description: **Tap Factory Capped**

Distance (ft): **129.0**  
 Structural Grade: **0**  
 O&M Grade: **0**  
 Clock Start/From: **1**  
 Clock To:  
 1st Value: **4.000**  
 2nd Value:  
 Value Percent:  
 Continuous Index:  
 Within 8" of Joint: **YES**  
 Remarks:

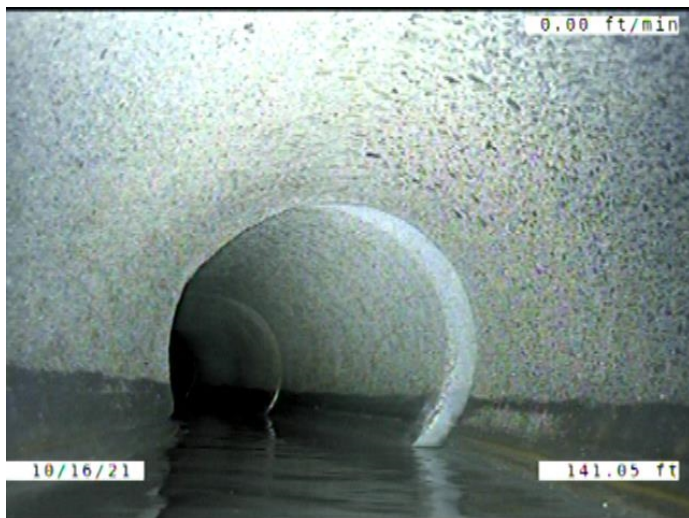
Code: **LL**  
 Description: **Line Left**

Distance (ft): **141.0**  
 Structural Grade: **0**  
 O&M Grade: **1**  
 Clock Start/From:  
 Clock To:  
 1st Value:  
 2nd Value:  
 Value Percent: **10.000**  
 Continuous Index:  
 Within 8" of Joint: **NO**  
 Remarks:

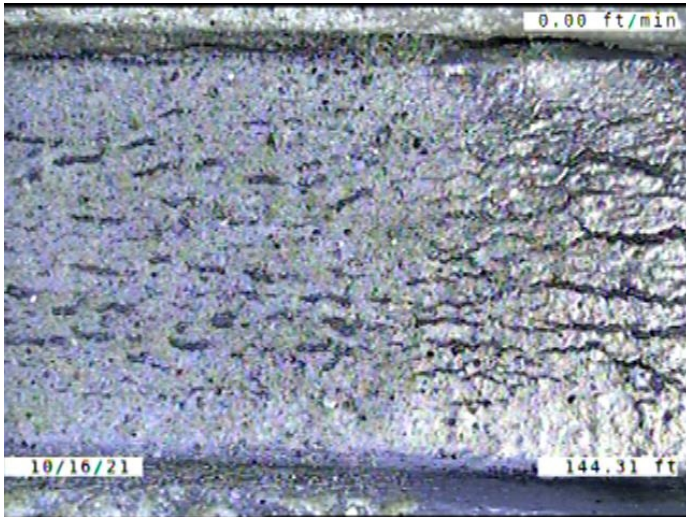
Code: **JAL**  
Description: **Joint Angular Large**

Distance (ft): **144.3**  
Structural Grade: **4**  
O&M Grade: **0**  
Clock Start/From:  
Clock To:  
1st Value:  
2nd Value:  
Value Percent:  
Continuous Index:  
Within 8" of Joint: **NO**  
Remarks:

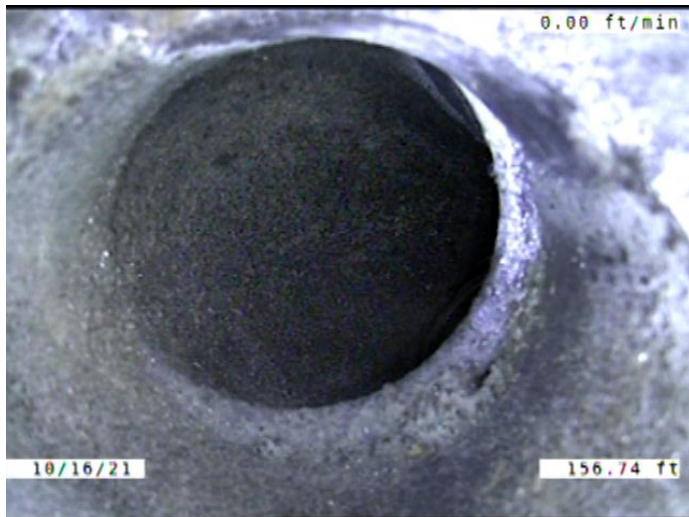
Code: **TF**  
 Description: **Tap Factory**

Distance (ft): **156.7**  
 Structural Grade: **0**  
 O&M Grade: **0**  
 Clock Start/From: **1**  
 Clock To:  
 1st Value: **4.000**  
 2nd Value:  
 Value Percent:  
 Continuous Index:  
 Within 8" of Joint: **YES**  
 Remarks:

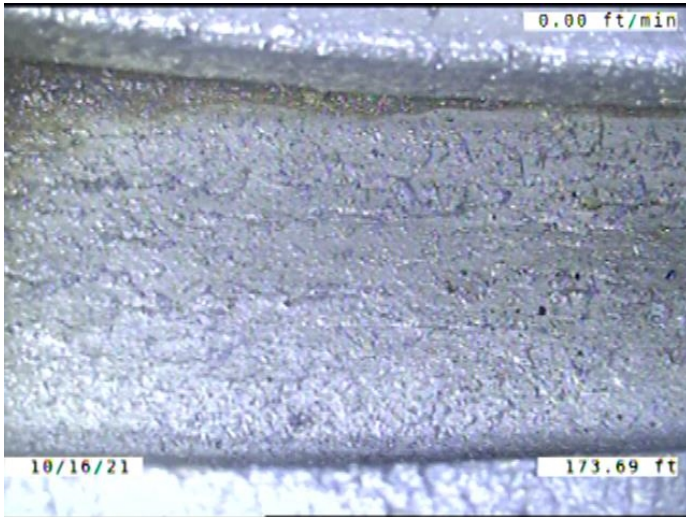
Code: **JAL**  
 Description: **Joint Angular Large**

Distance (ft): **173.7**  
 Structural Grade: **4**  
 O&M Grade: **0**  
 Clock Start/From:  
 Clock To:  
 1st Value:  
 2nd Value:  
 Value Percent:  
 Continuous Index:  
 Within 8" of Joint: **NO**  
 Remarks:

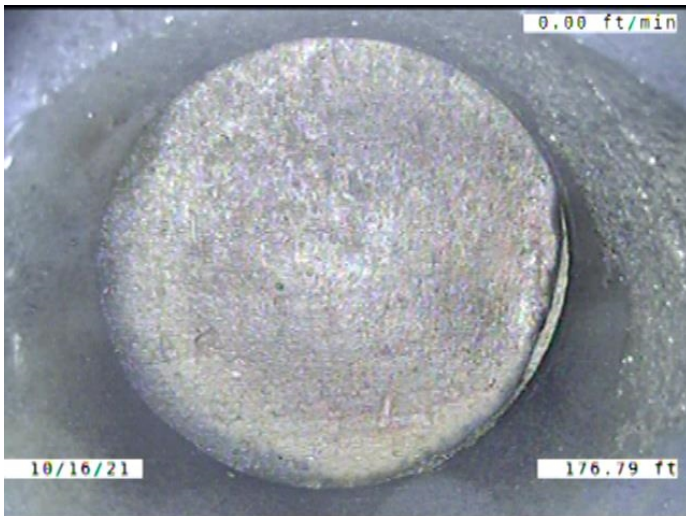
Code: **TFC**  
 Description: **Tap Factory Capped**

Distance (ft): **176.8**  
 Structural Grade: **0**  
 O&M Grade: **0**  
 Clock Start/From: **11**  
 Clock To:  
 1st Value: **4.000**  
 2nd Value:  
 Value Percent:  
 Continuous Index:  
 Within 8" of Joint: **YES**  
 Remarks:

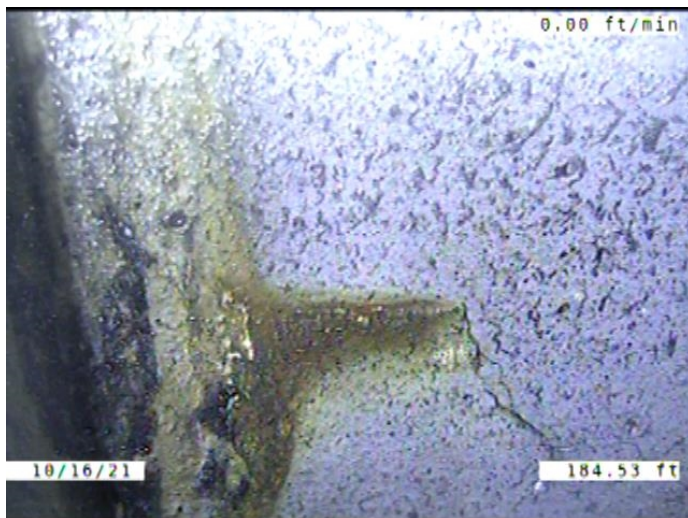
Code: **ISB**  
 Description: **Infiltration Stain Barrel**

Distance (ft): **184.5**  
 Structural Grade: **0**  
 O&M Grade: **1**  
 Clock Start/From: **8**  
 Clock To: **9**  
 1st Value:  
 2nd Value:  
 Value Percent:  
 Continuous Index:  
 Within 8" of Joint: **NO**  
 Remarks:

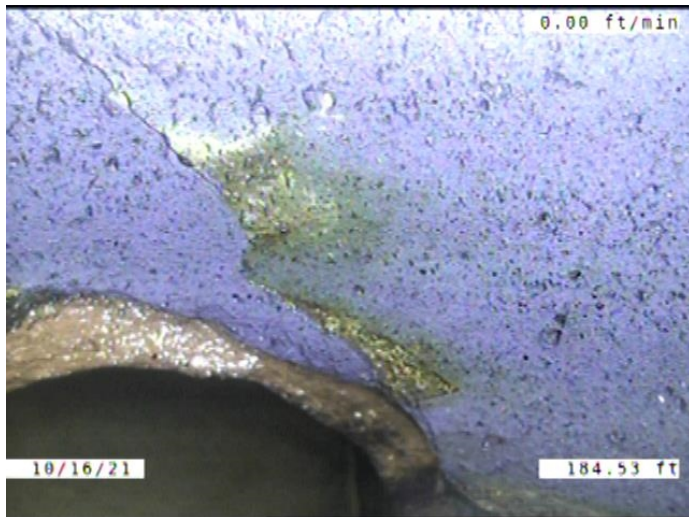
Code: **ISB**  
 Description: **Infiltration Stain Barrel**

Distance (ft): **184.5**  
 Structural Grade: **0**  
 O&M Grade: **1**  
 Clock Start/From: **2**  
 Clock To: **4**  
 1st Value:  
 2nd Value:  
 Value Percent:  
 Continuous Index:  
 Within 8" of Joint: **NO**  
 Remarks:

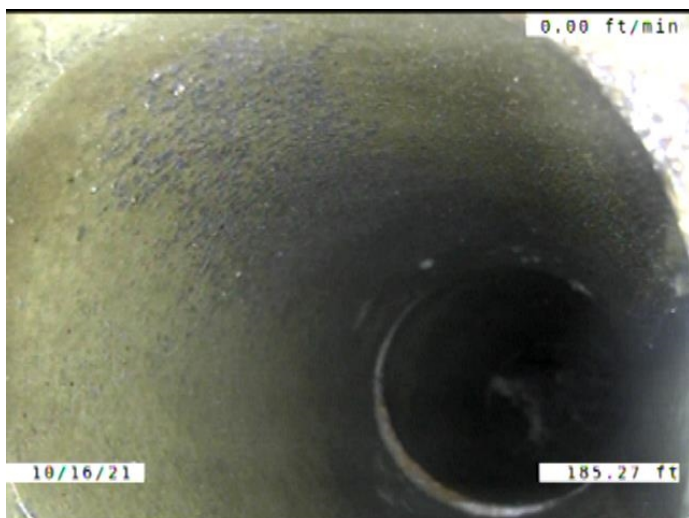
Code: **TB**  
 Description: **Tap Break-in/Hammer**

Distance (ft): **185.3**  
 Structural Grade: **0**  
 O&M Grade: **0**  
 Clock Start/From: **2**  
 Clock To:  
 1st Value: **4.000**  
 2nd Value:  
 Value Percent:  
 Continuous Index:  
 Within 8" of Joint: **YES**  
 Remarks:

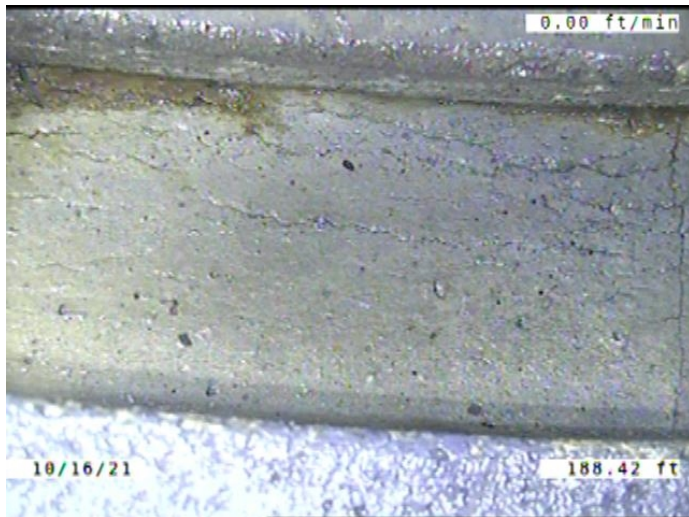
Code: **JAL**  
 Description: **Joint Angular Large**

Distance (ft): **188.4**  
 Structural Grade: **4**  
 O&M Grade: **0**  
 Clock Start/From:  
 Clock To:  
 1st Value:  
 2nd Value:  
 Value Percent:  
 Continuous Index:  
 Within 8" of Joint: **NO**  
 Remarks:

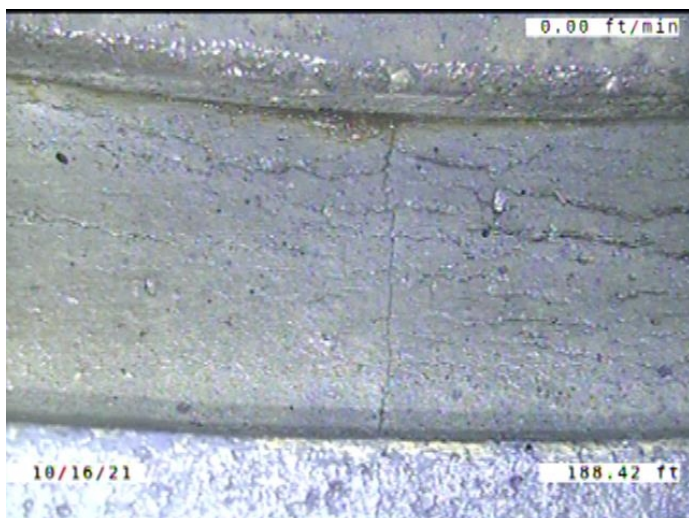
Code: **CL**  
 Description: **Crack Longitudinal**

Distance (ft): **188.4**  
 Structural Grade: **2**  
 O&M Grade: **0**  
 Clock Start/From: **10**  
 Clock To:  
 1st Value:  
 2nd Value:  
 Value Percent:  
 Continuous Index:  
 Within 8" of Joint: **YES**  
 Remarks:

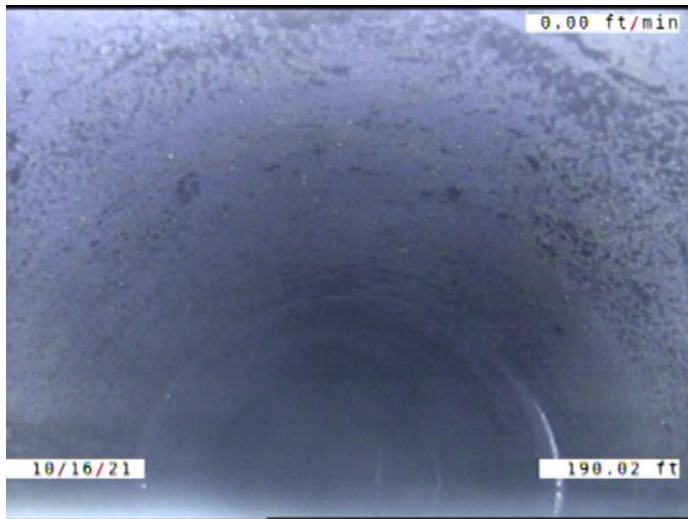
Code: **MWLS**  
Description: **Miscellaneous Water Level Sag**

Distance (ft): **190.0**  
Structural Grade: **2**  
O&M Grade: **0**  
Clock Start/From:  
Clock To:  
1st Value:  
2nd Value:  
Value Percent: **20.000**  
Continuous Index: **S08**  
Within 8" of Joint: **NO**  
Remarks:

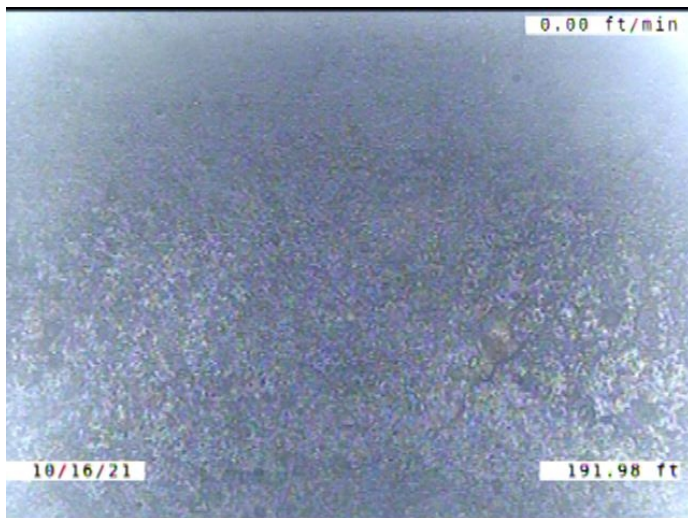
Code: **MCU**  
Description: **Miscellaneous Camera Underwater**

Distance (ft): **192.0**  
Structural Grade: **0**  
O&M Grade: **4**  
Clock Start/From:  
Clock To:  
1st Value:  
2nd Value:  
Value Percent:  
Continuous Index: **S09**  
Within 8" of Joint: **NO**  
Remarks:

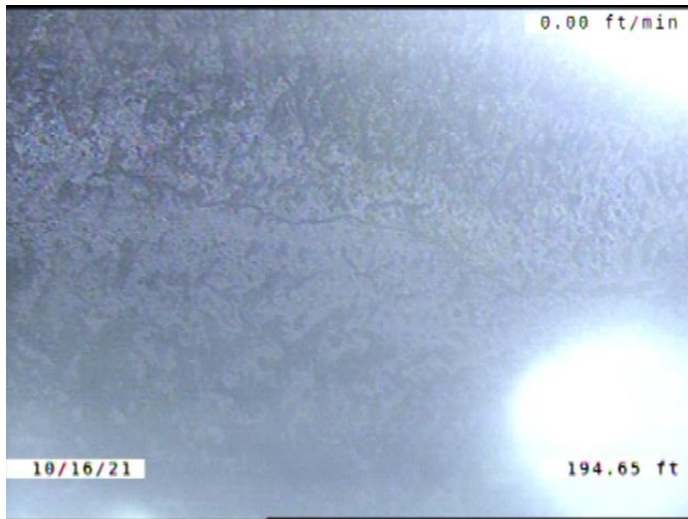
Code: **CM**  
 Description: **Crack Multiple**

Distance (ft): **194.7**  
 Structural Grade: **3**  
 O&M Grade: **0**  
 Clock Start/From: **12**  
 Clock To: **1**  
 1st Value:  
 2nd Value:  
 Value Percent:  
 Continuous Index:  
 Within 8" of Joint: **YES**  
 Remarks:

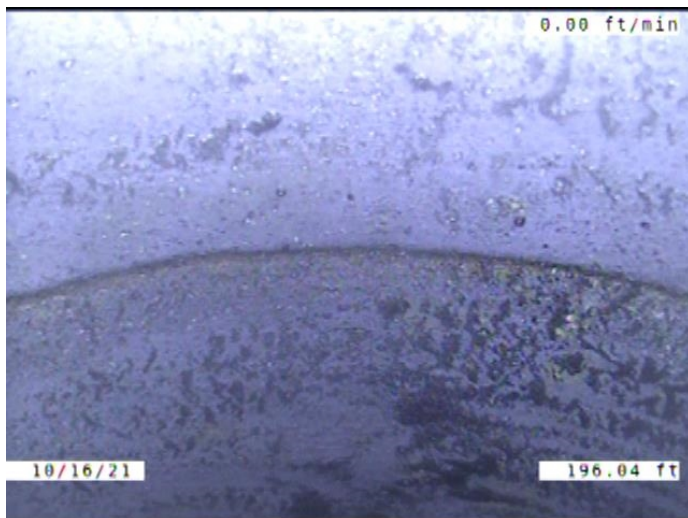
Code: **MCU**  
 Description: **Miscellaneous Camera Underwater**

Distance (ft): **196.0**  
 Structural Grade: **0**  
 O&M Grade: **4**  
 Clock Start/From:  
 Clock To:  
 1st Value:  
 2nd Value:  
 Value Percent:  
 Continuous Index: **F09**  
 Within 8" of Joint: **NO**  
 Remarks:

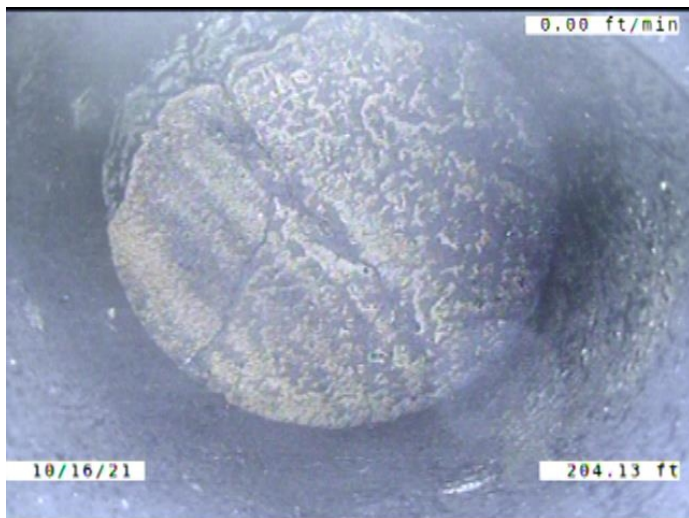
Code: **TFD**  
 Description: **Tap Factory Defective**

Distance (ft): **204.1**  
 Structural Grade: **0**  
 O&M Grade: **3**  
 Clock Start/From: **11**  
 Clock To:  
 1st Value: **4.000**  
 2nd Value:  
 Value Percent:  
 Continuous Index:  
 Within 8" of Joint: **YES**  
 Remarks: **CAP BROKEN**

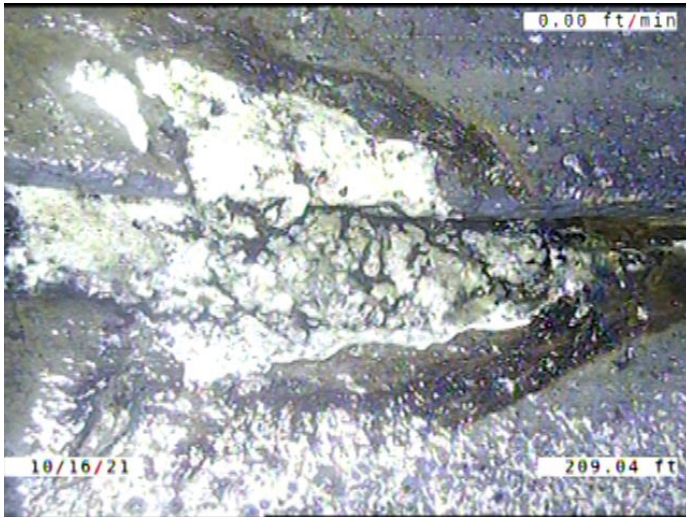
Code: **DAE**  
 Description: **Deposits Attached Encrustation**

Distance (ft): **209.0**  
 Structural Grade: **0**  
 O&M Grade: **2**  
 Clock Start/From: **3**  
 Clock To: **5**  
 1st Value:  
 2nd Value:  
 Value Percent: **5.000**  
 Continuous Index:  
 Within 8" of Joint: **YES**  
 Remarks:

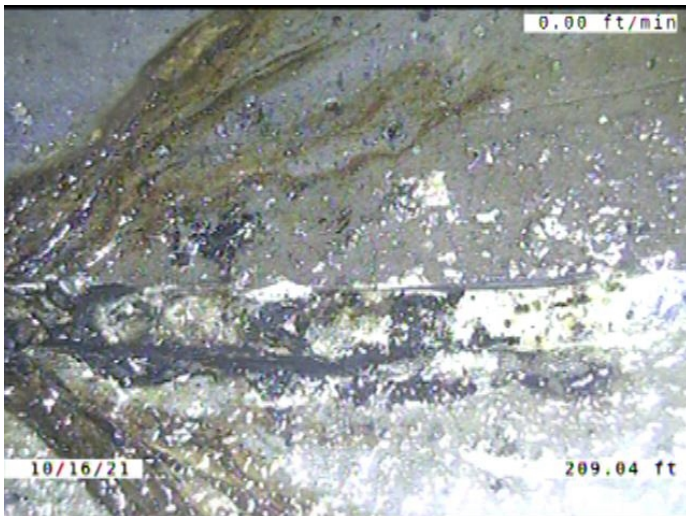
Code: **DAE**  
 Description: **Deposits Attached Encrustation**

Distance (ft): **209.0**  
 Structural Grade: **0**  
 O&M Grade: **2**  
 Clock Start/From: **7**  
 Clock To: **10**  
 1st Value:  
 2nd Value:  
 Value Percent: **5.000**  
 Continuous Index:  
 Within 8" of Joint: **YES**  
 Remarks:

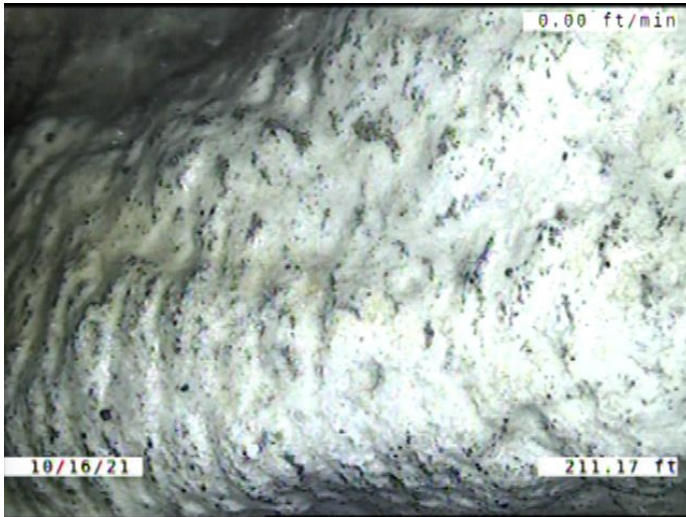
Code: **DAE**  
 Description: **Deposits Attached Encrustation**

Distance (ft): **211.2**  
 Structural Grade: **0**  
 O&M Grade: **2**  
 Clock Start/From: **7**  
 Clock To: **10**  
 1st Value:  
 2nd Value:  
 Value Percent: **10.000**  
 Continuous Index:  
 Within 8" of Joint: **YES**  
 Remarks:

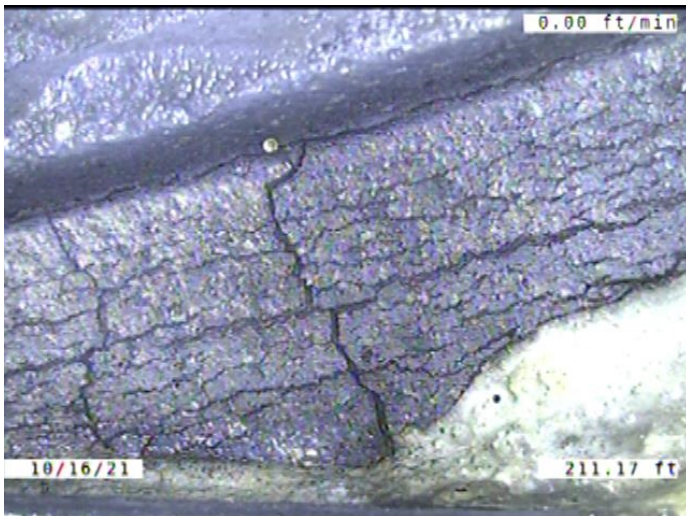
Code: **JAL**  
 Description: **Joint Angular Large**

Distance (ft): **211.2**  
 Structural Grade: **4**  
 O&M Grade: **0**  
 Clock Start/From:  
 Clock To:  
 1st Value:  
 2nd Value:  
 Value Percent:  
 Continuous Index:  
 Within 8" of Joint: **NO**  
 Remarks:

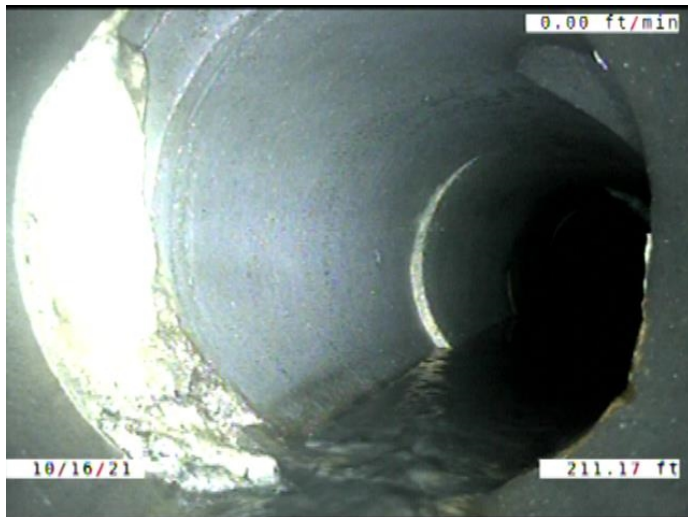
Code: **LR**  
 Description: **Line Right**

Distance (ft): **211.2**  
 Structural Grade: **0**  
 O&M Grade: **1**  
 Clock Start/From:  
 Clock To:  
 1st Value:  
 2nd Value:  
 Value Percent: **10.000**  
 Continuous Index:  
 Within 8" of Joint: **NO**  
 Remarks:

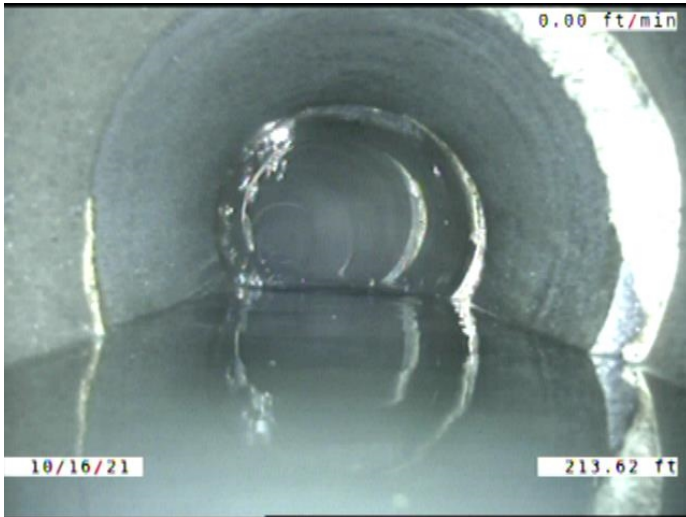
Code: **MWLS**  
 Description: **Miscellaneous Water Level Sag**

Distance (ft): **213.6**  
 Structural Grade: **2**  
 O&M Grade: **0**  
 Clock Start/From:  
 Clock To:  
 1st Value:  
 2nd Value:  
 Value Percent: **20.000**  
 Continuous Index: **F08**  
 Within 8" of Joint: **NO**  
 Remarks:

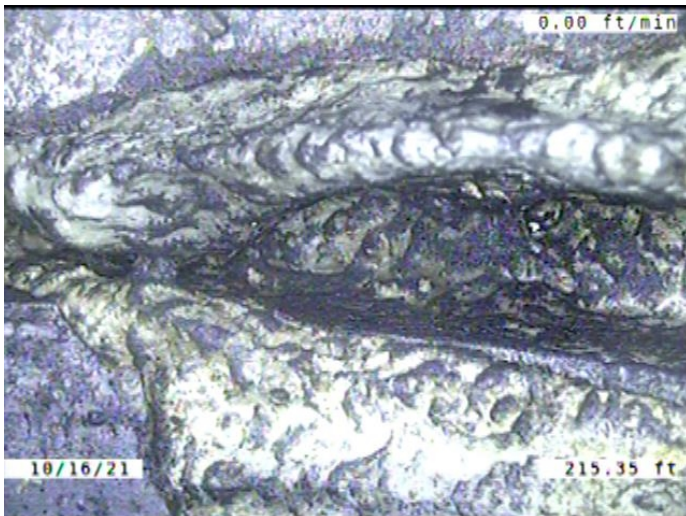
Code: **DAE**  
 Description: **Deposits Attached Encrustation**

Distance (ft): **215.4**  
 Structural Grade: **0**  
 O&M Grade: **2**  
 Clock Start/From: **8**  
 Clock To: **4**  
 1st Value:  
 2nd Value:  
 Value Percent: **5.000**  
 Continuous Index: **S10**  
 Within 8" of Joint: **YES**  
 Remarks:

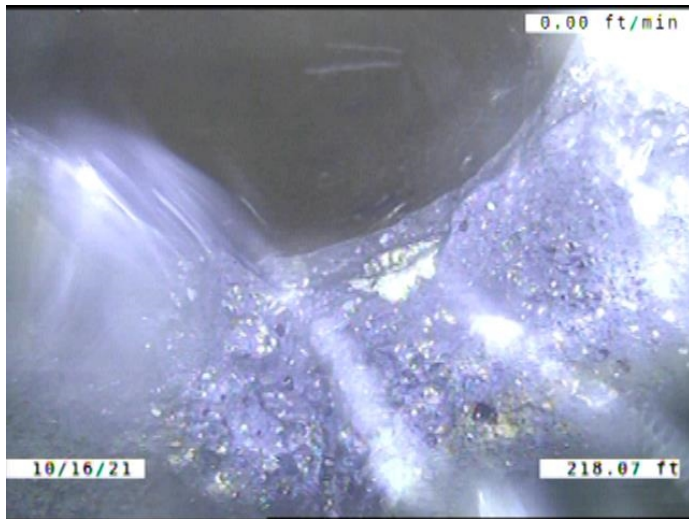
Code: **SSS**  
 Description: **Surface Damage Surface Spalling**

Distance (ft): **218.1**  
 Structural Grade: **2**  
 O&M Grade: **0**  
 Clock Start/From: **11**  
 Clock To: **1**  
 1st Value:  
 2nd Value:  
 Value Percent:  
 Continuous Index:  
 Within 8" of Joint: **YES**  
 Remarks:

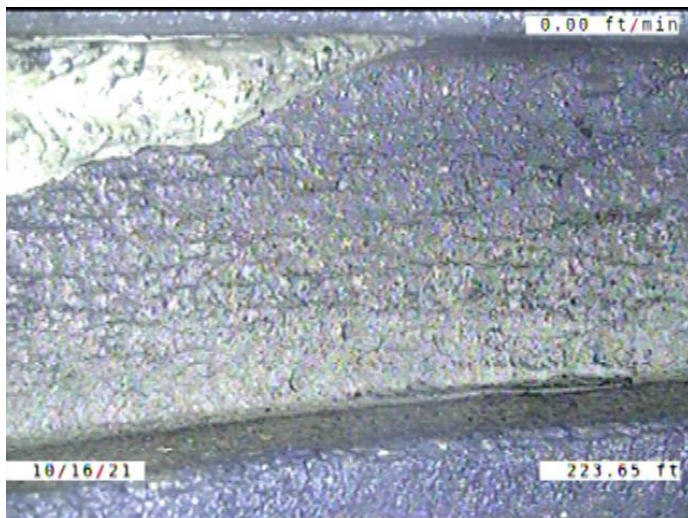
Code: **JAL**  
 Description: **Joint Angular Large**

Distance (ft): **223.6**  
 Structural Grade: **4**  
 O&M Grade: **0**  
 Clock Start/From:  
 Clock To:  
 1st Value:  
 2nd Value:  
 Value Percent:  
 Continuous Index:  
 Within 8" of Joint: **NO**  
 Remarks:

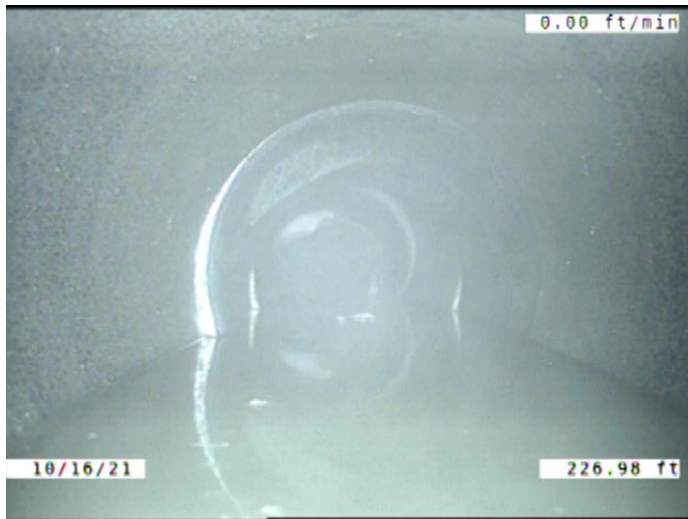
Code: **DAE**  
 Description: **Deposits Attached Encrustation**

Distance (ft): **227.0**  
 Structural Grade: **0**  
 O&M Grade: **2**  
 Clock Start/From: **8**  
 Clock To: **4**  
 1st Value:  
 2nd Value:  
 Value Percent: **5.000**  
 Continuous Index: **F10**  
 Within 8" of Joint: **YES**  
 Remarks:

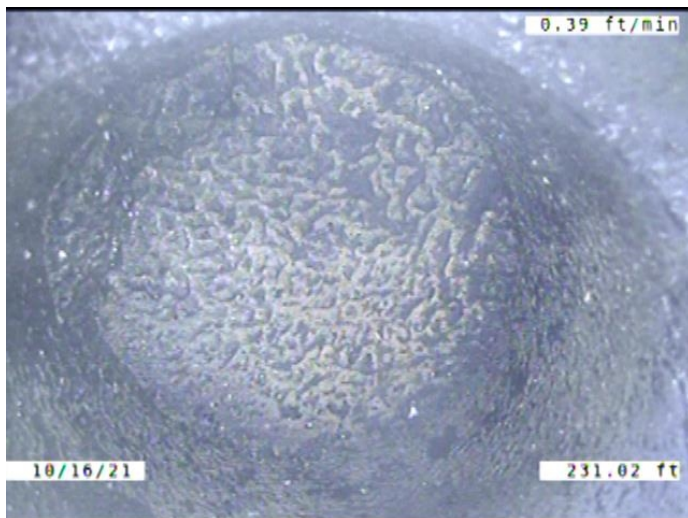
Code: **TFC**  
 Description: **Tap Factory Capped**

Distance (ft): **231.0**  
 Structural Grade: **0**  
 O&M Grade: **0**  
 Clock Start/From: **11**  
 Clock To:  
 1st Value: **4.000**  
 2nd Value:  
 Value Percent:  
 Continuous Index:  
 Within 8" of Joint: **YES**  
 Remarks:

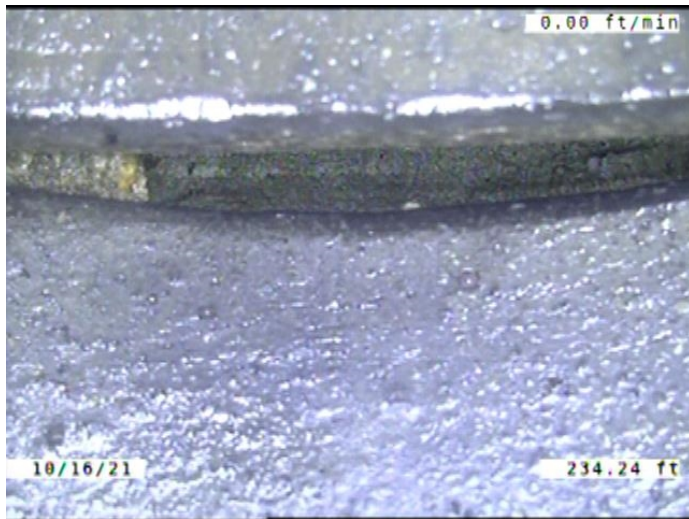
Code: **JAL**  
 Description: **Joint Angular Large**

Distance (ft): **234.2**  
 Structural Grade: **4**  
 O&M Grade: **0**  
 Clock Start/From:  
 Clock To:  
 1st Value:  
 2nd Value:  
 Value Percent:  
 Continuous Index:  
 Within 8" of Joint: **NO**  
 Remarks: **SOIL VISIBLE**

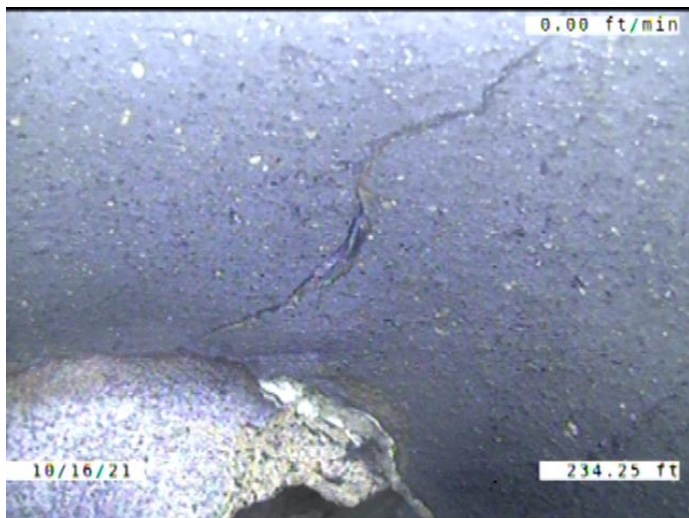
Code: **FM**  
 Description: **Fracture Multiple**

Distance (ft): **234.2**  
 Structural Grade: **4**  
 O&M Grade: **0**  
 Clock Start/From: **8**  
 Clock To: **3**  
 1st Value:  
 2nd Value:  
 Value Percent:  
 Continuous Index:  
 Within 8" of Joint: **YES**  
 Remarks:

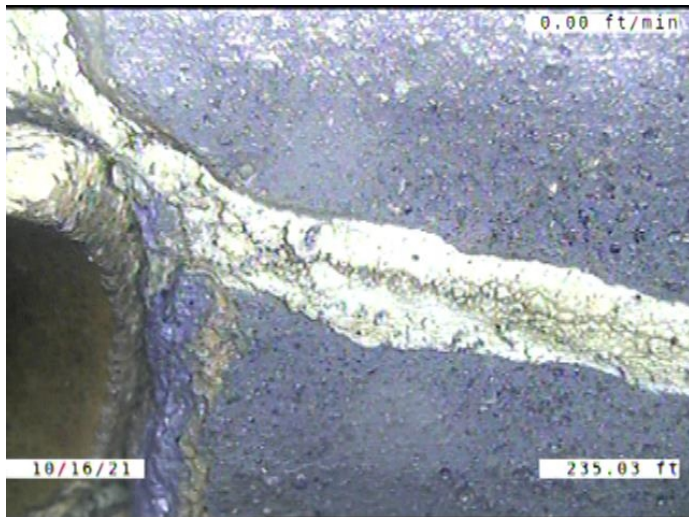
Code: **DAE**  
 Description: **Deposits Attached Encrustation**

Distance (ft): **235.0**  
 Structural Grade: **0**  
 O&M Grade: **2**  
 Clock Start/From: **9**  
 Clock To: **2**  
 1st Value:  
 2nd Value:  
 Value Percent: **5.000**  
 Continuous Index:  
 Within 8" of Joint: **NO**  
 Remarks:

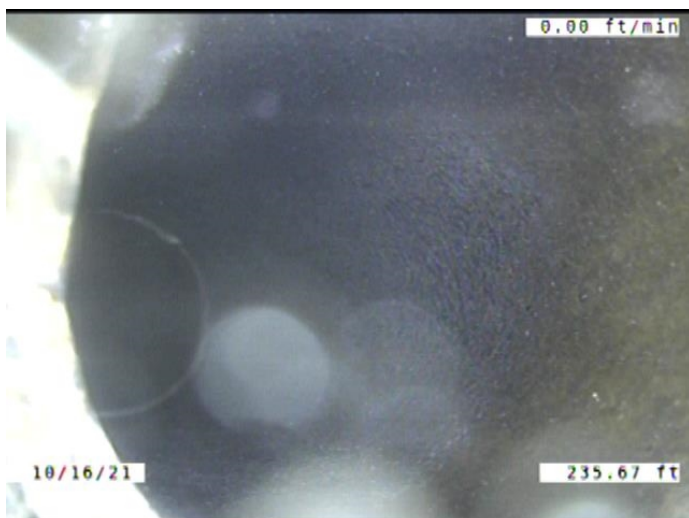
Code: **TBI**  
 Description: **Tap Break-in Intruding**

Distance (ft): **235.7**  
 Structural Grade: **0**  
 O&M Grade: **2**  
 Clock Start/From: **11**  
 Clock To:  
 1st Value: **4.000**  
 2nd Value: **1.000**  
 Value Percent:  
 Continuous Index:  
 Within 8" of Joint: **YES**  
 Remarks: **CONSTANTLY RUNNING WATER**

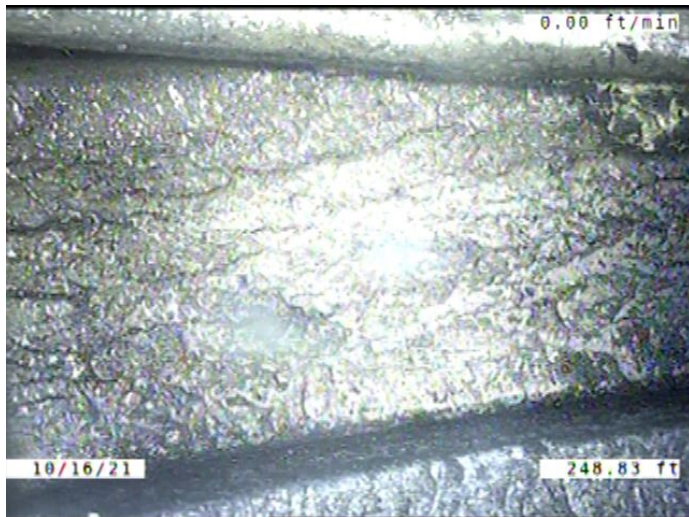
Code: **JAL**  
 Description: **Joint Angular Large**

Distance (ft): **248.8**  
 Structural Grade: **4**  
 O&M Grade: **0**  
 Clock Start/From:  
 Clock To:  
 1st Value:  
 2nd Value:  
 Value Percent:  
 Continuous Index:  
 Within 8" of Joint: **NO**  
 Remarks:

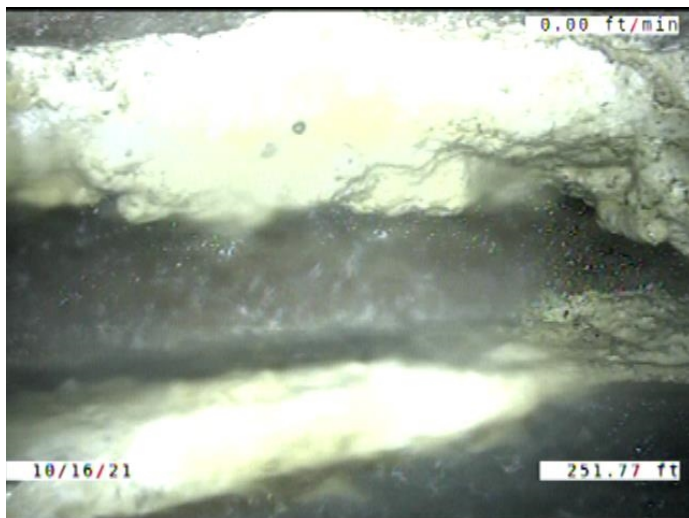
Code: **DAE**  
 Description: **Deposits Attached Encrustation**

Distance (ft): **251.8**  
 Structural Grade: **0**  
 O&M Grade: **2**  
 Clock Start/From: **8**  
 Clock To: **3**  
 1st Value:  
 2nd Value:  
 Value Percent: **5.000**  
 Continuous Index:  
 Within 8" of Joint: **YES**  
 Remarks:

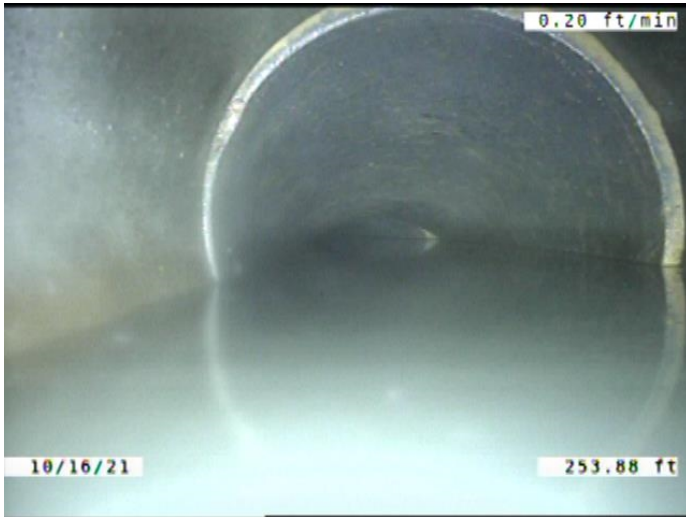
Code: **MWLS**  
 Description: **Miscellaneous Water Level Sag**

Distance (ft): **253.9**  
 Structural Grade: **5**  
 O&M Grade: **0**  
 Clock Start/From:  
 Clock To:  
 1st Value:  
 2nd Value:  
 Value Percent: **80.000**  
 Continuous Index: **S11**  
 Within 8" of Joint: **NO**  
 Remarks:
