Street:	North Michigan Avenue		Flow Control:	Not Controlled	
City:	Hobart, IN		Year Renewed:		
Location:	Local rural streets with light traffic, t		Tape/Media #:		
Purpose:	Routine Assessment		Dia/Height:	12"	
Use:	Sanitary Sewage Pipe		Material:	VCP	
Drain Area:			Lining:		
Category:	NA				
Comment:					
Location Details:			Direction of Survey:	Downstream	
US MH:	M-704-014	DS MH:	M-704-013	Total Length Surveyed (ft):	262.2

**Thursday, December 30, 2021**

**M-704-013**

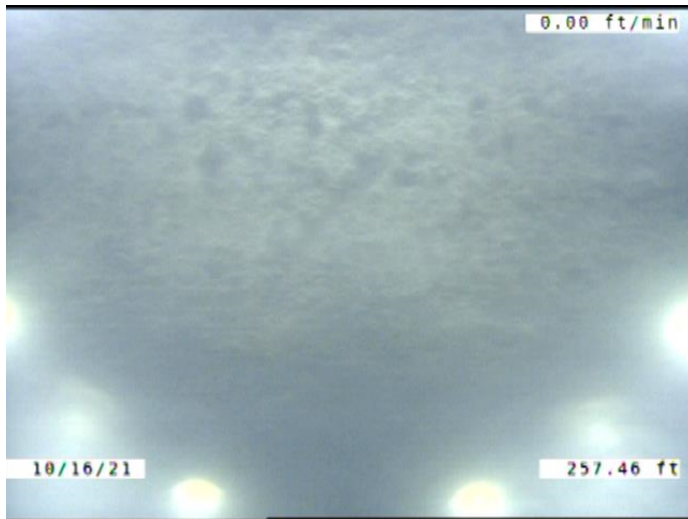
Code:	<b>MCU</b>
Description:	<b>Miscellaneous Camera Underwater</b>
Distance (ft):	<b>257.5</b>
Structural Grade:	<b>0</b>
O&M Grade:	<b>4</b>
Clock Start/From:	
Clock To:	
1st Value:	
2nd Value:	
Value Percent:	
Continuous Index:	<b>S12</b>
Within 8" of Joint:	<b>NO</b>
Remarks:

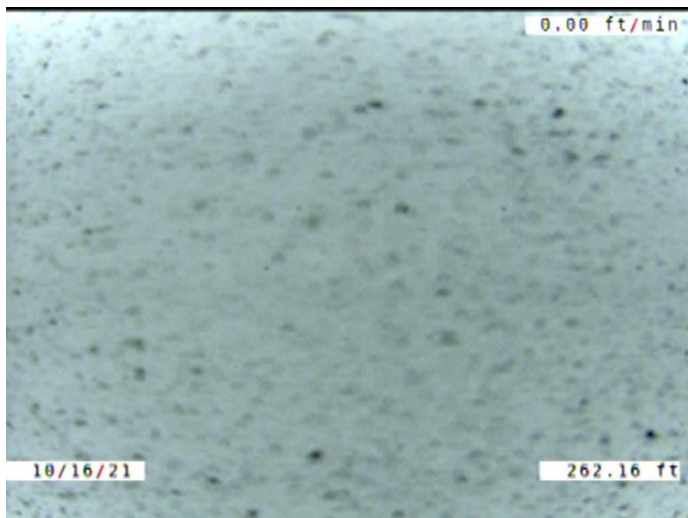
Code:	<b>DSF</b>
Description:	<b>Deposits Settled Fine</b>
Distance (ft):	<b>262.2</b>
Structural Grade:	<b>0</b>
O&M Grade:	<b>2</b>
Clock Start/From:	<b>5</b>
Clock To:	<b>7</b>
1st Value:	
2nd Value:	
Value Percent:	<b>5.000</b>
Continuous Index:	<b>F02</b>
Within 8" of Joint:	<b>YES</b>
Remarks:

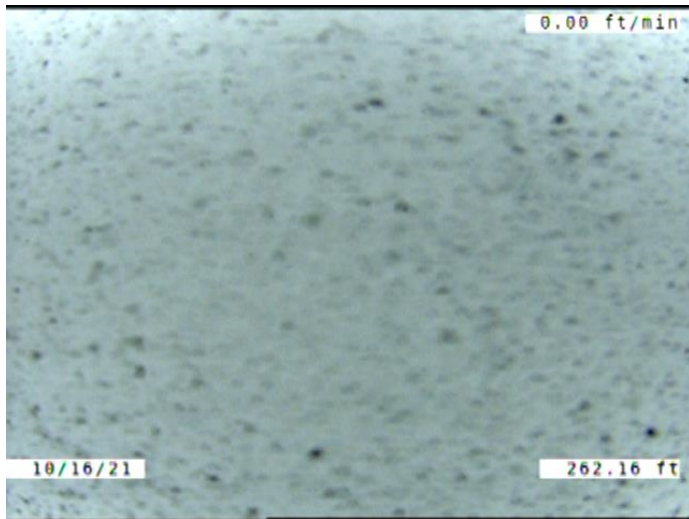
Code: **JAM**  
Description: **Joint Angular Medium**

Distance (ft): **262.2**  
Structural Grade: **3**  
O&M Grade: **0**  
Clock Start/From:  
Clock To:  
1st Value:  
2nd Value:  
Value Percent:  
Continuous Index: **F05**  
Within 8" of Joint: **NO**  
Remarks:

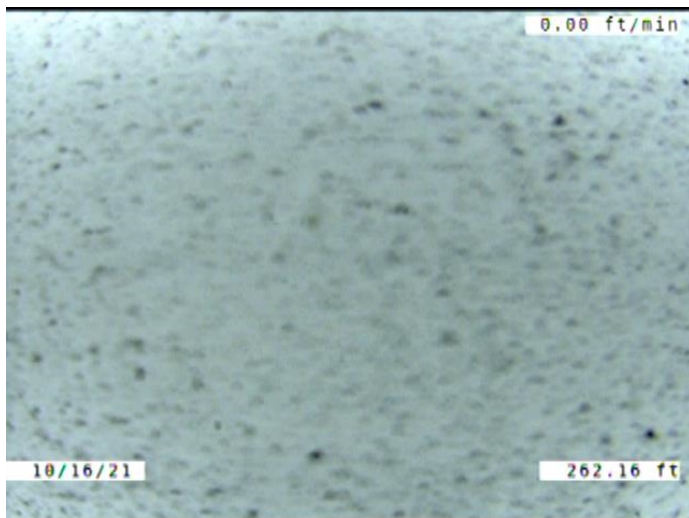
Code: **MWLS**  
Description: **Miscellaneous Water Level Sag**

Distance (ft): **262.2**  
Structural Grade: **5**  
O&M Grade: **0**  
Clock Start/From:  
Clock To:  
1st Value:  
2nd Value:  
Value Percent: **80.000**  
Continuous Index: **F11**  
Within 8" of Joint: **NO**  
Remarks:

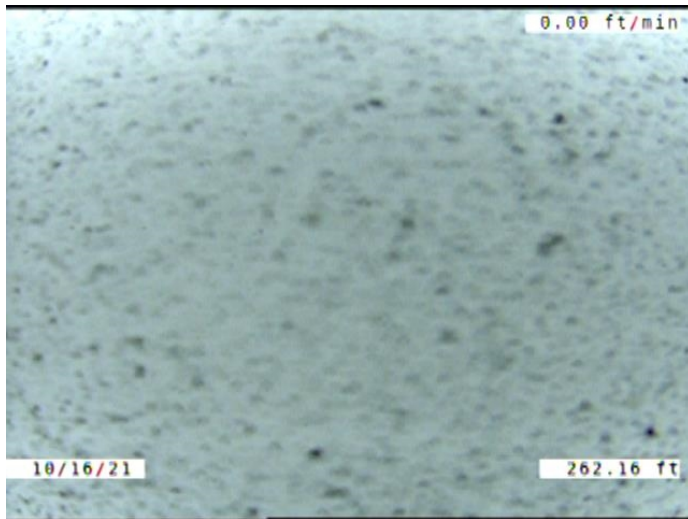
Code: **MCU**  
Description: **Miscellaneous Camera Underwater**

Distance (ft): **262.2**  
Structural Grade: **0**  
O&M Grade: **4**  
Clock Start/From:  
Clock To:  
1st Value:  
2nd Value:  
Value Percent:  
Continuous Index: **F12**  
Within 8" of Joint: **NO**  
Remarks:

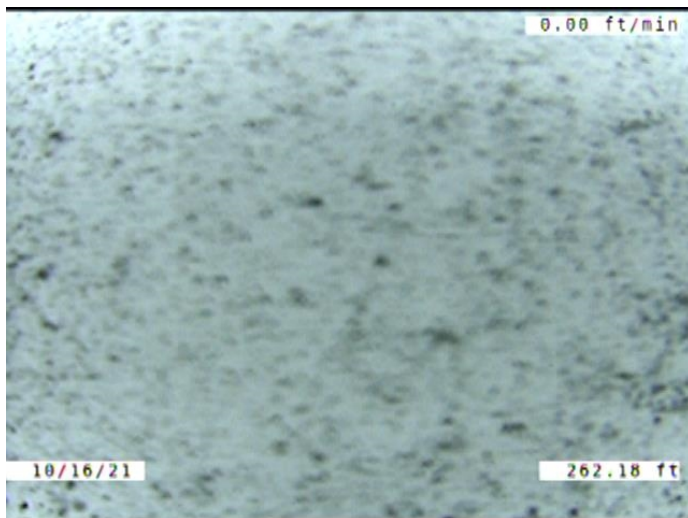
Code: **MSA**  
Description: **Miscellaneous Survey Abandoned**

Distance (ft): **262.2**  
Structural Grade: **0**  
O&M Grade: **0**  
Clock Start/From:  
Clock To:  
1st Value:  
2nd Value:  
Value Percent:  
Continuous Index:  
Within 8" of Joint: **NO**  
Remarks: **CAMERA CANT SEE ANYMORE.  
WATER NOT CLEAR ENOUGH TO CO**
