Profile/Photo Observation Report

Date:	10/10/2021	Weather:		Coding:	PACP 7.0
Pipe Length (ft):	393.6	Owner:	City of Hobart	Pre Clean:	Heavy Cleaning
P.O.#:	YES502259	Surveyor:	S. Bucklin	PSR:	P-704-015-014
Customer:	City of Hobart	Clean Date:	10/09/2021	Shape:	C

Street:	East Home Avenue	Flow Control:	Not Controlled
City:	Hobart, IN	Year Renewed:	
Location:	Local rural streets with light traffic, t	Tape/Media #:	
Purpose:	Routine Assessment	Dia/Height:	12"
Use:	Sanitary Sewage Pipe	Material:	VCP
Drain Area:		Lining:	
Category:	NA		
Comment:			
Location Details:		Direction of Survey:	Upstream
US MH:	M-704-014	DS MH:	M-704-015
		Total Length Surveyed (ft):	393.6

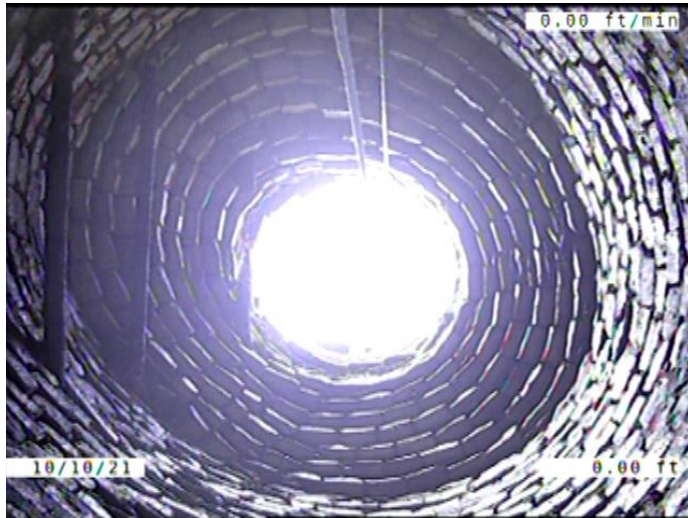
Code: **AMH**
Description: **Manhole**

Distance (ft): **.0**
Structural Grade: **0**
O&M Grade: **0**
Clock Start/From:
Clock To:
1st Value:
2nd Value:
Value Percent:
Continuous Index:
Within 8" of Joint: **NO**
Remarks: **M-704-015**

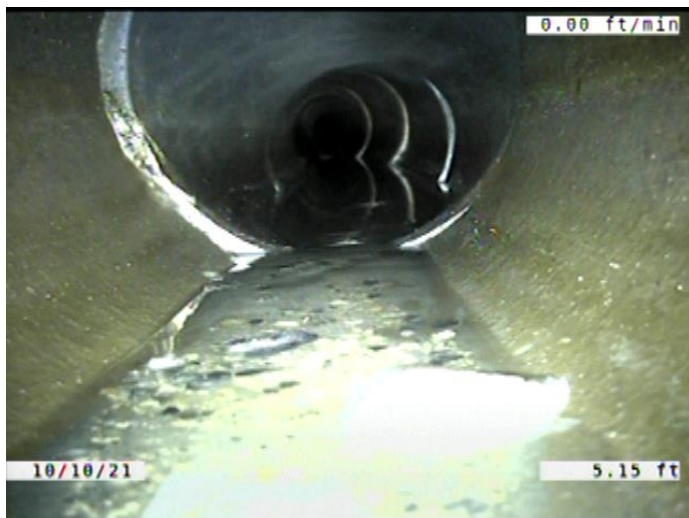
Code: **DSF**
Description: **Deposits Settled Fine**

Distance (ft): **5.2**
Structural Grade: **0**
O&M Grade: **2**
Clock Start/From: **5**
Clock To: **7**
1st Value:
2nd Value:
Value Percent: **5.000**
Continuous Index: **S01**
Within 8" of Joint: **YES**
Remarks:

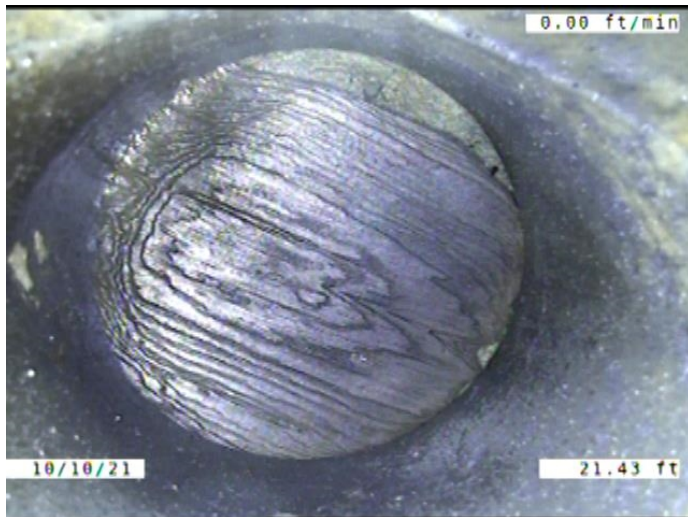
Code:	TFC
Description:	Tap Factory Capped
Distance (ft):	21.4
Structural Grade:	0
O&M Grade:	0
Clock Start/From:	11
Clock To:	
1st Value:	4.000
2nd Value:	
Value Percent:	
Continuous Index:	
Within 8" of Joint:	YES
Remarks:	CAP LOOKS TO BE WOOD AND ROTTING AWAY

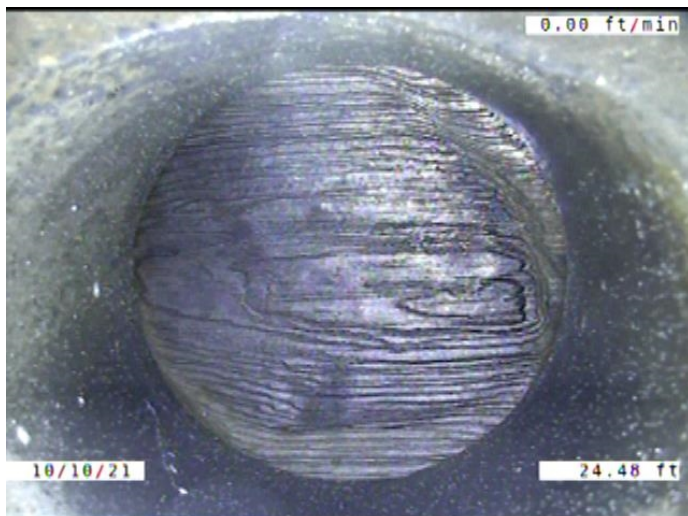
Code:	TFC
Description:	Tap Factory Capped
Distance (ft):	24.5
Structural Grade:	0
O&M Grade:	0
Clock Start/From:	1
Clock To:	
1st Value:	4.000
2nd Value:	
Value Percent:	
Continuous Index:	
Within 8" of Joint:	YES
Remarks:

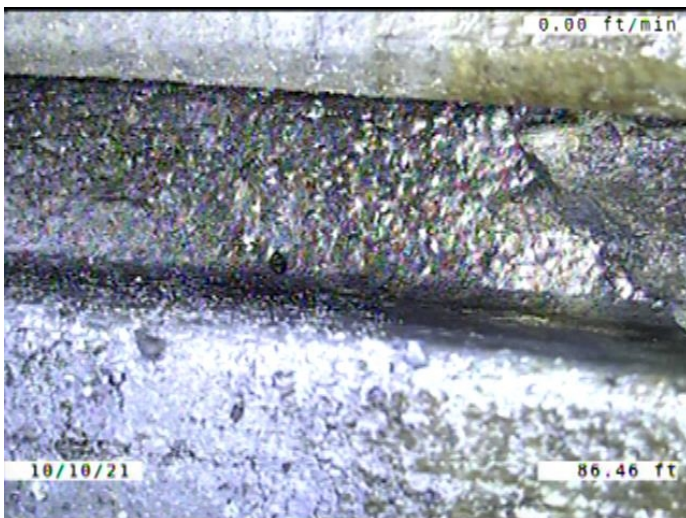
Code: **JAM**
Description: **Joint Angular Medium**

Distance (ft): **86.5**
Structural Grade: **3**
O&M Grade: **0**
Clock Start/From:
Clock To:
1st Value:
2nd Value:
Value Percent:
Continuous Index:
Within 8" of Joint: **NO**
Remarks:

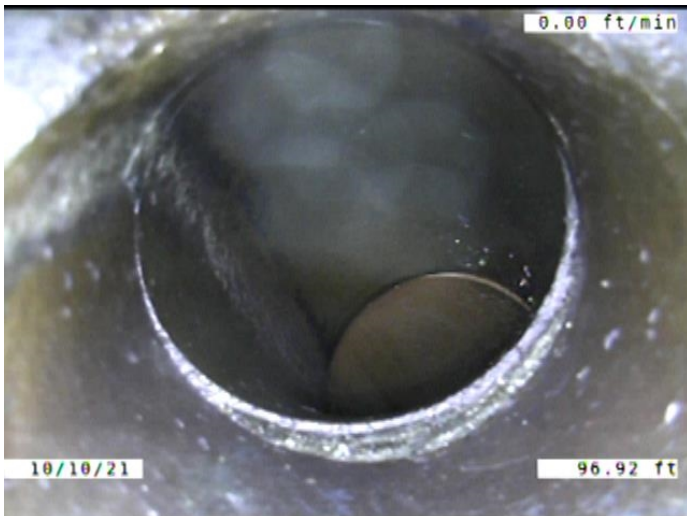
Code: **TF**
Description: **Tap Factory**

Distance (ft): **96.9**
Structural Grade: **0**
O&M Grade: **0**
Clock Start/From: **10**
Clock To:
1st Value: **4.000**
2nd Value:
Value Percent:
Continuous Index:
Within 8" of Joint: **YES**
Remarks:

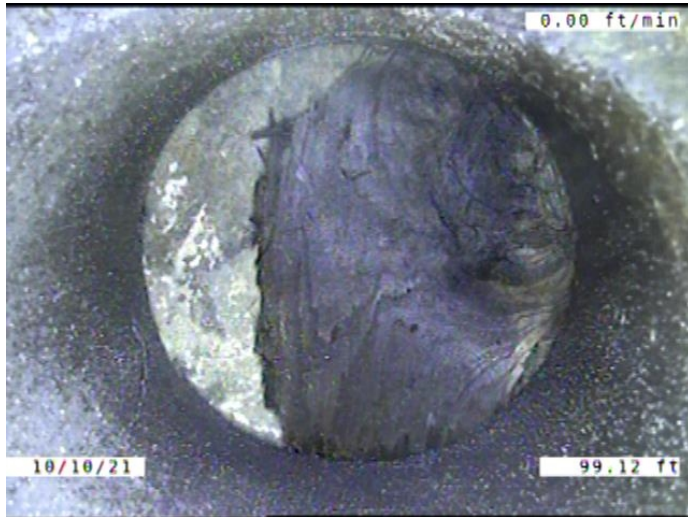
Code: **TFC**
 Description: **Tap Factory Capped**

Distance (ft): **99.1**
 Structural Grade: **0**
 O&M Grade: **0**
 Clock Start/From: **1**
 Clock To:
 1st Value: **4.000**

2nd Value:
 Value Percent:
 Continuous Index:
 Within 8" of Joint:

YES
CAP LOOKS TO BE WOOD AND
ROTTING AWAY

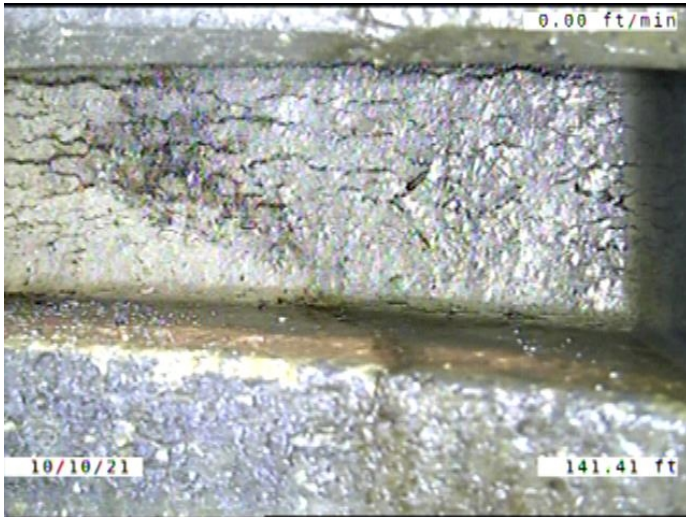
Code: **JAM**
 Description: **Joint Angular Medium**

Distance (ft): **141.4**
 Structural Grade: **3**
 O&M Grade: **0**
 Clock Start/From:
 Clock To:
 1st Value:
 2nd Value:
 Value Percent:
 Continuous Index:
 Within 8" of Joint: **NO**
 Remarks:

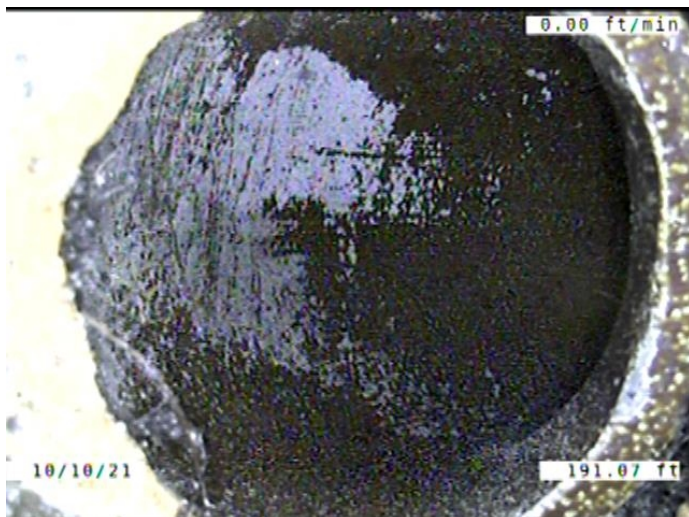
Code: **TB**
Description: **Tap Break-in/Hammer**

Distance (ft): **191.1**
Structural Grade: **0**
O&M Grade: **0**
Clock Start/From: **12**
Clock To:
1st Value: **4.000**
2nd Value:
Value Percent:
Continuous Index:
Within 8" of Joint: **YES**
Remarks:

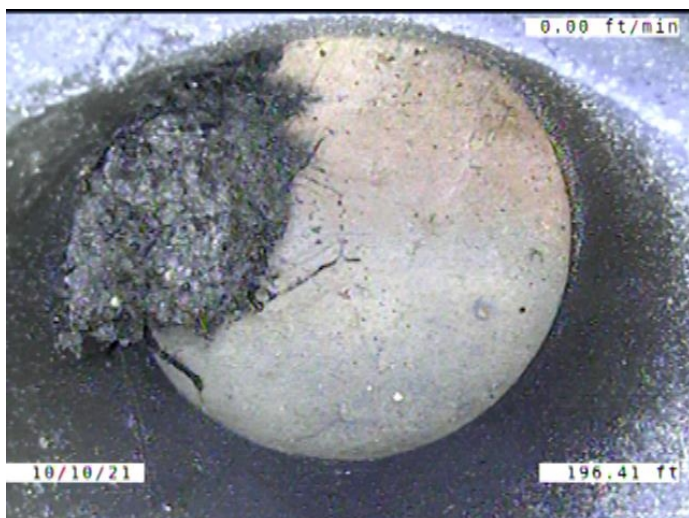
Code: **TFC**
Description: **Tap Factory Capped**

Distance (ft): **196.4**
Structural Grade: **0**
O&M Grade: **0**
Clock Start/From: **11**
Clock To:
1st Value: **4.000**
2nd Value:
Value Percent:
Continuous Index:
Within 8" of Joint: **YES**
Remarks: **ROOTS GROWING AROUND THE CAP**

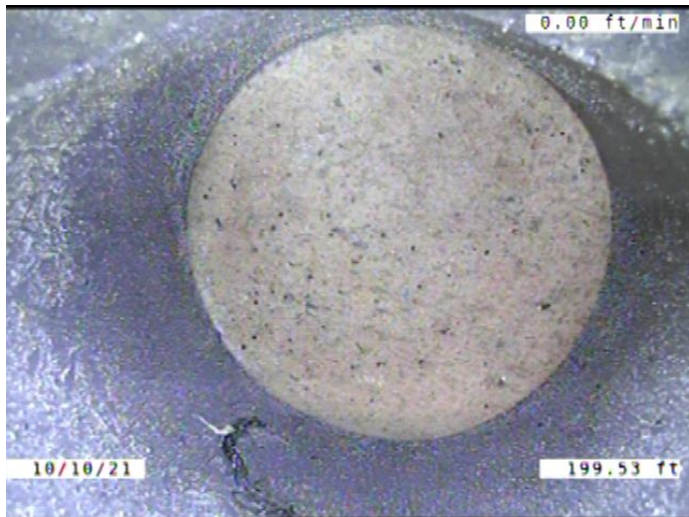
Code: **TFC**
 Description: **Tap Factory Capped**

Distance (ft): **199.5**
 Structural Grade: **0**
 O&M Grade: **0**
 Clock Start/From: **1**
 Clock To:
 1st Value: **4.000**
 2nd Value:
 Value Percent:
 Continuous Index:
 Within 8" of Joint: **YES**
 Remarks:

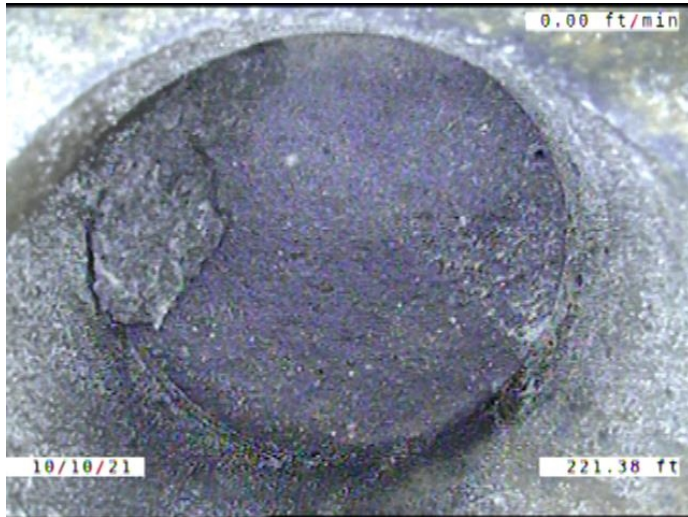
Code: **TFC**
Description: **Tap Factory Capped**

Distance (ft): **221.4**
Structural Grade: **0**
O&M Grade: **0**
Clock Start/From: **11**
Clock To:
1st Value: **4.000**
2nd Value:
Value Percent:
Continuous Index:
Within 8" of Joint: **YES**
Remarks:

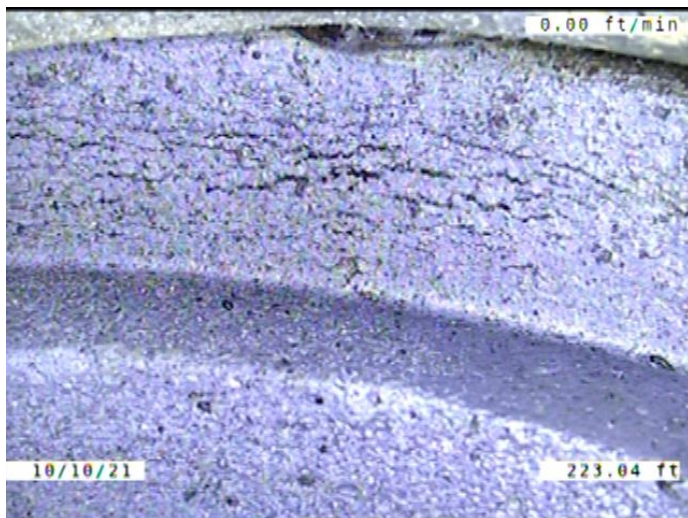
Code: **JAL**
Description: **Joint Angular Large**

Distance (ft): **223.0**
Structural Grade: **4**
O&M Grade: **0**
Clock Start/From:
Clock To:
1st Value:
2nd Value:
Value Percent:
Continuous Index:
Within 8" of Joint: **NO**
Remarks:

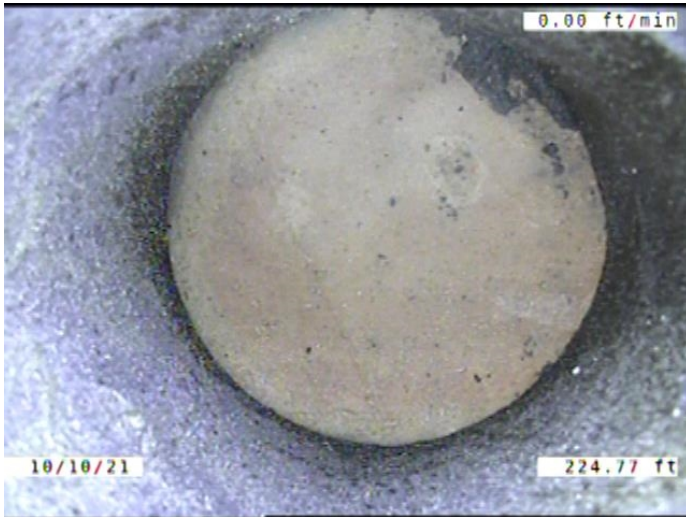
Code: **TFC**
Description: **Tap Factory Capped**

Distance (ft): **224.8**
Structural Grade: **0**
O&M Grade: **0**
Clock Start/From: **2**
Clock To:
1st Value: **4.000**
2nd Value:
Value Percent:
Continuous Index:
Within 8" of Joint: **YES**
Remarks:

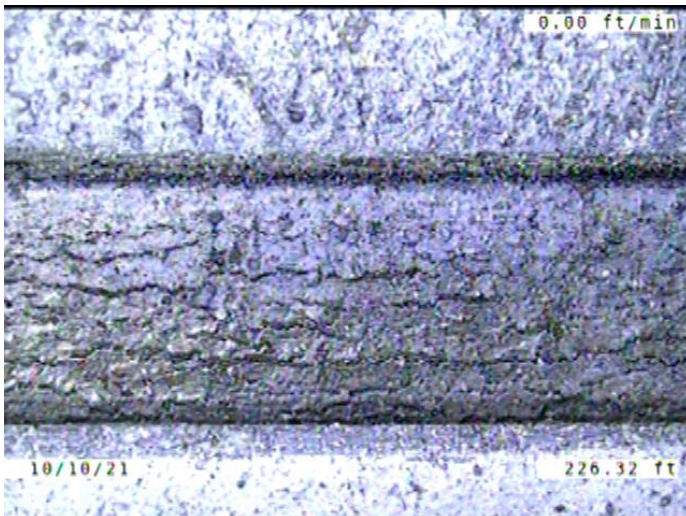
Code: **JAM**
Description: **Joint Angular Medium**

Distance (ft): **226.3**
Structural Grade: **3**
O&M Grade: **0**
Clock Start/From:
Clock To:
1st Value:
2nd Value:
Value Percent:
Continuous Index:
Within 8" of Joint: **NO**
Remarks:

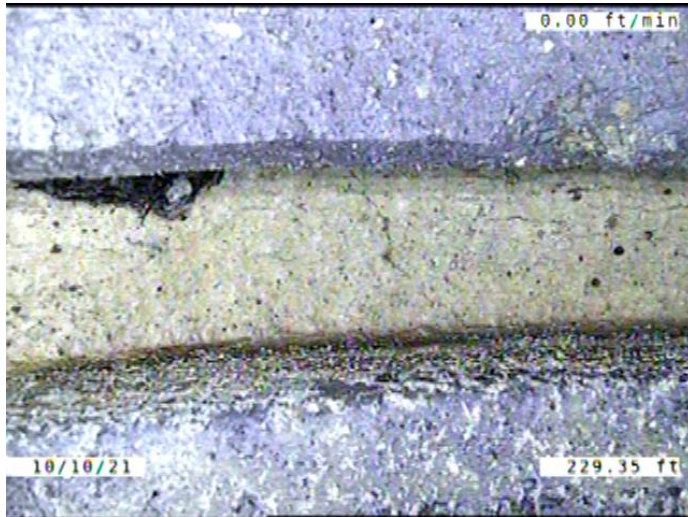
Code: **JAM**
 Description: **Joint Angular Medium**

Distance (ft): **229.3**
 Structural Grade: **3**
 O&M Grade: **0**
 Clock Start/From:
 Clock To:
 1st Value:
 2nd Value:
 Value Percent:
 Continuous Index:
 Within 8" of Joint: **NO**
 Remarks:

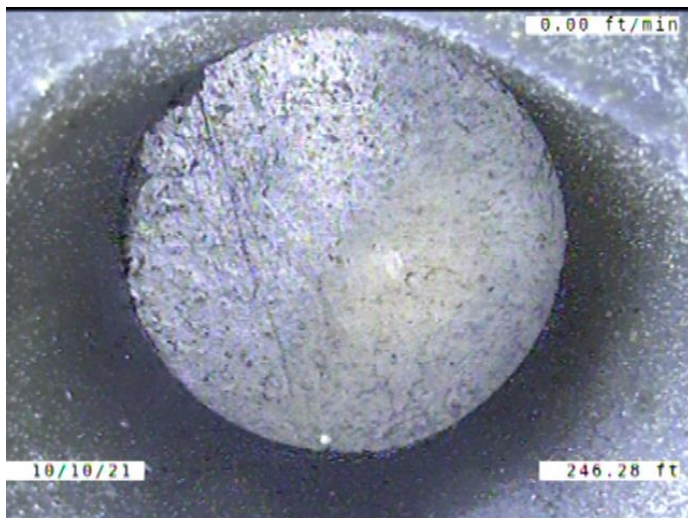
Code: **TFC**
 Description: **Tap Factory Capped**

Distance (ft): **246.3**
 Structural Grade: **0**
 O&M Grade: **0**
 Clock Start/From: **11**
 Clock To:
 1st Value: **4.000**
 2nd Value:
 Value Percent:
 Continuous Index:
 Within 8" of Joint: **YES**
 Remarks:

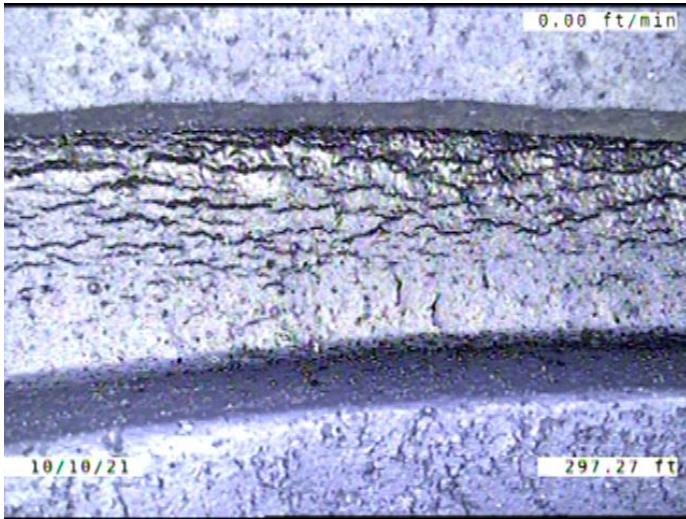
Code: **JAM**
 Description: **Joint Angular Medium**

Distance (ft): **297.3**
 Structural Grade: **3**
 O&M Grade: **0**
 Clock Start/From:
 Clock To:
 1st Value:
 2nd Value:
 Value Percent:
 Continuous Index:
 Within 8" of Joint: **NO**
 Remarks:

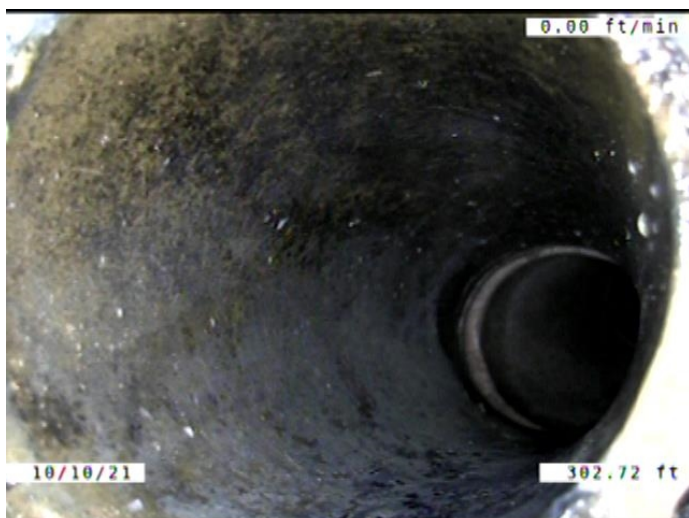
Code: **B**
 Description: **Broken**

Distance (ft): **302.6**
 Structural Grade: **4**
 O&M Grade: **0**
 Clock Start/From: **10**
 Clock To: **2**
 1st Value:
 2nd Value:
 Value Percent:
 Continuous Index:
 Within 8" of Joint: **YES**
 Remarks:

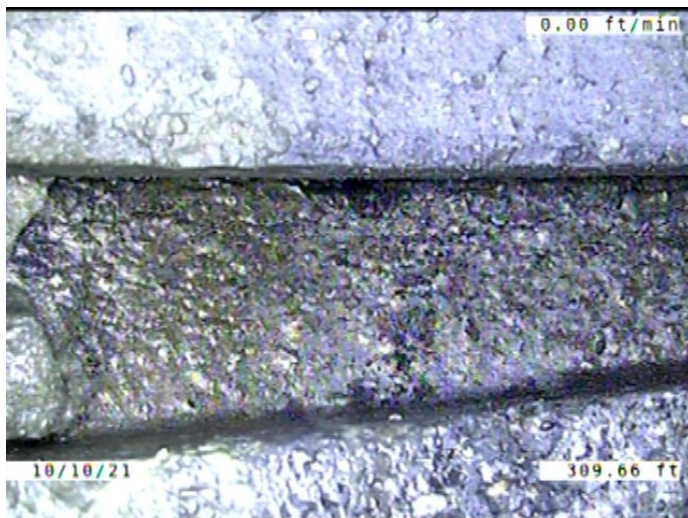
Code: **JAM**
Description: **Joint Angular Medium**

Distance (ft): **309.7**
Structural Grade: **3**
O&M Grade: **0**
Clock Start/From:
Clock To:
1st Value:
2nd Value:
Value Percent:
Continuous Index:
Within 8" of Joint: **NO**
Remarks:

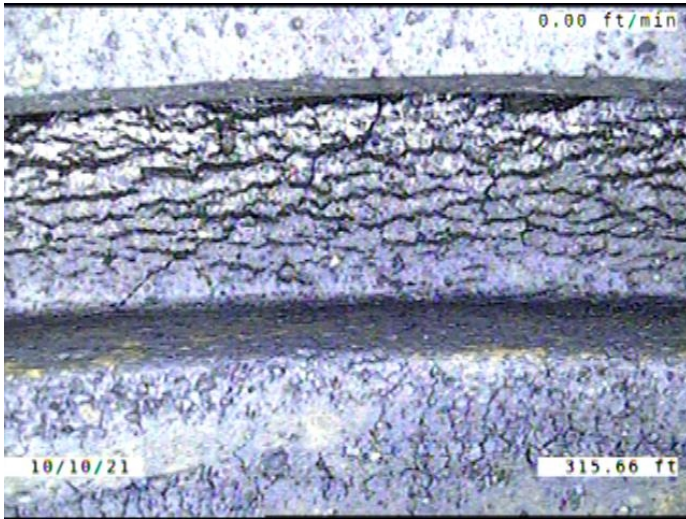
Code: **JAM**
Description: **Joint Angular Medium**

Distance (ft): **315.7**
Structural Grade: **3**
O&M Grade: **0**
Clock Start/From:
Clock To:
1st Value:
2nd Value:
Value Percent:
Continuous Index:
Within 8" of Joint: **NO**
Remarks:

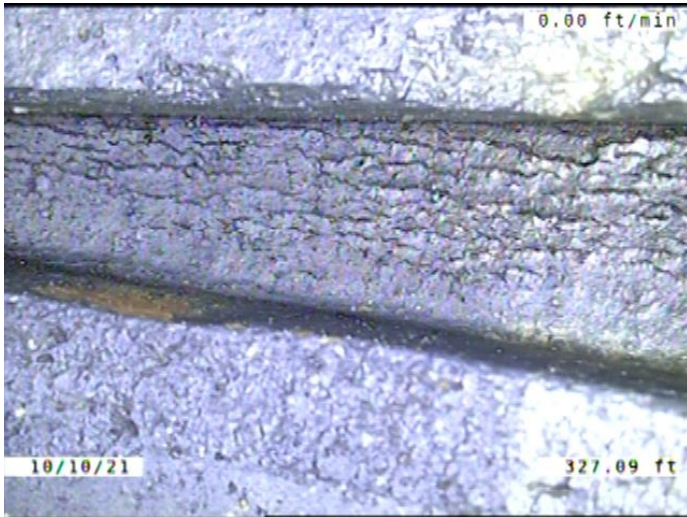
Code: **JAM**
Description: **Joint Angular Medium**

Distance (ft): **327.1**
Structural Grade: **3**
O&M Grade: **0**
Clock Start/From:
Clock To:
1st Value:
2nd Value:
Value Percent:
Continuous Index:
Within 8" of Joint: **NO**
Remarks:

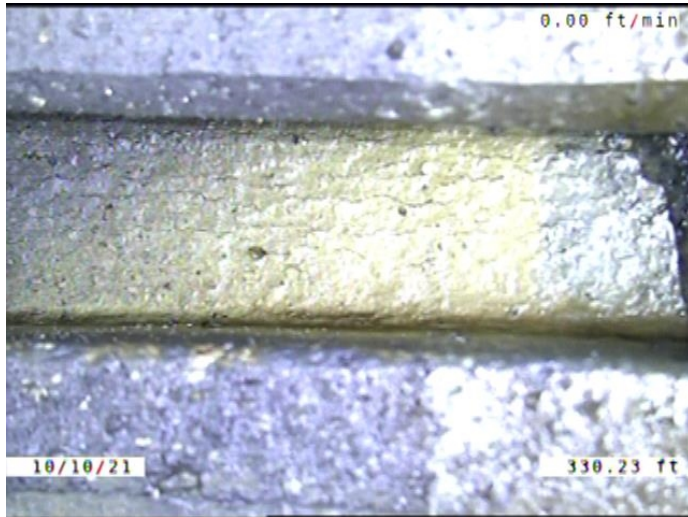
Code: **JAM**
Description: **Joint Angular Medium**

Distance (ft): **330.2**
Structural Grade: **3**
O&M Grade: **0**
Clock Start/From:
Clock To:
1st Value:
2nd Value:
Value Percent:
Continuous Index:
Within 8" of Joint: **NO**
Remarks:

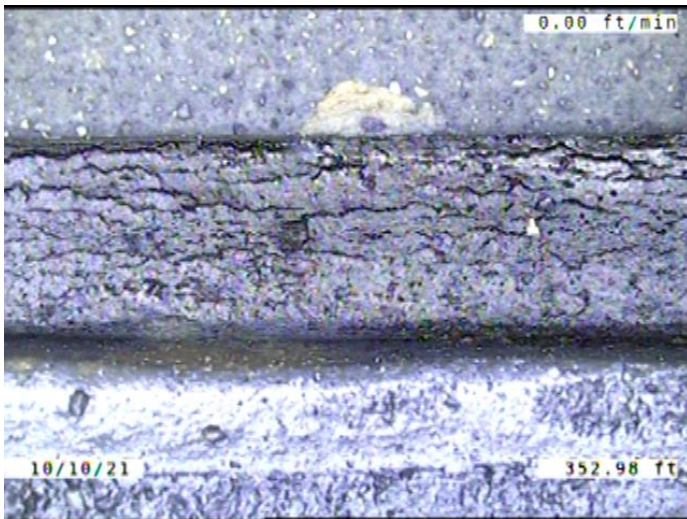
Code: **JAM**
Description: **Joint Angular Medium**

Distance (ft): **353.0**
Structural Grade: **3**
O&M Grade: **0**
Clock Start/From:
Clock To:
1st Value:
2nd Value:
Value Percent:
Continuous Index:
Within 8" of Joint: **NO**
Remarks:

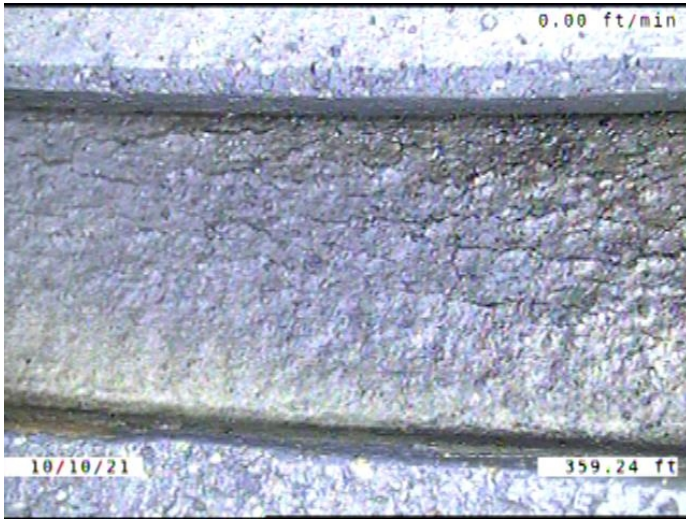
Code: **JAM**
Description: **Joint Angular Medium**

Distance (ft): **359.2**
Structural Grade: **3**
O&M Grade: **0**
Clock Start/From:
Clock To:
1st Value:
2nd Value:
Value Percent:
Continuous Index:
Within 8" of Joint: **NO**
Remarks:

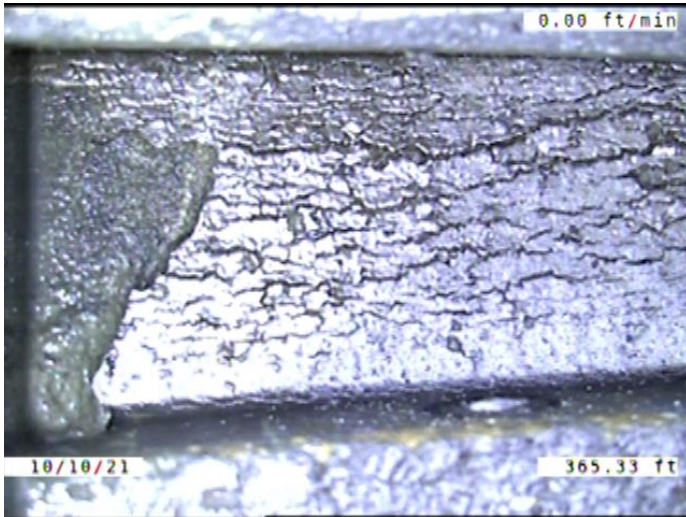
Code: **FM**
 Description: **Fracture Multiple**

Distance (ft): **362.2**
 Structural Grade: **4**
 O&M Grade: **0**
 Clock Start/From: **9**
 Clock To: **3**
 1st Value:
 2nd Value:
 Value Percent:
 Continuous Index:
 Within 8" of Joint: **YES**
 Remarks:

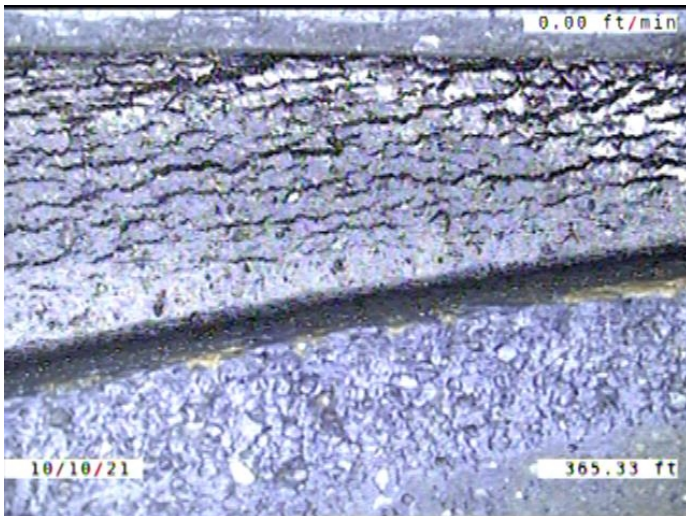
Code: **JAL**
Description: **Joint Angular Large**

Distance (ft): **365.3**
Structural Grade: **4**
O&M Grade: **0**
Clock Start/From:
Clock To:
1st Value:
2nd Value:
Value Percent:
Continuous Index:
Within 8" of Joint: **NO**
Remarks:

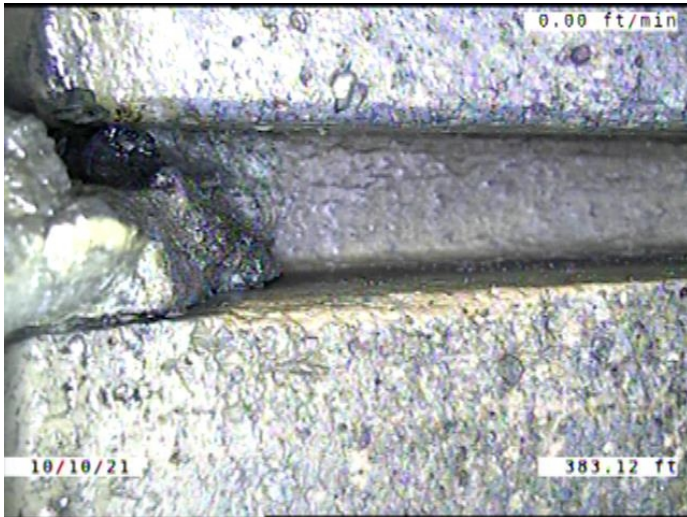
Code: **JAL**
Description: **Joint Angular Large**

Distance (ft): **374.6**
Structural Grade: **4**
O&M Grade: **0**
Clock Start/From:
Clock To:
1st Value:
2nd Value:
Value Percent:
Continuous Index:
Within 8" of Joint: **NO**
Remarks:

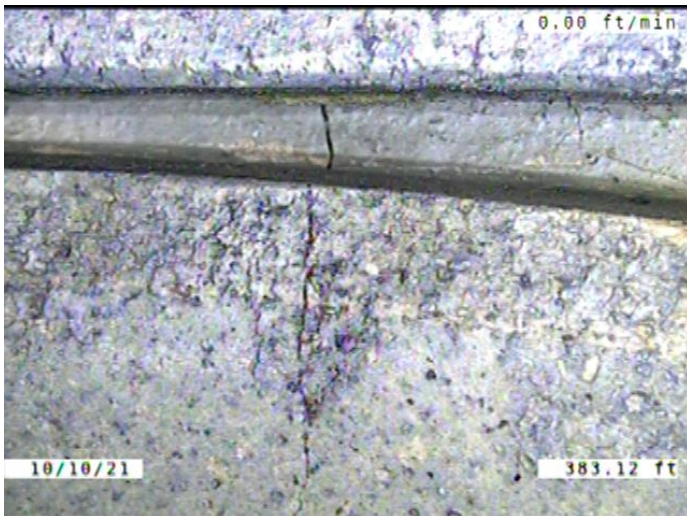
Code: **DAE**
 Description: **Deposits Attached Encrustation**

Distance (ft): **383.1**
 Structural Grade: **0**
 O&M Grade: **2**
 Clock Start/From: **9**
 Clock To:
 1st Value:
 2nd Value:
 Value Percent: **5.000**
 Continuous Index:
 Within 8" of Joint: **YES**
 Remarks:

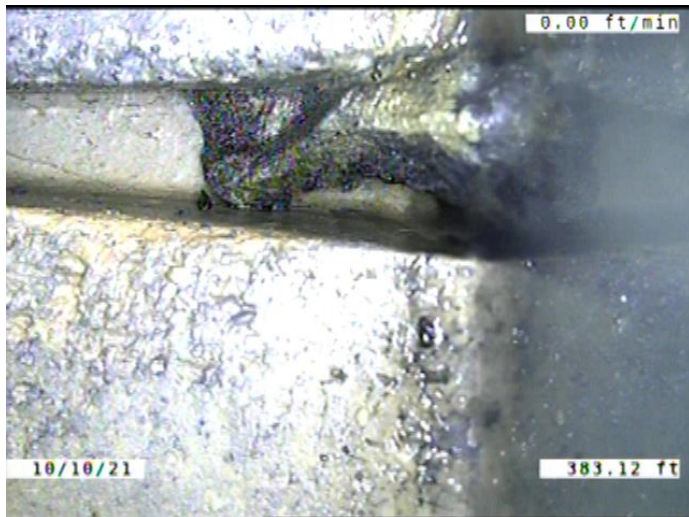
Code: **CM**
 Description: **Crack Multiple**

Distance (ft): **383.1**
 Structural Grade: **3**
 O&M Grade: **0**
 Clock Start/From: **9**
 Clock To: **3**
 1st Value:
 2nd Value:
 Value Percent:
 Continuous Index:
 Within 8" of Joint: **YES**
 Remarks:

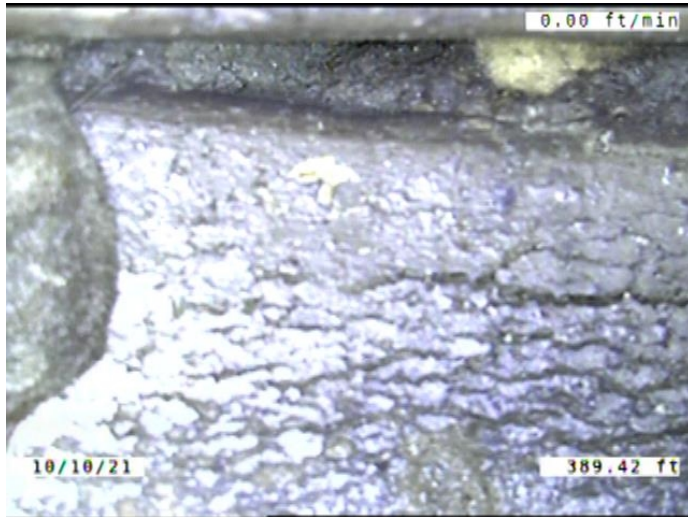
Code: **FM**
 Description: **Fracture Multiple**

Distance (ft): **385.1**
 Structural Grade: **4**
 O&M Grade: **0**
 Clock Start/From: **9**
 Clock To: **3**
 1st Value:
 2nd Value:
 Value Percent:
 Continuous Index:
 Within 8" of Joint: **YES**
 Remarks:

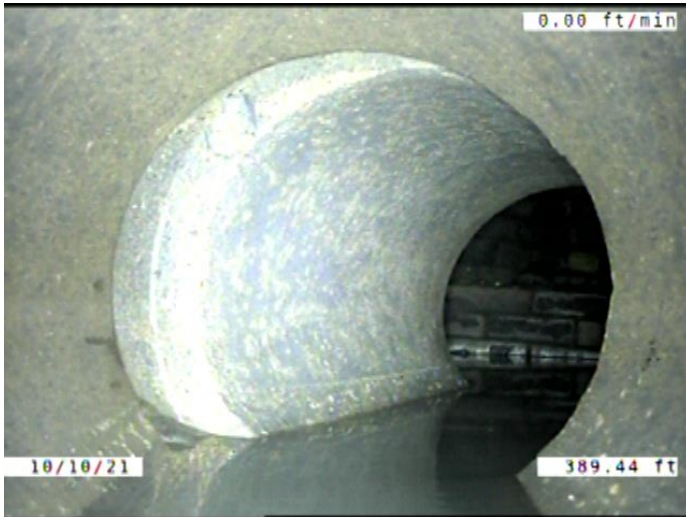
Code: **FM**
 Description: **Fracture Multiple**

Distance (ft): **389.4**
 Structural Grade: **4**
 O&M Grade: **0**
 Clock Start/From: **8**
 Clock To: **2**
 1st Value:
 2nd Value:
 Value Percent:
 Continuous Index:
 Within 8" of Joint: **YES**
 Remarks:

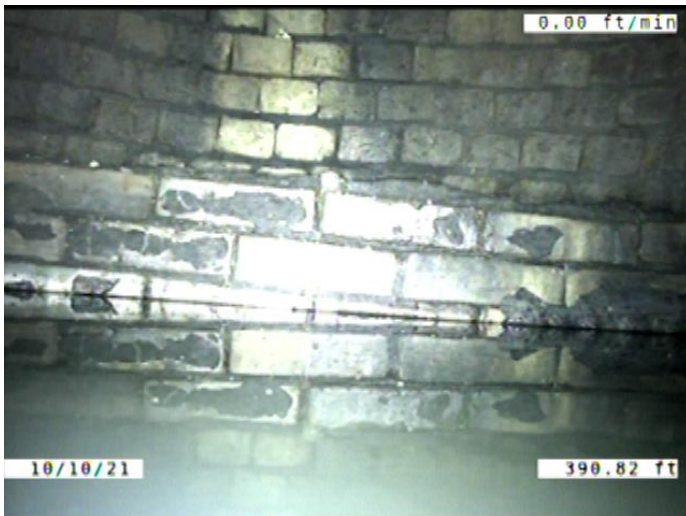
Code: **LR**
 Description: **Line Right**

Distance (ft): **389.4**
 Structural Grade: **0**
 O&M Grade: **4**
 Clock Start/From:
 Clock To:
 1st Value:
 2nd Value:
 Value Percent: **35.000**
 Continuous Index:
 Within 8" of Joint: **NO**
 Remarks:
