Profile/Photo Observation Report

Date:	10/10/2021	Weather:		Coding:	PACP 7.0
Pipe Length (ft):	393.6	Owner:	City of Hobart	Pre Clean:	Heavy Cleaning
P.O.#:	YES502259	Surveyor:	S. Bucklin	PSR:	P-704-015-014
Customer:	City of Hobart	Clean Date:	10/09/2021	Shape:	C

Street:	East Home Avenue	Flow Control:	Not Controlled
City:	Hobart, IN	Year Renewed:	
Location:	Local rural streets with light traffic, t	Tape/Media #:	
Purpose:	Routine Assessment	Dia/Height:	12"
Use:	Sanitary Sewage Pipe	Material:	VCP
Drain Area:		Lining:	
Category:	NA		
Comment:			
Location Details:		Direction of Survey:	Upstream
US MH:	M-704-014	DS MH:	M-704-015
		Total Length Surveyed (ft):	393.6

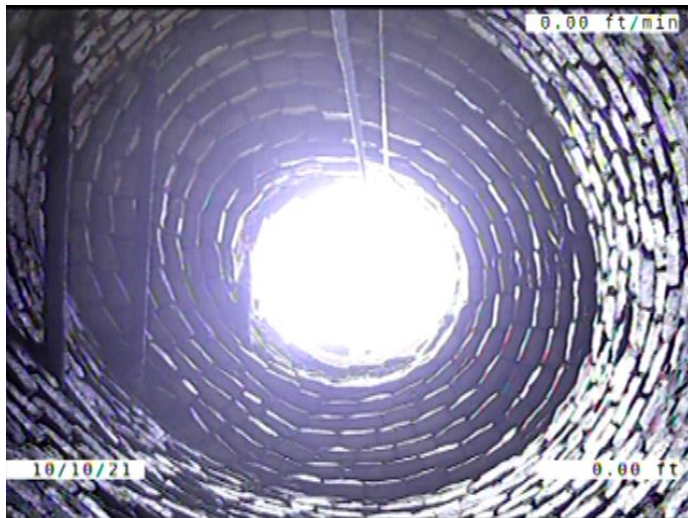
Code: **AMH**
Description: **Manhole**

Distance (ft): **.0**
Structural Grade: **0**
O&M Grade: **0**
Clock Start/From:
Clock To:
1st Value:
2nd Value:
Value Percent:
Continuous Index:
Within 8" of Joint: **NO**
Remarks: **M-704-015**

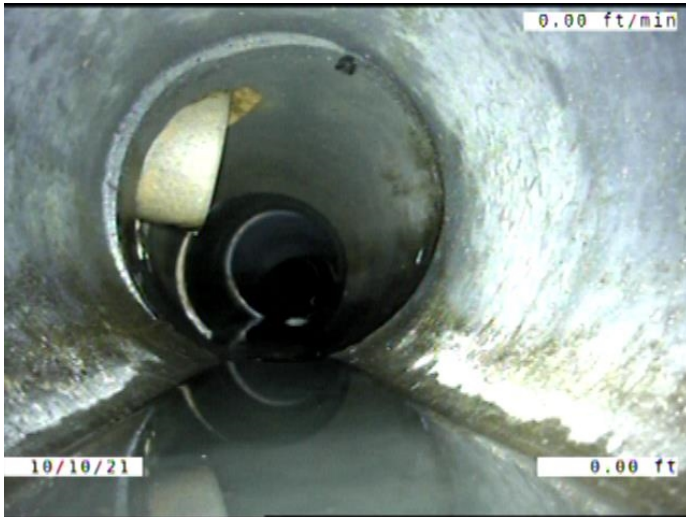
Code: **MWL**
 Description: **Miscellaneous Water Level**

Distance (ft): **.0**
 Structural Grade: **0**
 O&M Grade: **0**
 Clock Start/From:
 Clock To:
 1st Value:
 2nd Value:
 Value Percent: **5.000**
 Continuous Index:
 Within 8" of Joint: **NO**
 Remarks:

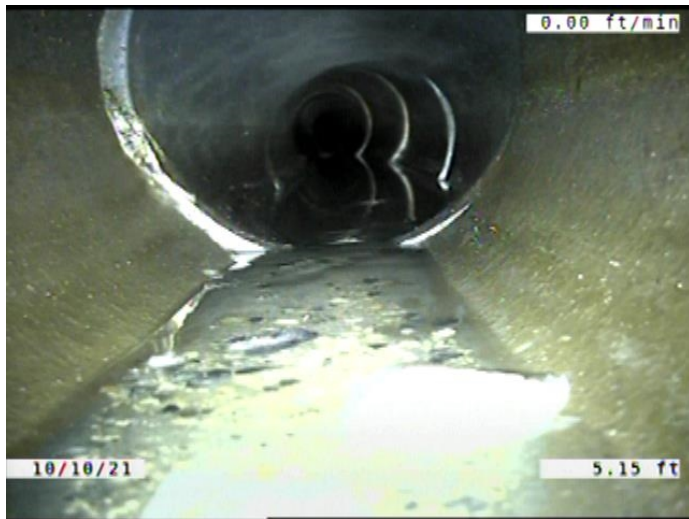
Code: **DSF**
 Description: **Deposits Settled Fine**

Distance (ft): **5.2**
 Structural Grade: **0**
 O&M Grade: **2**
 Clock Start/From: **5**
 Clock To: **7**
 1st Value:
 2nd Value:
 Value Percent: **5.000**
 Continuous Index: **S01**
 Within 8" of Joint: **YES**
 Remarks:

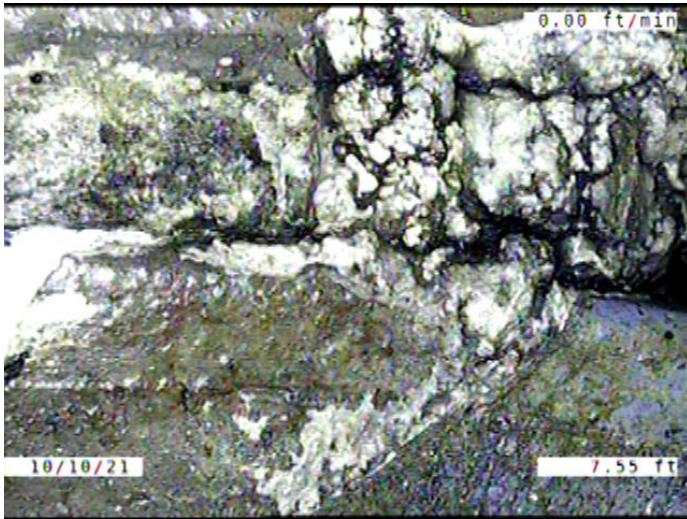
Code: **DAE**
 Description: **Deposits Attached Encrustation**

Distance (ft): **7.5**
 Structural Grade: **0**
 O&M Grade: **2**
 Clock Start/From: **8**
 Clock To: **9**
 1st Value:
 2nd Value:
 Value Percent: **5.000**
 Continuous Index:
 Within 8" of Joint: **YES**
 Remarks:

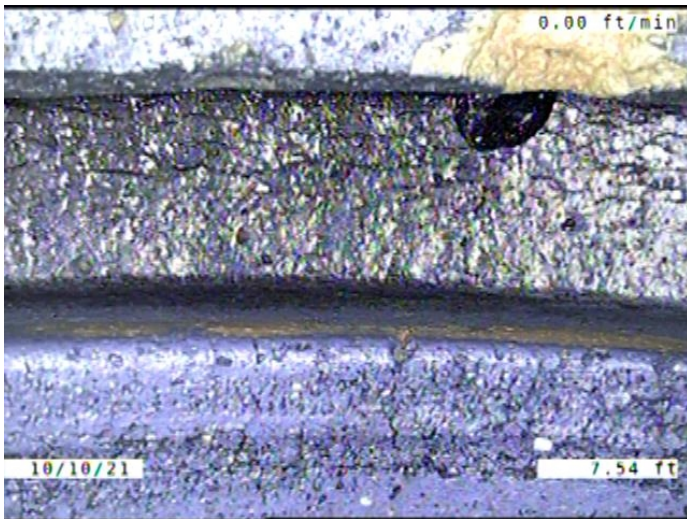
Code: **JAM**
 Description: **Joint Angular Medium**

Distance (ft): **7.5**
 Structural Grade: **3**
 O&M Grade: **0**
 Clock Start/From:
 Clock To:
 1st Value:
 2nd Value:
 Value Percent:
 Continuous Index:
 Within 8" of Joint: **NO**
 Remarks:

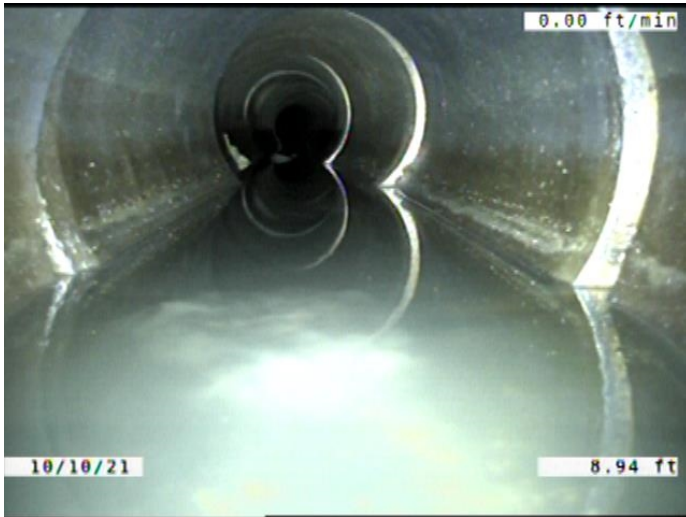
Code: **MWLS**
Description: **Miscellaneous Water Level Sag**

Distance (ft): **8.9**
Structural Grade: **2**
O&M Grade: **0**
Clock Start/From:
Clock To:
1st Value:
2nd Value:
Value Percent: **10.000**
Continuous Index: **S02**
Within 8" of Joint: **NO**
Remarks:

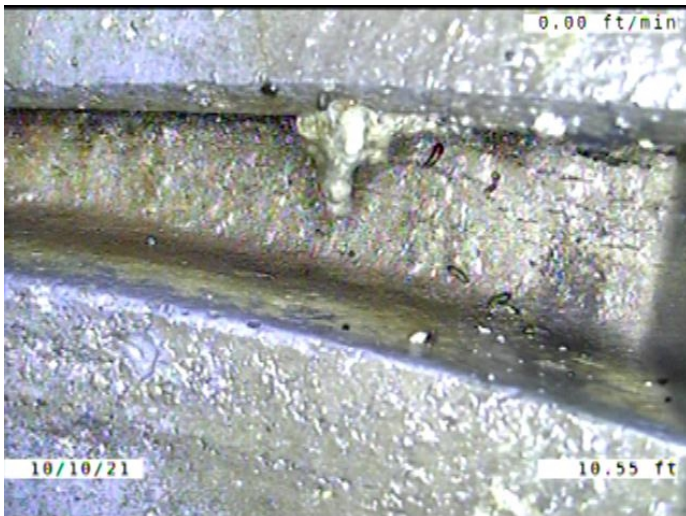
Code: **JAM**
Description: **Joint Angular Medium**

Distance (ft): **10.5**
Structural Grade: **3**
O&M Grade: **0**
Clock Start/From:
Clock To:
1st Value:
2nd Value:
Value Percent:
Continuous Index:
Within 8" of Joint: **NO**
Remarks:

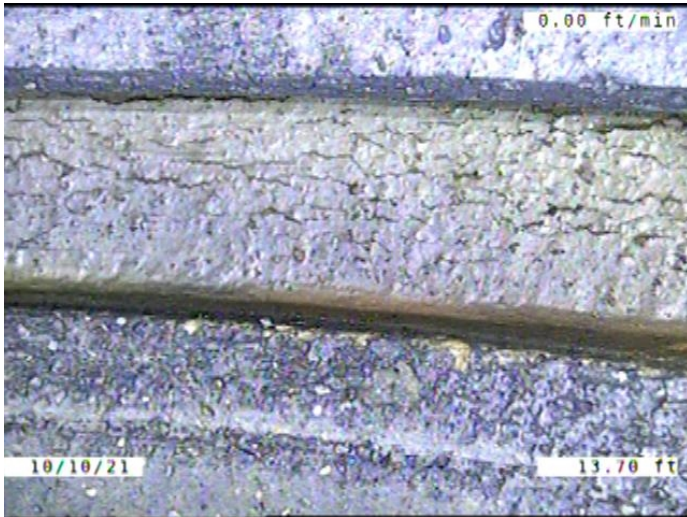
Code: **JAM**
 Description: **Joint Angular Medium**

Distance (ft): **13.7**
 Structural Grade: **3**
 O&M Grade: **0**
 Clock Start/From:
 Clock To:
 1st Value:
 2nd Value:
 Value Percent:
 Continuous Index:
 Within 8" of Joint: **NO**
 Remarks:

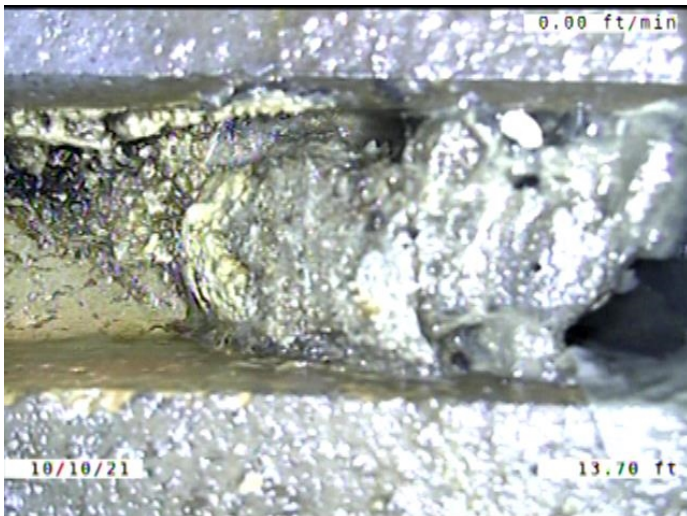
Code: **DAE**
 Description: **Deposits Attached Encrustation**

Distance (ft): **13.7**
 Structural Grade: **0**
 O&M Grade: **2**
 Clock Start/From: **3**
 Clock To: **4**
 1st Value:
 2nd Value:
 Value Percent: **5.000**
 Continuous Index:
 Within 8" of Joint: **YES**
 Remarks:

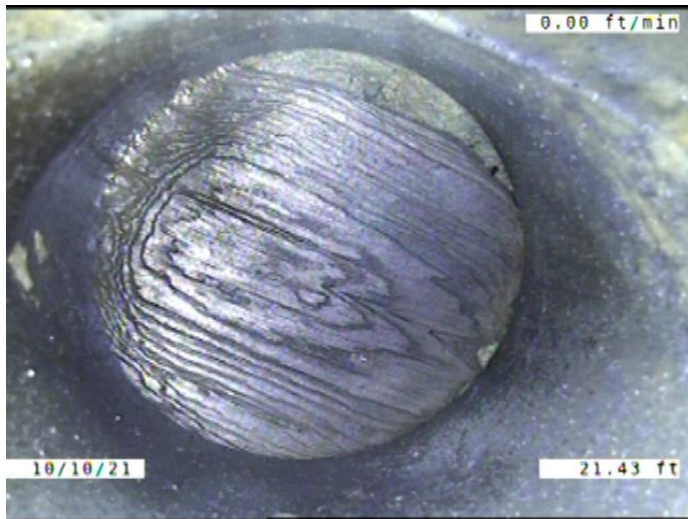
Code: **TFC**
 Description: **Tap Factory Capped**

Distance (ft): **21.4**
 Structural Grade: **0**
 O&M Grade: **0**
 Clock Start/From: **11**
 Clock To:
 1st Value: **4.000**
 2nd Value:
 Value Percent:
 Continuous Index:
 Within 8" of Joint: **YES**
 Remarks: **CAP LOOKS TO BE WOOD AND ROTTING AWAY**

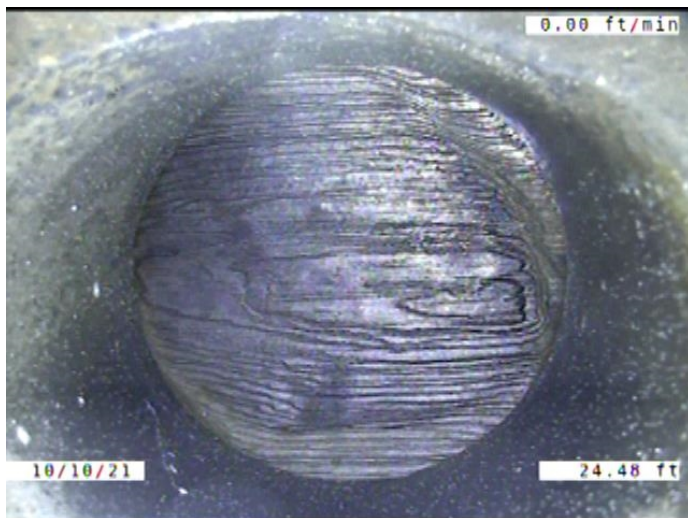
Code: **TFC**
 Description: **Tap Factory Capped**

Distance (ft): **24.5**
 Structural Grade: **0**
 O&M Grade: **0**
 Clock Start/From: **1**
 Clock To:
 1st Value: **4.000**
 2nd Value:
 Value Percent:
 Continuous Index:
 Within 8" of Joint: **YES**
 Remarks:

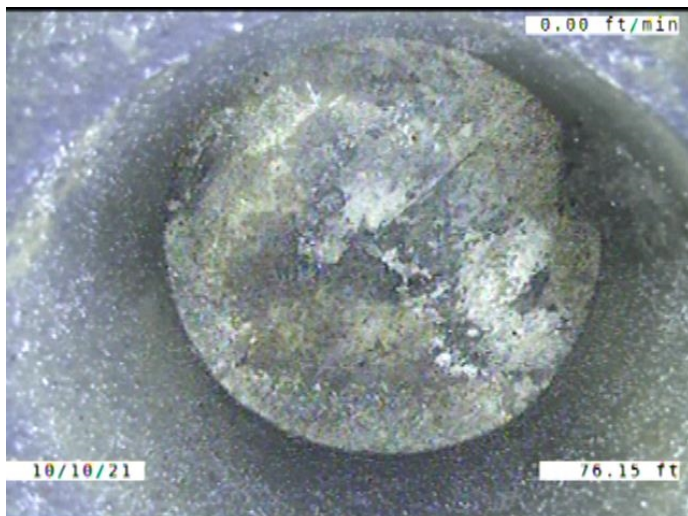
Code: **TFC**
 Description: **Tap Factory Capped**

Distance (ft): **76.2**
 Structural Grade: **0**
 O&M Grade: **0**
 Clock Start/From: **1**
 Clock To:
 1st Value: **4.000**
 2nd Value:
 Value Percent:
 Continuous Index:
 Within 8" of Joint: **YES**
 Remarks:

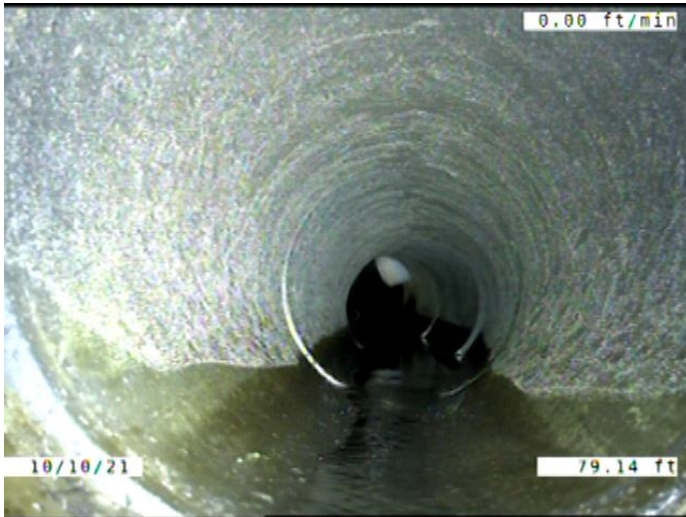
Code: **MWLS**
 Description: **Miscellaneous Water Level Sag**

Distance (ft): **79.1**
 Structural Grade: **2**
 O&M Grade: **0**
 Clock Start/From:
 Clock To:
 1st Value:
 2nd Value:
 Value Percent: **10.000**
 Continuous Index: **F02**
 Within 8" of Joint: **NO**
 Remarks:

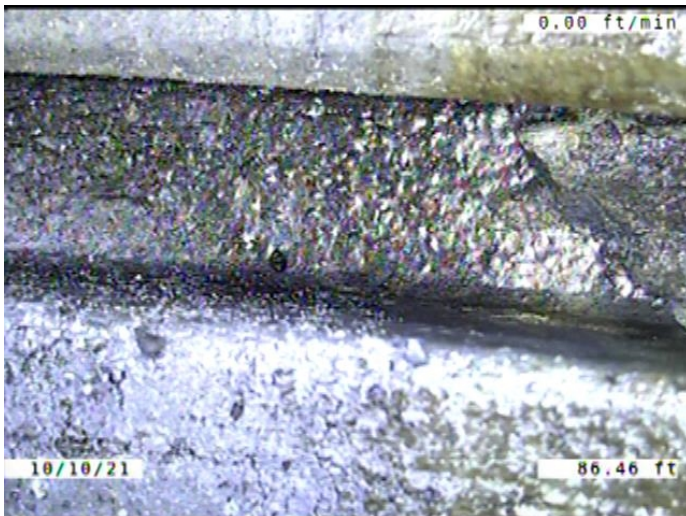
Code: **JAM**
 Description: **Joint Angular Medium**

Distance (ft): **86.5**
 Structural Grade: **3**
 O&M Grade: **0**
 Clock Start/From:
 Clock To:
 1st Value:
 2nd Value:
 Value Percent:
 Continuous Index:
 Within 8" of Joint: **NO**
 Remarks:

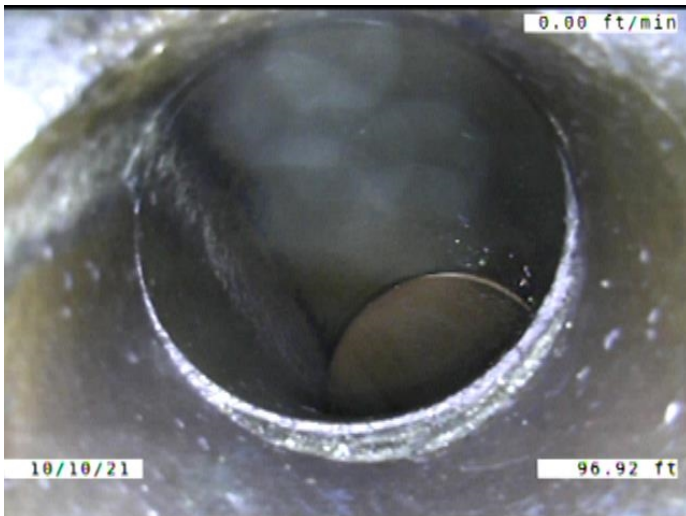
Code: **TF**
Description: **Tap Factory**

Distance (ft): **96.9**
Structural Grade: **0**
O&M Grade: **0**
Clock Start/From: **10**
Clock To:
1st Value: **4.000**
2nd Value:
Value Percent:
Continuous Index:
Within 8" of Joint: **YES**
Remarks:

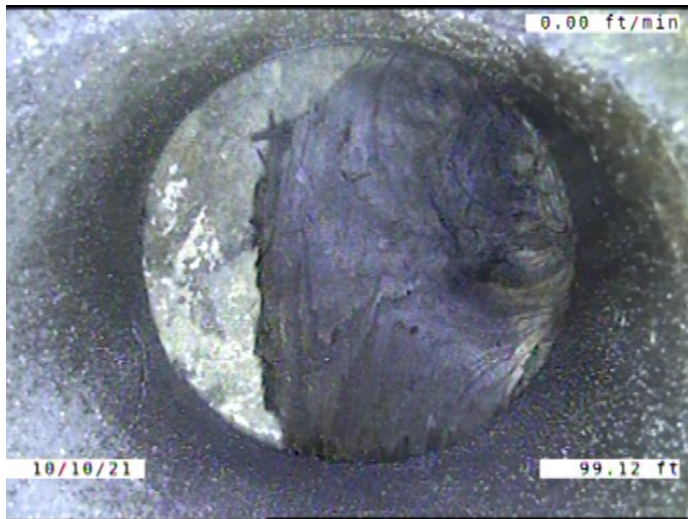
Code: **TFC**
 Description: **Tap Factory Capped**

Distance (ft): **99.1**
 Structural Grade: **0**
 O&M Grade: **0**
 Clock Start/From: **1**
 Clock To:
 1st Value: **4.000**

2nd Value:
 Value Percent:
 Continuous Index:
 Within 8" of Joint: **YES**
 Remarks: **CAP LOOKS TO BE WOOD AND ROTTING AWAY**

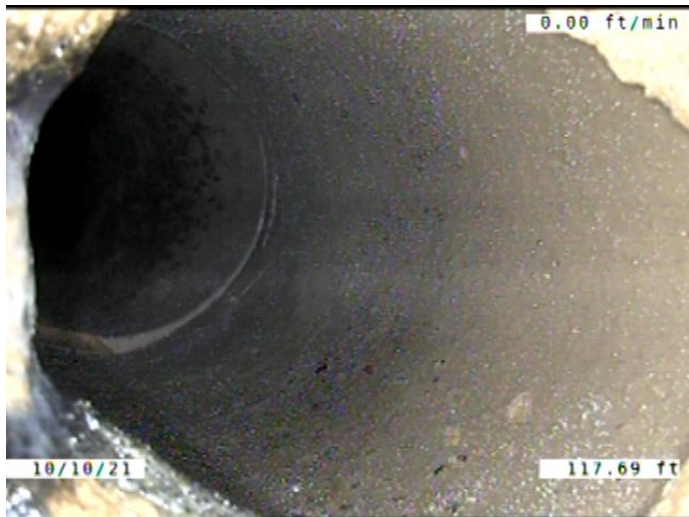
Code: **TB**
 Description: **Tap Break-in/Hammer**

Distance (ft): **117.7**
 Structural Grade: **0**
 O&M Grade: **0**
 Clock Start/From: **11**
 Clock To:
 1st Value: **4.000**
 2nd Value:
 Value Percent:
 Continuous Index:
 Within 8" of Joint: **YES**
 Remarks:

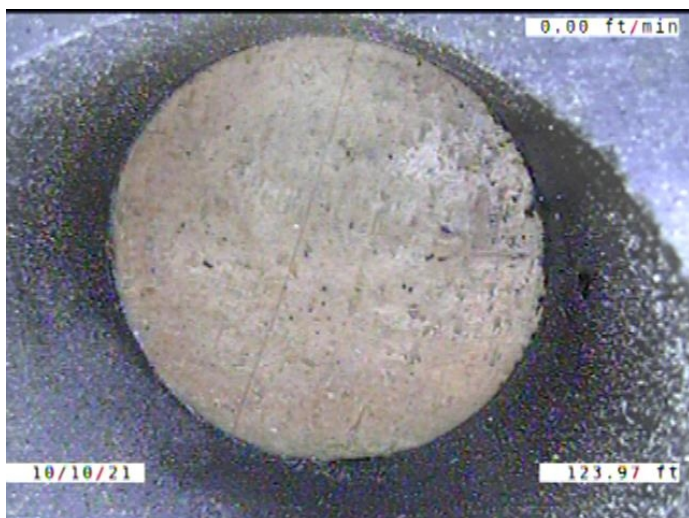
Code: **TFC**
 Description: **Tap Factory Capped**

Distance (ft): **124.0**
 Structural Grade: **0**
 O&M Grade: **0**
 Clock Start/From: **1**
 Clock To:
 1st Value: **4.000**
 2nd Value:
 Value Percent:
 Continuous Index:
 Within 8" of Joint: **YES**
 Remarks:

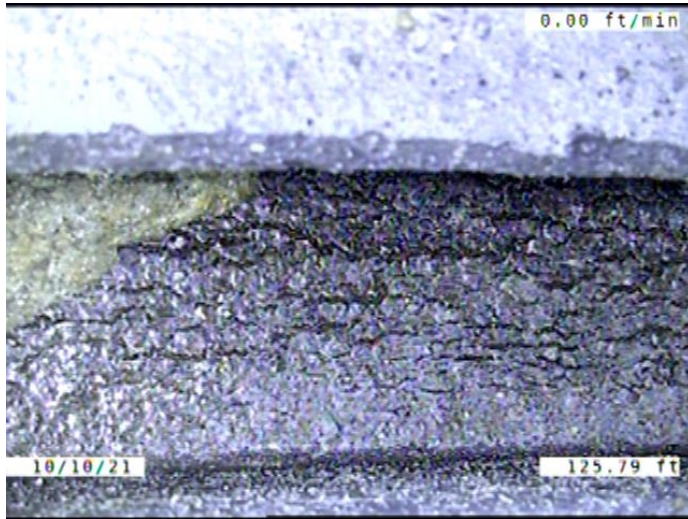
Code: **JAM**
 Description: **Joint Angular Medium**

Distance (ft): **125.8**
 Structural Grade: **3**
 O&M Grade: **0**
 Clock Start/From:
 Clock To:
 1st Value:
 2nd Value:
 Value Percent:
 Continuous Index:
 Within 8" of Joint: **NO**
 Remarks:

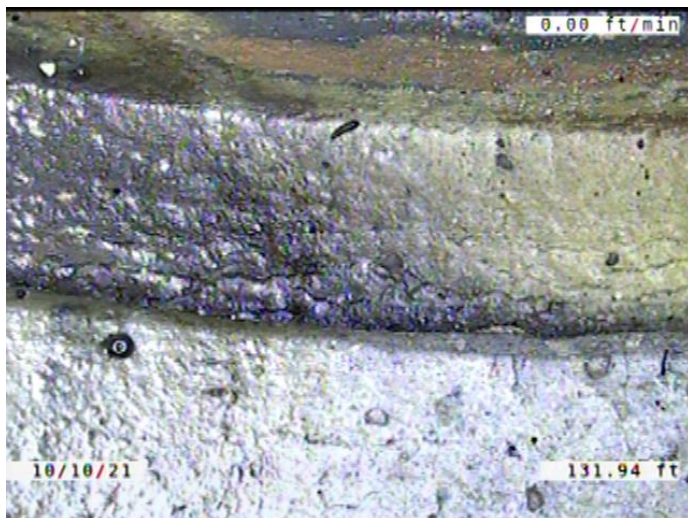
Code: **JAM**
 Description: **Joint Angular Medium**

Distance (ft): **131.9**
 Structural Grade: **3**
 O&M Grade: **0**
 Clock Start/From:
 Clock To:
 1st Value:
 2nd Value:
 Value Percent:
 Continuous Index:
 Within 8" of Joint: **NO**
 Remarks:

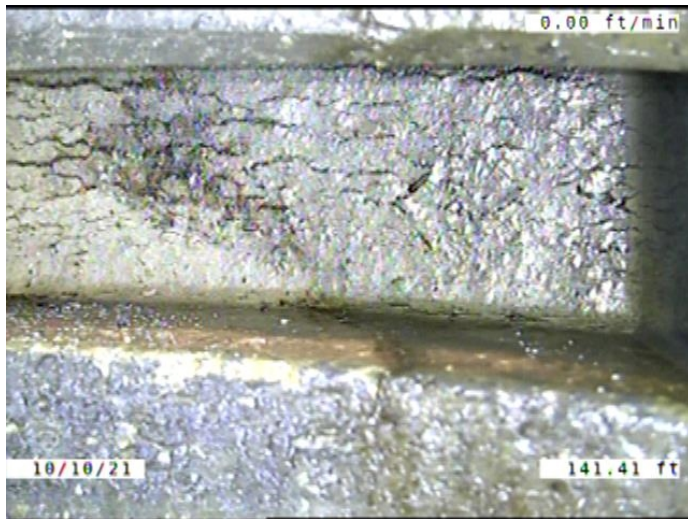
Code: **JAM**
 Description: **Joint Angular Medium**

Distance (ft): **141.4**
 Structural Grade: **3**
 O&M Grade: **0**
 Clock Start/From:
 Clock To:
 1st Value:
 2nd Value:
 Value Percent:
 Continuous Index:
 Within 8" of Joint: **NO**
 Remarks:

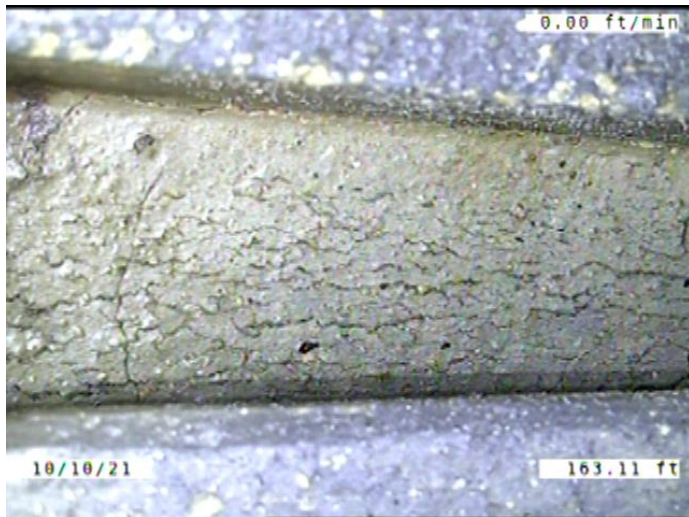
Code: **JAM**
 Description: **Joint Angular Medium**

Distance (ft): **163.1**
 Structural Grade: **3**
 O&M Grade: **0**
 Clock Start/From:
 Clock To:
 1st Value:
 2nd Value:
 Value Percent:
 Continuous Index:
 Within 8" of Joint: **NO**
 Remarks:

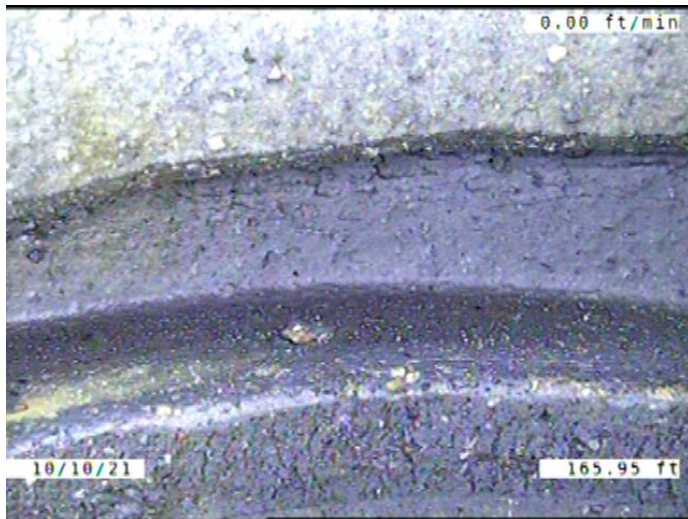
Code: **JAM**
Description: **Joint Angular Medium**

Distance (ft): **166.0**
Structural Grade: **3**
O&M Grade: **0**
Clock Start/From:
Clock To:
1st Value:
2nd Value:
Value Percent:
Continuous Index:
Within 8" of Joint: **NO**
Remarks:

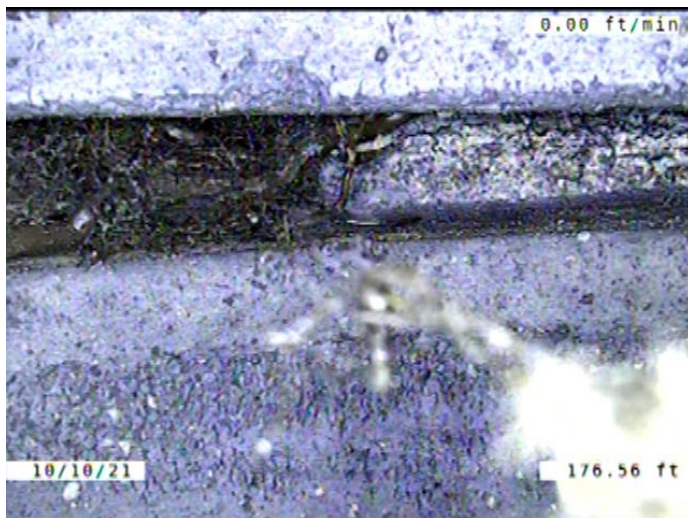
Code: **RFJ**
 Description: **Roots Fine Joint**

Distance (ft): **176.6**
 Structural Grade: **0**
 O&M Grade: **1**
 Clock Start/From: **11**
 Clock To: **12**
 1st Value:
 2nd Value:
 Value Percent:
 Continuous Index:
 Within 8" of Joint: **YES**
 Remarks:

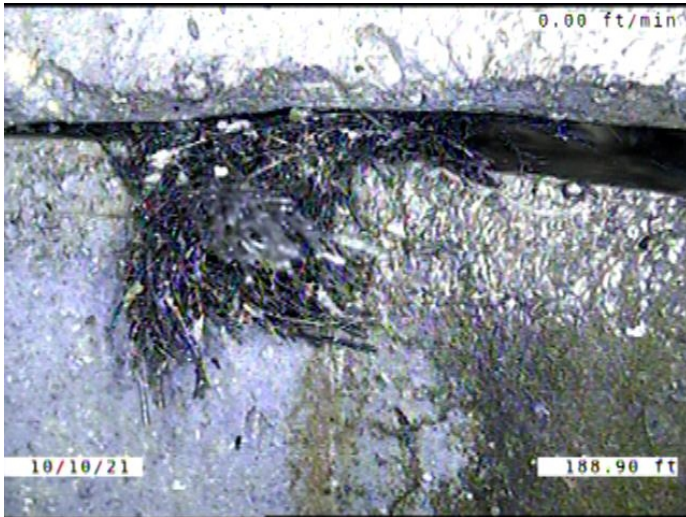
Code: **RFJ**
 Description: **Roots Fine Joint**

Distance (ft): **188.9**
 Structural Grade: **0**
 O&M Grade: **1**
 Clock Start/From: **2**
 Clock To: **3**
 1st Value:
 2nd Value:
 Value Percent:
 Continuous Index:
 Within 8" of Joint: **YES**
 Remarks:

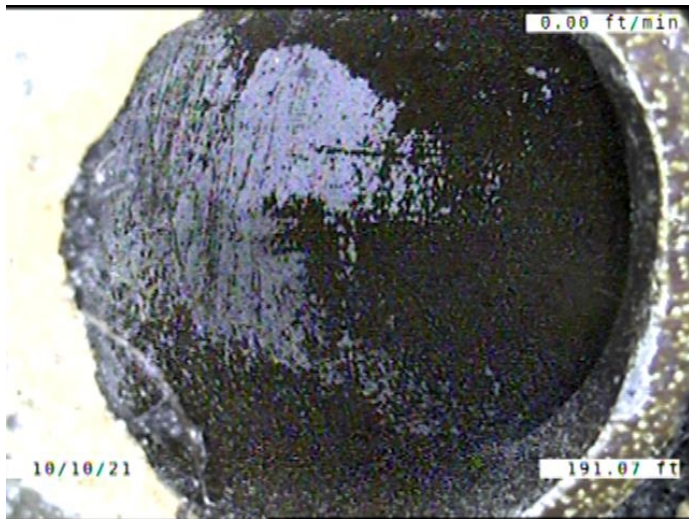
Code: **TB**
Description: **Tap Break-in/Hammer**

Distance (ft): **191.1**
Structural Grade: **0**
O&M Grade: **0**
Clock Start/From: **12**
Clock To:
1st Value: **4.000**
2nd Value:
Value Percent:
Continuous Index:
Within 8" of Joint: **YES**
Remarks:

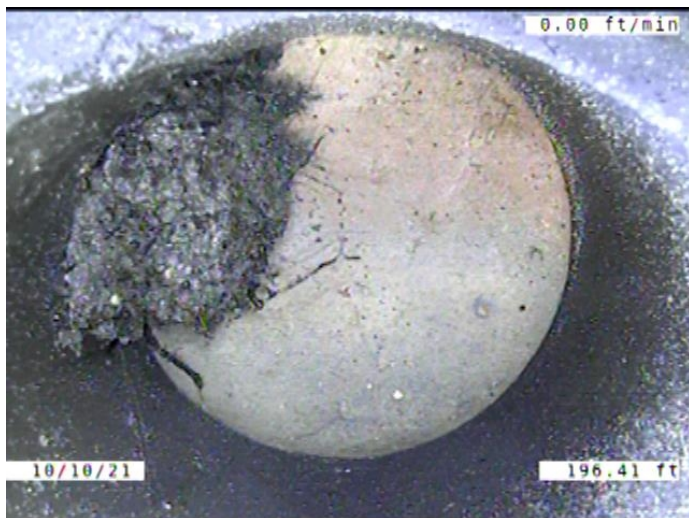
Code: **TFC**
Description: **Tap Factory Capped**

Distance (ft): **196.4**
Structural Grade: **0**
O&M Grade: **0**
Clock Start/From: **11**
Clock To:
1st Value: **4.000**
2nd Value:
Value Percent:
Continuous Index:
Within 8" of Joint: **YES**
Remarks: **ROOTS GROWING AROUND THE CAP**

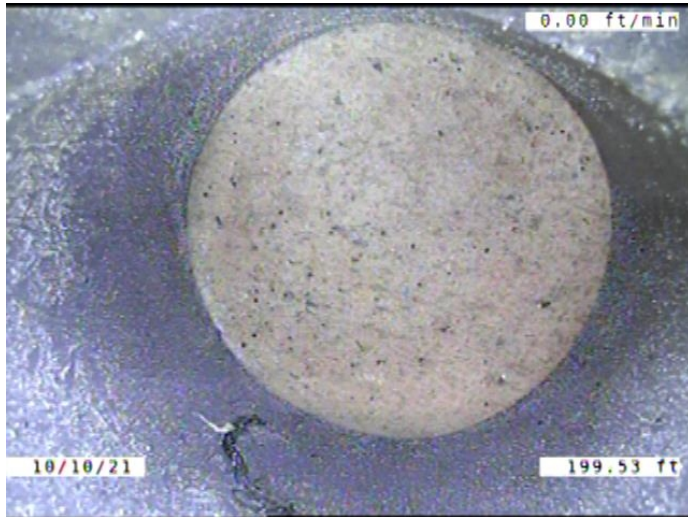
Code: **TFC**
 Description: **Tap Factory Capped**

Distance (ft): **199.5**
 Structural Grade: **0**
 O&M Grade: **0**
 Clock Start/From: **1**
 Clock To:
 1st Value: **4.000**
 2nd Value:
 Value Percent:
 Continuous Index:
 Within 8" of Joint: **YES**
 Remarks:

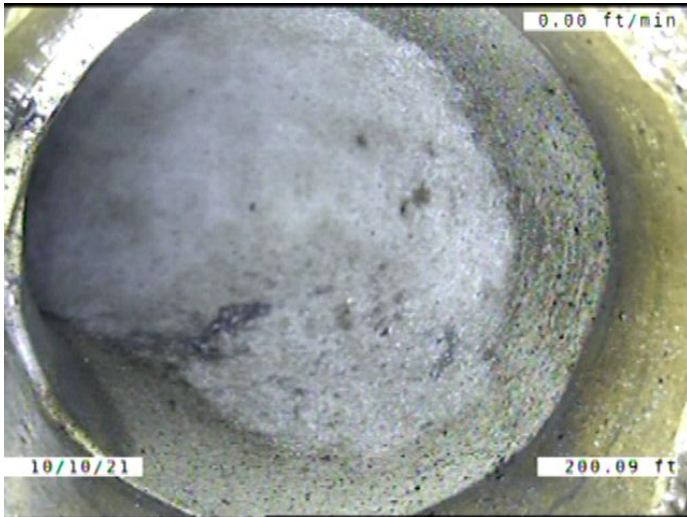
Code: **TB**
 Description: **Tap Break-in/Hammer**

Distance (ft): **200.1**
 Structural Grade: **0**
 O&M Grade: **0**
 Clock Start/From: **12**
 Clock To:
 1st Value: **4.000**
 2nd Value:
 Value Percent:
 Continuous Index:
 Within 8" of Joint: **YES**
 Remarks:

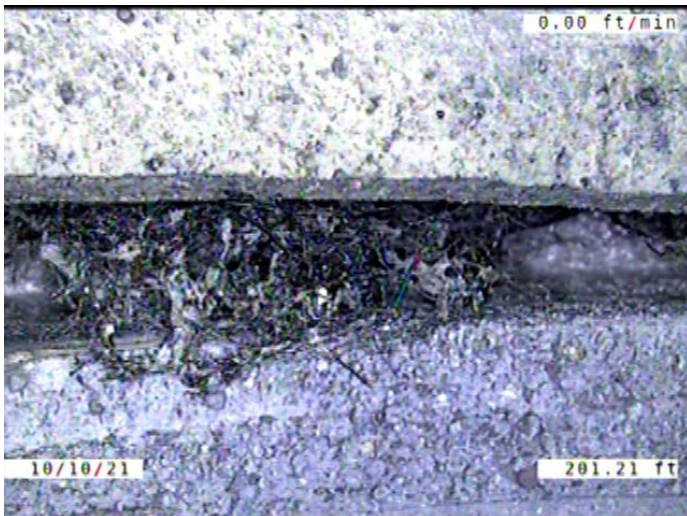
Code: **RFJ**
 Description: **Roots Fine Joint**

Distance (ft): **201.2**
 Structural Grade: **0**
 O&M Grade: **1**
 Clock Start/From: **9**
 Clock To: **3**
 1st Value:
 2nd Value:
 Value Percent:
 Continuous Index: **S03**
 Within 8" of Joint: **YES**
 Remarks:

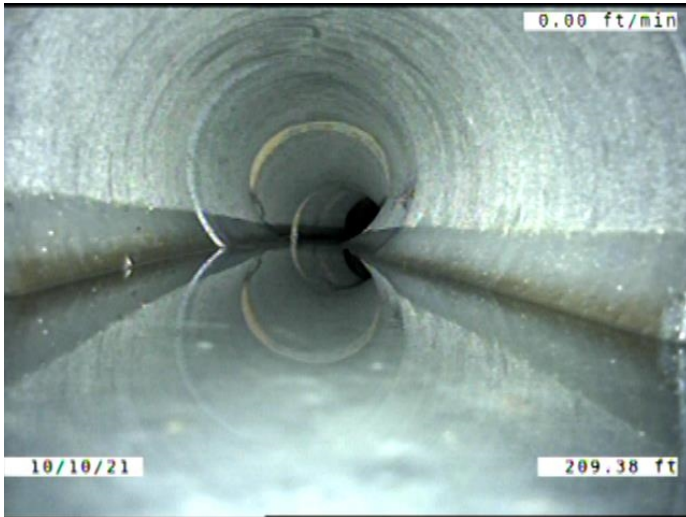
Code: **MWLS**
 Description: **Miscellaneous Water Level Sag**

Distance (ft): **209.4**
 Structural Grade: **2**
 O&M Grade: **0**
 Clock Start/From:
 Clock To:
 1st Value:
 2nd Value:
 Value Percent: **10.000**
 Continuous Index: **S04**
 Within 8" of Joint: **NO**
 Remarks:

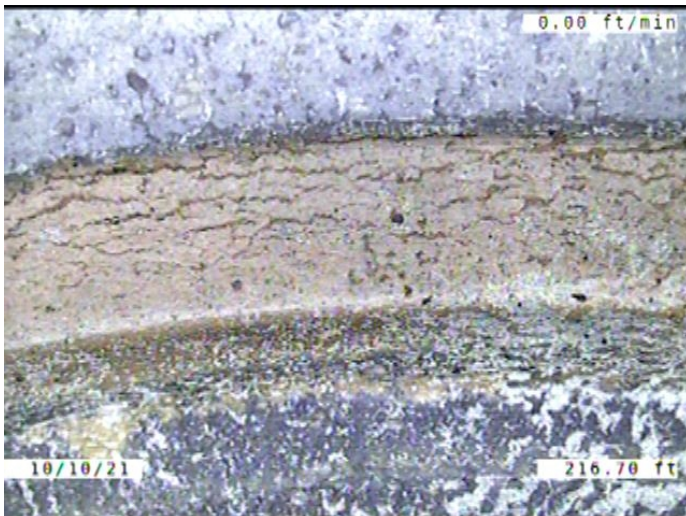
Code: **JAM**
 Description: **Joint Angular Medium**

Distance (ft): **216.7**
 Structural Grade: **3**
 O&M Grade: **0**
 Clock Start/From:
 Clock To:
 1st Value:
 2nd Value:
 Value Percent:
 Continuous Index:
 Within 8" of Joint: **NO**
 Remarks:

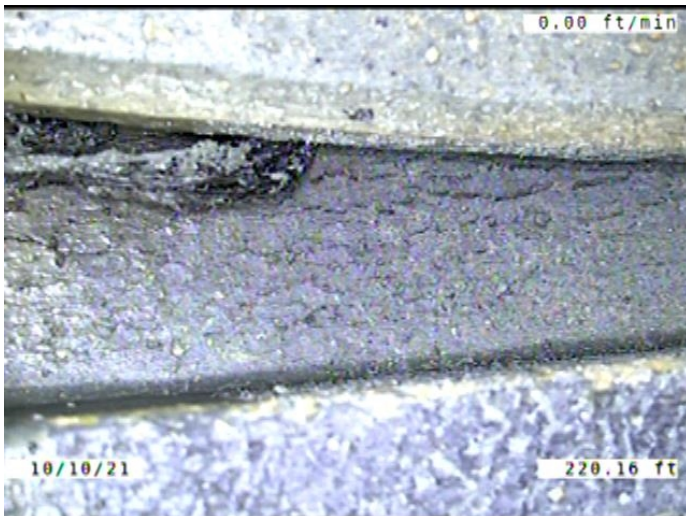
Code: **JAM**
 Description: **Joint Angular Medium**

Distance (ft): **220.2**
 Structural Grade: **3**
 O&M Grade: **0**
 Clock Start/From:
 Clock To:
 1st Value:
 2nd Value:
 Value Percent:
 Continuous Index:
 Within 8" of Joint: **NO**
 Remarks:

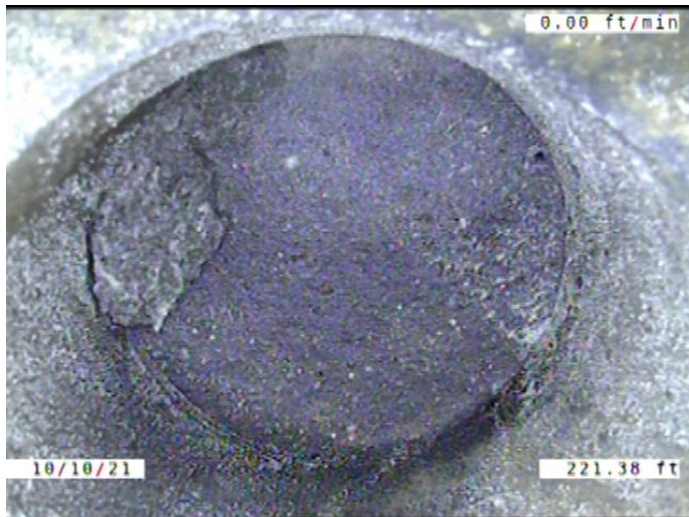
Code: **TFC**
 Description: **Tap Factory Capped**

Distance (ft): **221.4**
 Structural Grade: **0**
 O&M Grade: **0**
 Clock Start/From: **11**
 Clock To:
 1st Value: **4.000**
 2nd Value:
 Value Percent:
 Continuous Index:
 Within 8" of Joint: **YES**
 Remarks:

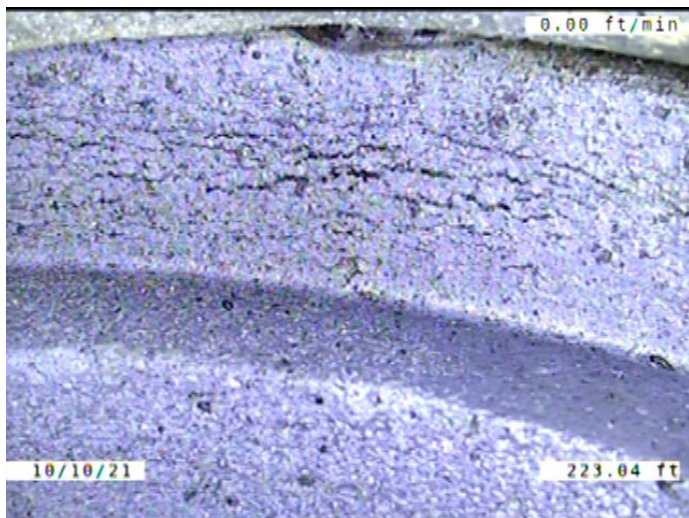
Code: **JAL**
 Description: **Joint Angular Large**

Distance (ft): **223.0**
 Structural Grade: **4**
 O&M Grade: **0**
 Clock Start/From:
 Clock To:
 1st Value:
 2nd Value:
 Value Percent:
 Continuous Index:
 Within 8" of Joint: **NO**
 Remarks:

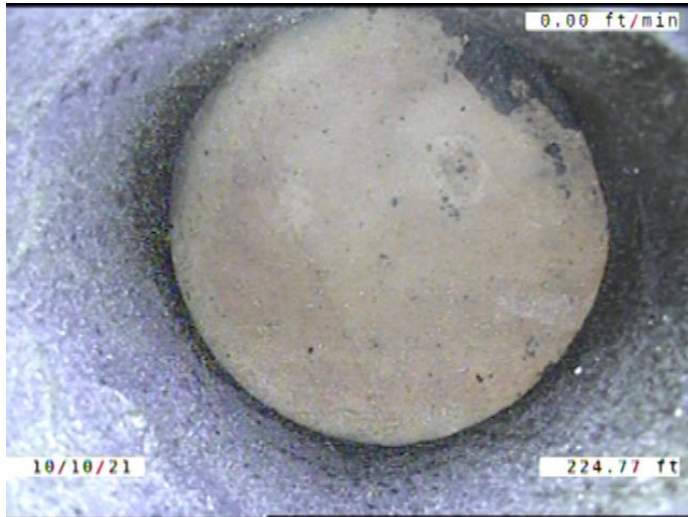
Code: **TFC**
 Description: **Tap Factory Capped**

Distance (ft): **224.8**
 Structural Grade: **0**
 O&M Grade: **0**
 Clock Start/From: **2**
 Clock To:
 1st Value: **4.000**
 2nd Value:
 Value Percent:
 Continuous Index:
 Within 8" of Joint: **YES**
 Remarks:

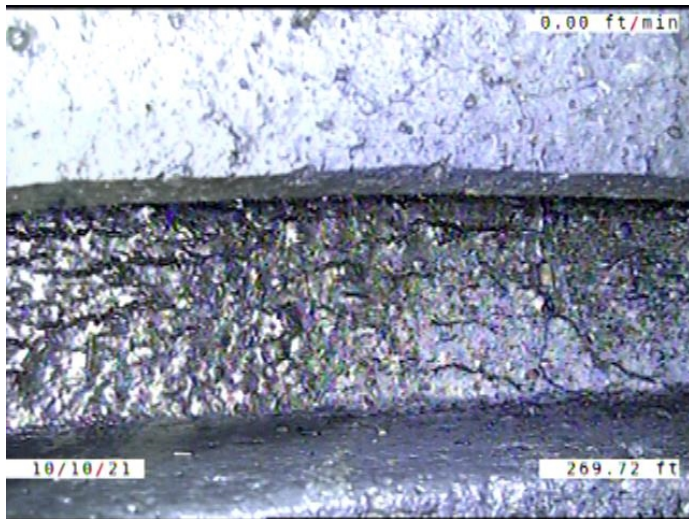
Code: **JAM**
 Description: **Joint Angular Medium**

Distance (ft): **269.7**
 Structural Grade: **3**
 O&M Grade: **0**
 Clock Start/From:
 Clock To:
 1st Value:
 2nd Value:
 Value Percent:
 Continuous Index:
 Within 8" of Joint: **NO**
 Remarks:

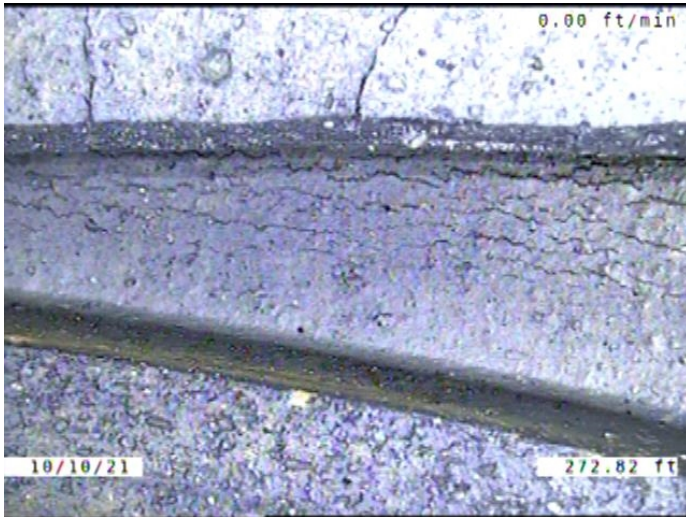
Code: **JAM**
 Description: **Joint Angular Medium**

Distance (ft): **272.8**
 Structural Grade: **3**
 O&M Grade: **0**
 Clock Start/From:
 Clock To:
 1st Value:
 2nd Value:
 Value Percent:
 Continuous Index:
 Within 8" of Joint: **NO**
 Remarks:

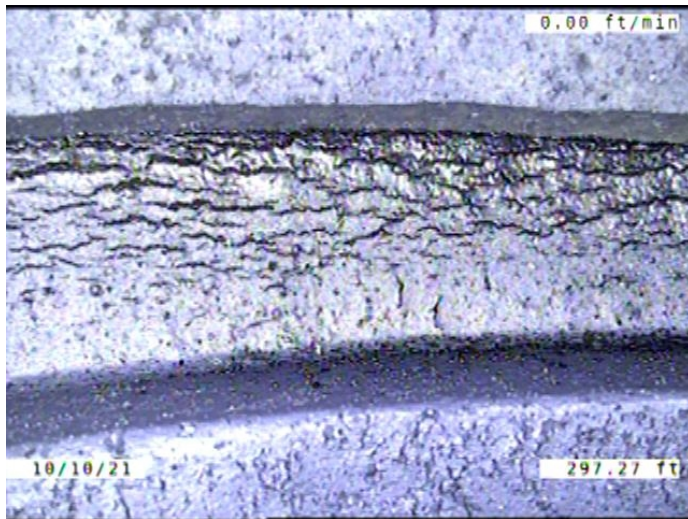
Code: **JAM**
Description: **Joint Angular Medium**

Distance (ft): **297.3**
Structural Grade: **3**
O&M Grade: **0**
Clock Start/From:
Clock To:
1st Value:
2nd Value:
Value Percent:
Continuous Index:
Within 8" of Joint: **NO**
Remarks:

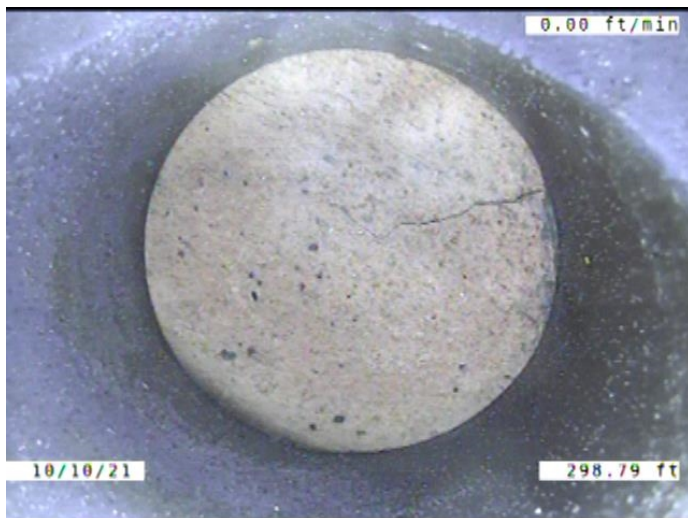
Code: **CM**
 Description: **Crack Multiple**

Distance (ft): **297.3**
 Structural Grade: **3**
 O&M Grade: **0**
 Clock Start/From: **8**
 Clock To: **1**
 1st Value:
 2nd Value:
 Value Percent:
 Continuous Index:
 Within 8" of Joint: **YES**
 Remarks:

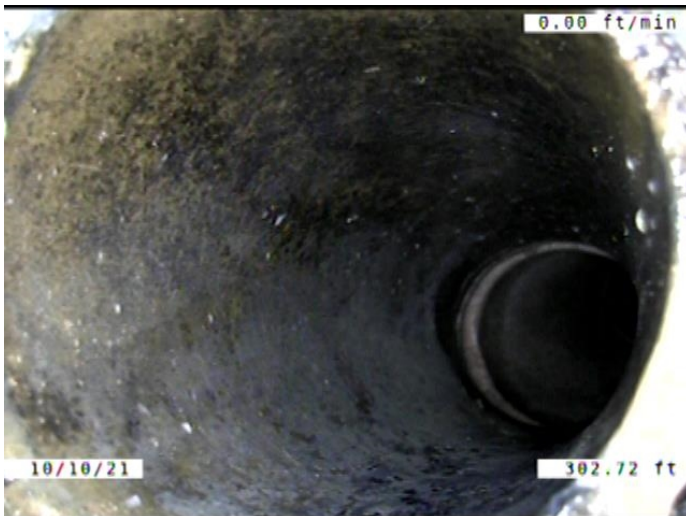
Code: **B**
 Description: **Broken**

Distance (ft): **302.6**
 Structural Grade: **4**
 O&M Grade: **0**
 Clock Start/From: **10**
 Clock To: **2**
 1st Value:
 2nd Value:
 Value Percent:
 Continuous Index:
 Within 8" of Joint: **YES**
 Remarks:

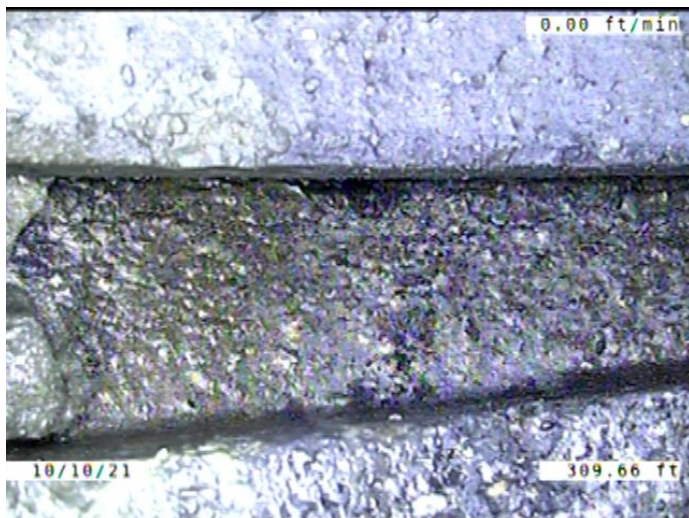
Code: **JAM**
Description: **Joint Angular Medium**

Distance (ft): **309.7**
Structural Grade: **3**
O&M Grade: **0**
Clock Start/From:
Clock To:
1st Value:
2nd Value:
Value Percent:
Continuous Index:
Within 8" of Joint: **NO**
Remarks:

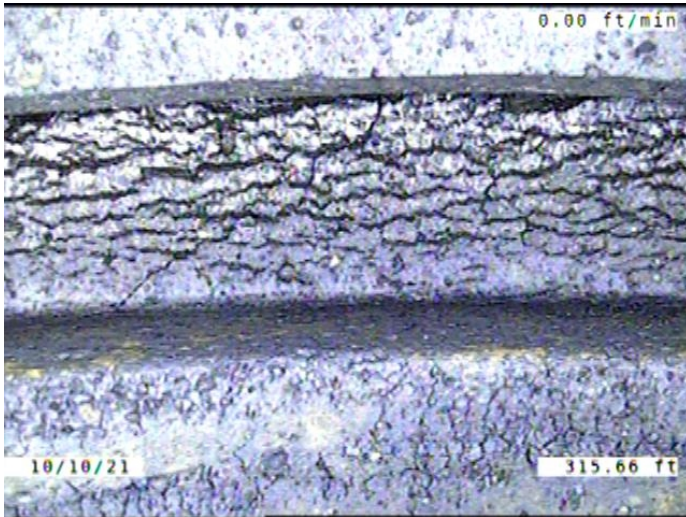
Code: **JAM**
 Description: **Joint Angular Medium**

Distance (ft): **315.7**
 Structural Grade: **3**
 O&M Grade: **0**
 Clock Start/From:
 Clock To:
 1st Value:
 2nd Value:
 Value Percent:
 Continuous Index:
 Within 8" of Joint: **NO**
 Remarks:

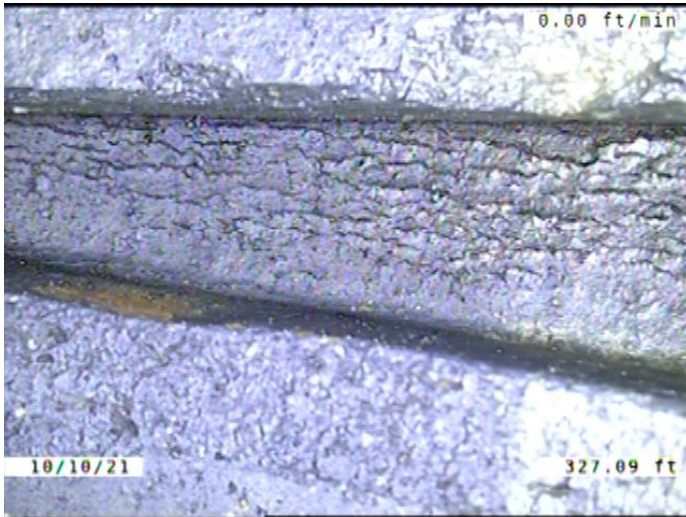
Code: **JAM**
Description: **Joint Angular Medium**

Distance (ft): **327.1**
Structural Grade: **3**
O&M Grade: **0**
Clock Start/From:
Clock To:
1st Value:
2nd Value:
Value Percent:
Continuous Index:
Within 8" of Joint: **NO**
Remarks:

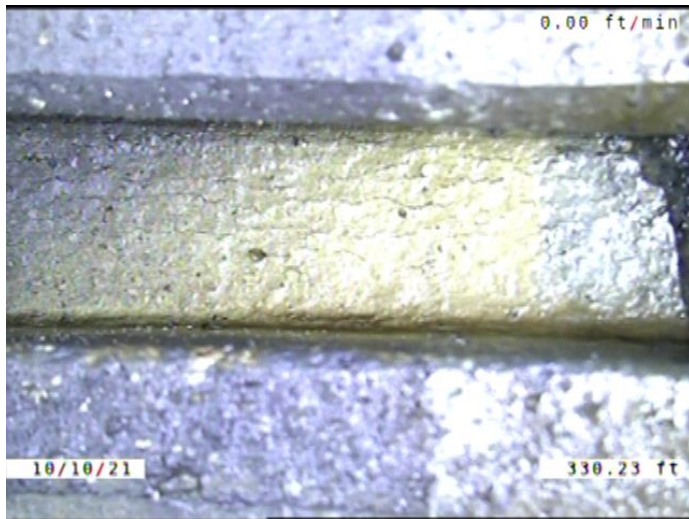
Code: **JAM**
 Description: **Joint Angular Medium**

Distance (ft): **330.2**
 Structural Grade: **3**
 O&M Grade: **0**
 Clock Start/From:
 Clock To:
 1st Value:
 2nd Value:
 Value Percent:
 Continuous Index:
 Within 8" of Joint: **NO**
 Remarks:

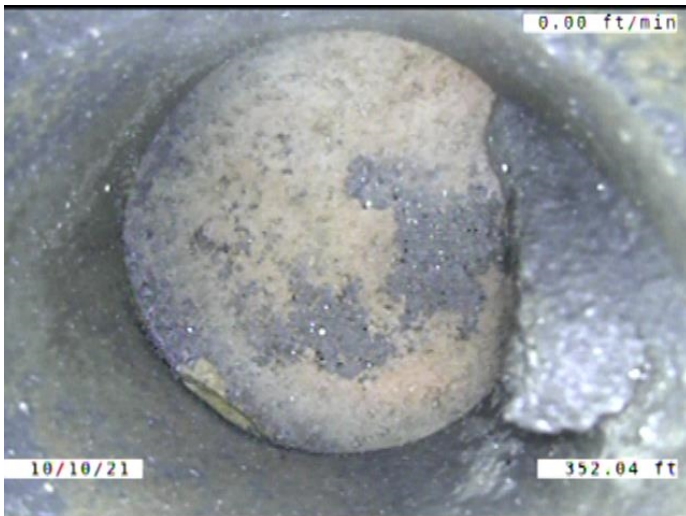
Code: **TFC**
Description: **Tap Factory Capped**

Distance (ft): **349.9**
Structural Grade: **0**
O&M Grade: **0**
Clock Start/From: **11**
Clock To:
1st Value: **4.000**
2nd Value:
Value Percent:
Continuous Index:
Within 8" of Joint: **YES**
Remarks:

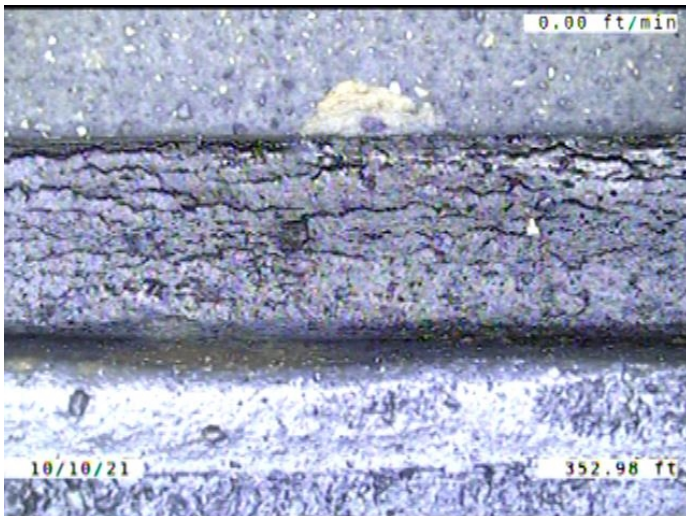
Code: **JAM**
 Description: **Joint Angular Medium**

Distance (ft): **353.0**
 Structural Grade: **3**
 O&M Grade: **0**
 Clock Start/From:
 Clock To:
 1st Value:
 2nd Value:
 Value Percent:
 Continuous Index:
 Within 8" of Joint: **NO**
 Remarks:

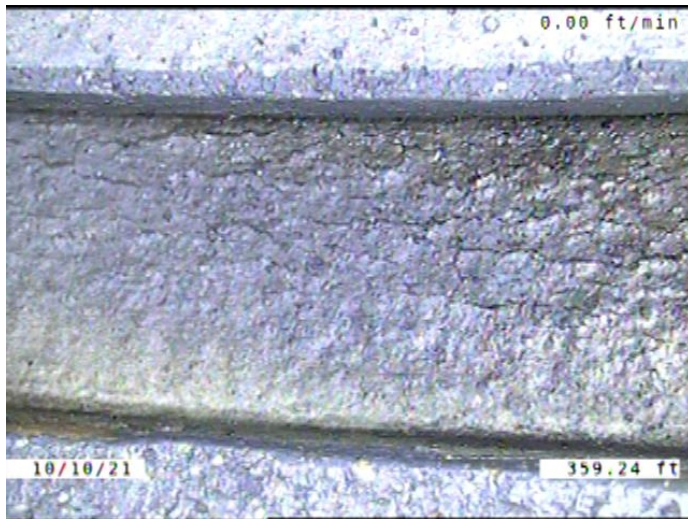
Code: **JAM**
 Description: **Joint Angular Medium**

Distance (ft): **359.2**
 Structural Grade: **3**
 O&M Grade: **0**
 Clock Start/From:
 Clock To:
 1st Value:
 2nd Value:
 Value Percent:
 Continuous Index:
 Within 8" of Joint: **NO**
 Remarks:

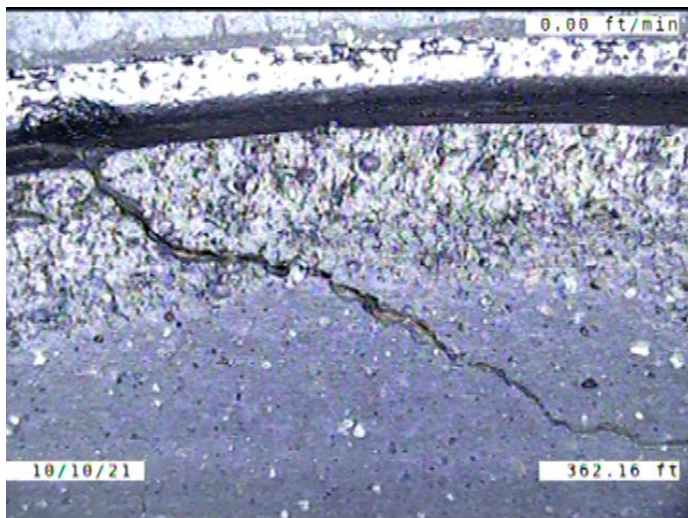
Code: **CM**
 Description: **Crack Multiple**

Distance (ft): **359.2**
 Structural Grade: **3**
 O&M Grade: **0**
 Clock Start/From: **12**
 Clock To: **3**
 1st Value:
 2nd Value:
 Value Percent:
 Continuous Index:
 Within 8" of Joint: **YES**
 Remarks:

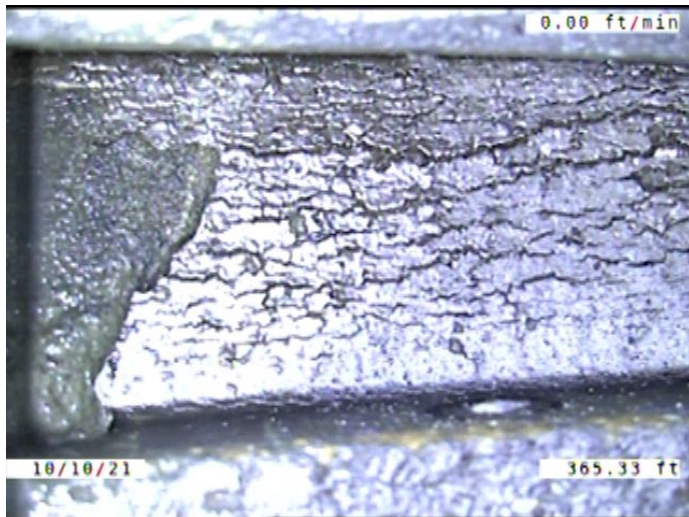
Code: **FM**
 Description: **Fracture Multiple**

Distance (ft): **362.2**
 Structural Grade: **4**
 O&M Grade: **0**
 Clock Start/From: **9**
 Clock To: **3**
 1st Value:
 2nd Value:
 Value Percent:
 Continuous Index:
 Within 8" of Joint: **YES**
 Remarks:

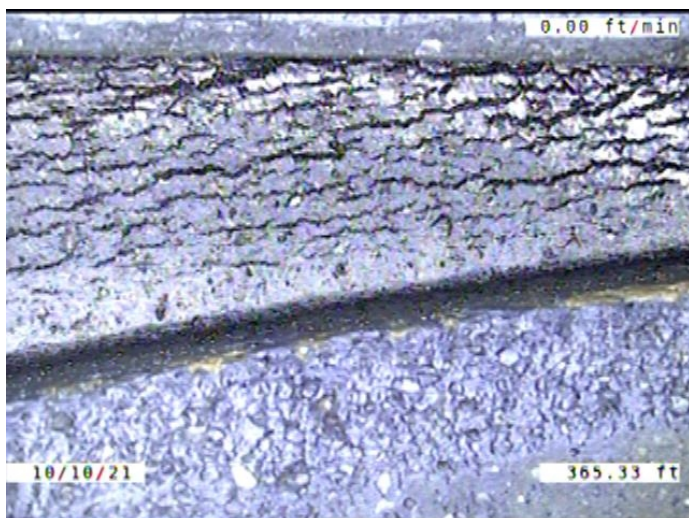
Code: **JAL**
 Description: **Joint Angular Large**

Distance (ft): **365.3**
 Structural Grade: **4**
 O&M Grade: **0**
 Clock Start/From:
 Clock To:
 1st Value:
 2nd Value:
 Value Percent:
 Continuous Index:
 Within 8" of Joint: **NO**
 Remarks:

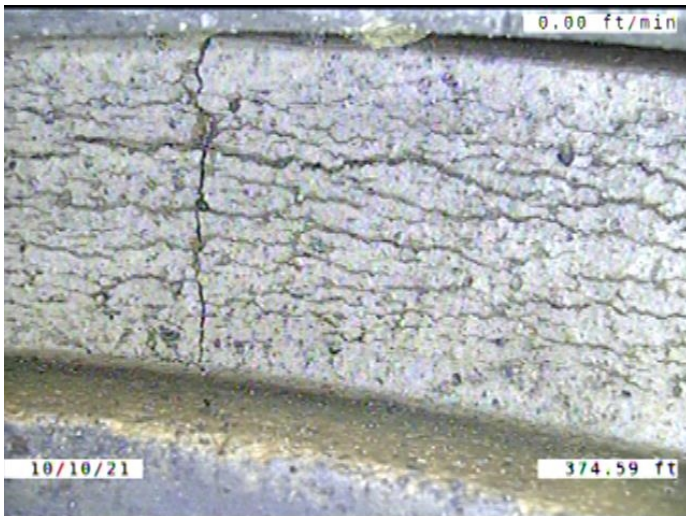
Code: **CM**
 Description: **Crack Multiple**

Distance (ft): **374.6**
 Structural Grade: **3**
 O&M Grade: **0**
 Clock Start/From: **11**
 Clock To: **3**
 1st Value:
 2nd Value:
 Value Percent:
 Continuous Index:
 Within 8" of Joint: **YES**
 Remarks:

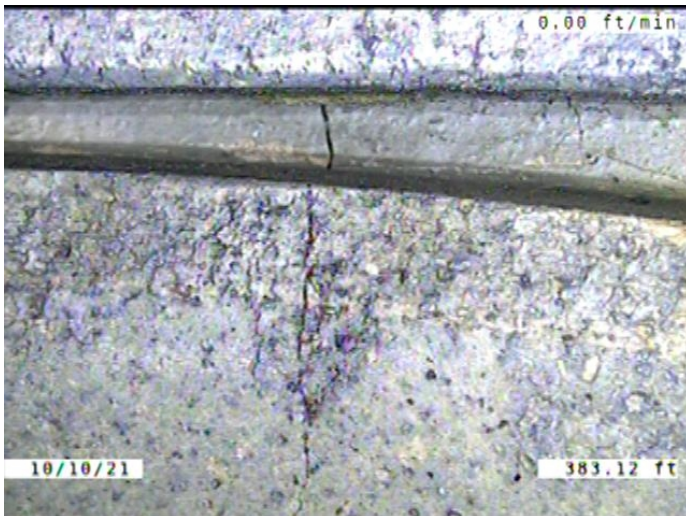
Code: **DAE**
 Description: **Deposits Attached Encrustation**

Distance (ft): **383.1**
 Structural Grade: **0**
 O&M Grade: **2**
 Clock Start/From: **9**
 Clock To:
 1st Value:
 2nd Value:
 Value Percent: **5.000**
 Continuous Index:
 Within 8" of Joint: **YES**
 Remarks:
